Re: Hazardous Building Materials Assessment (Preconstruction)

Renovations to Sir Allan MacNab Secondary School
145 Magnolia Drive, Hamilton, ON
Pinchin File: 352293.014

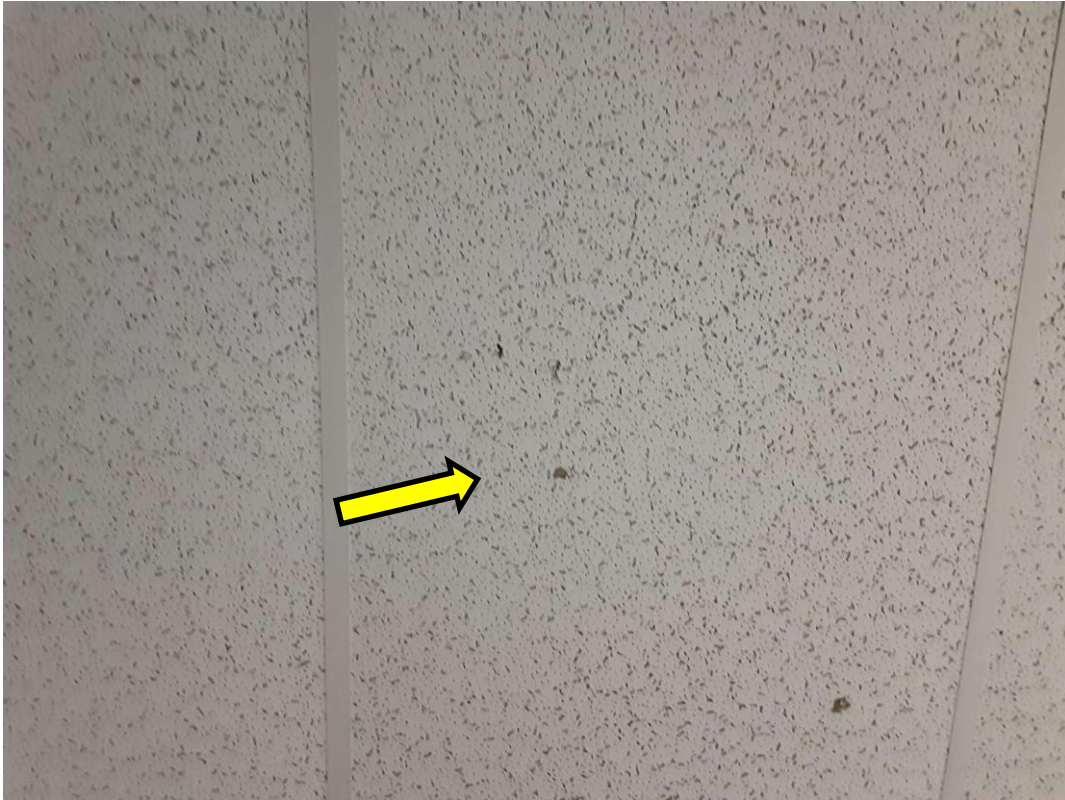
V0000 (None), 2' x 4' Fissures and Pinholes, 08/15/07, Ceiling, All, Ceiling Tiles (lay-in), Corridor (Location #: 7744)

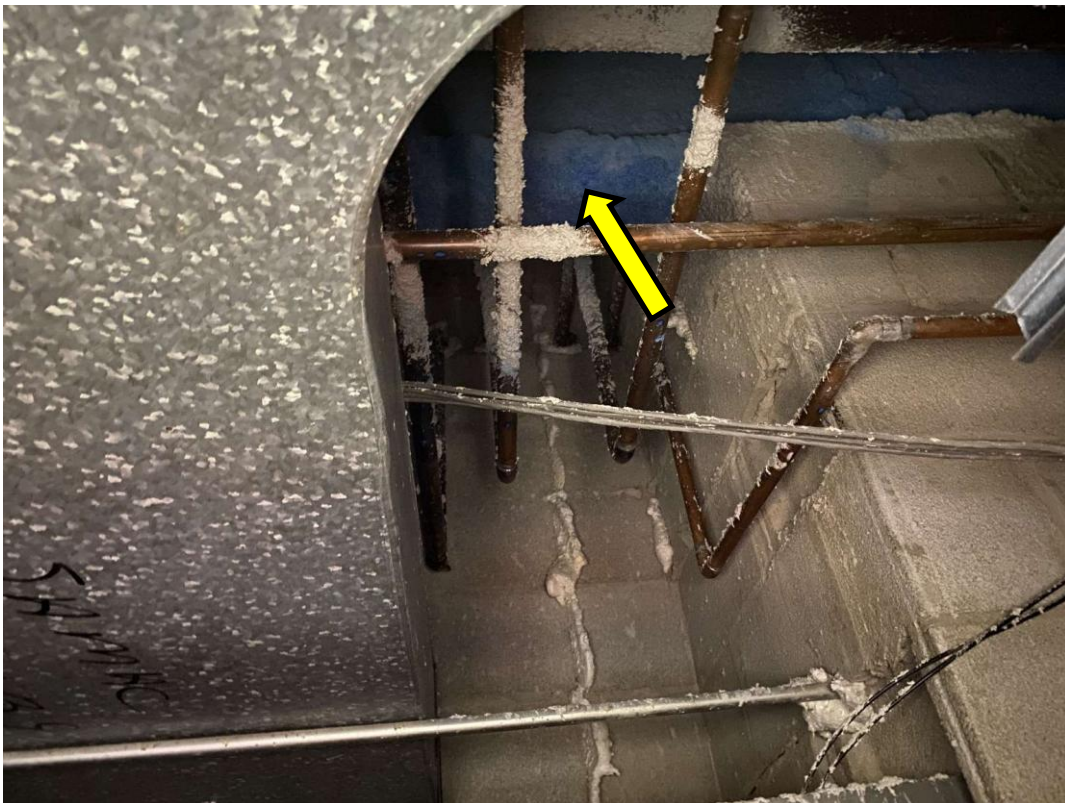
V0000 (None), Blue/grey, Structure, Fireproofing, Fireproofing (Cementitious), Corridor (Location #: 7554)
Installed in 2025.

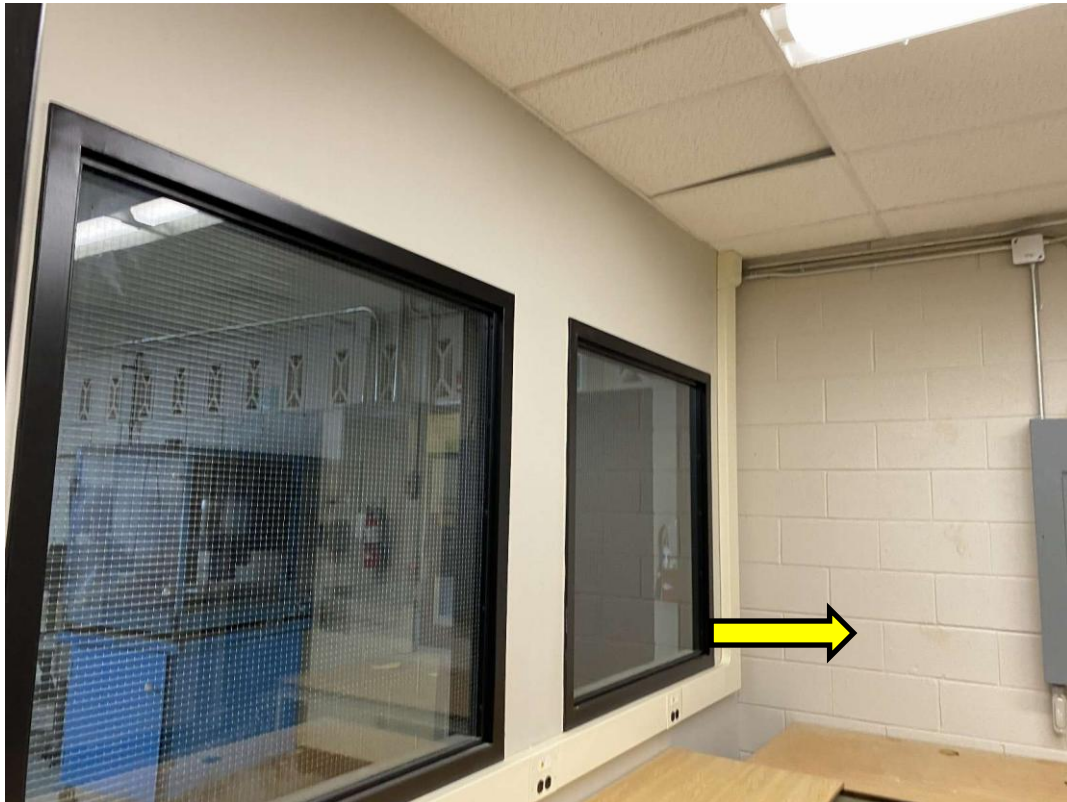
L0016(Lead, Low), White on concrete block, Wall, Classroom (Location #: 7561)

For paints identified as having low levels of lead (i.e., equal to or above 0.009% (90 mg/kg) but less than or equal to the EACC guideline of 0.1% (1,000 mg/kg) for lead-containing paints) special precautions are not recommended unless aggressive disturbance (grinding, blasting, torching) is planned.

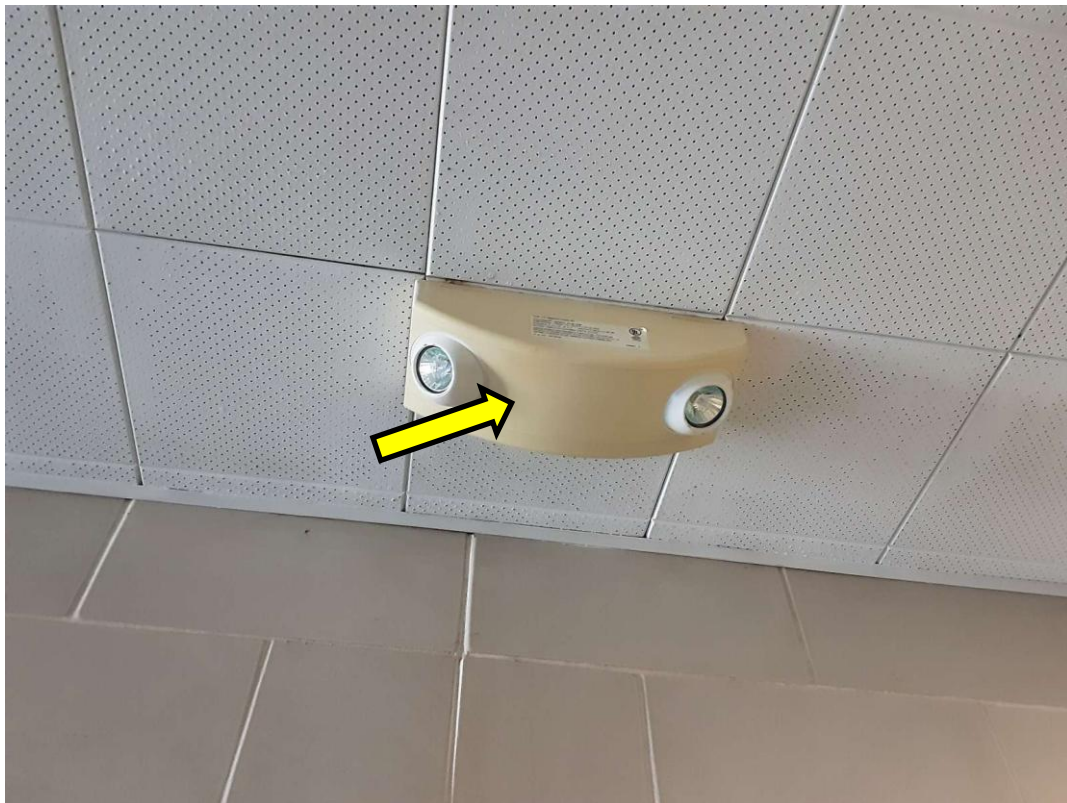
Pb Products, V9500(Presumed), Batteries in emergency lights, Corridor (Location #: 7696)

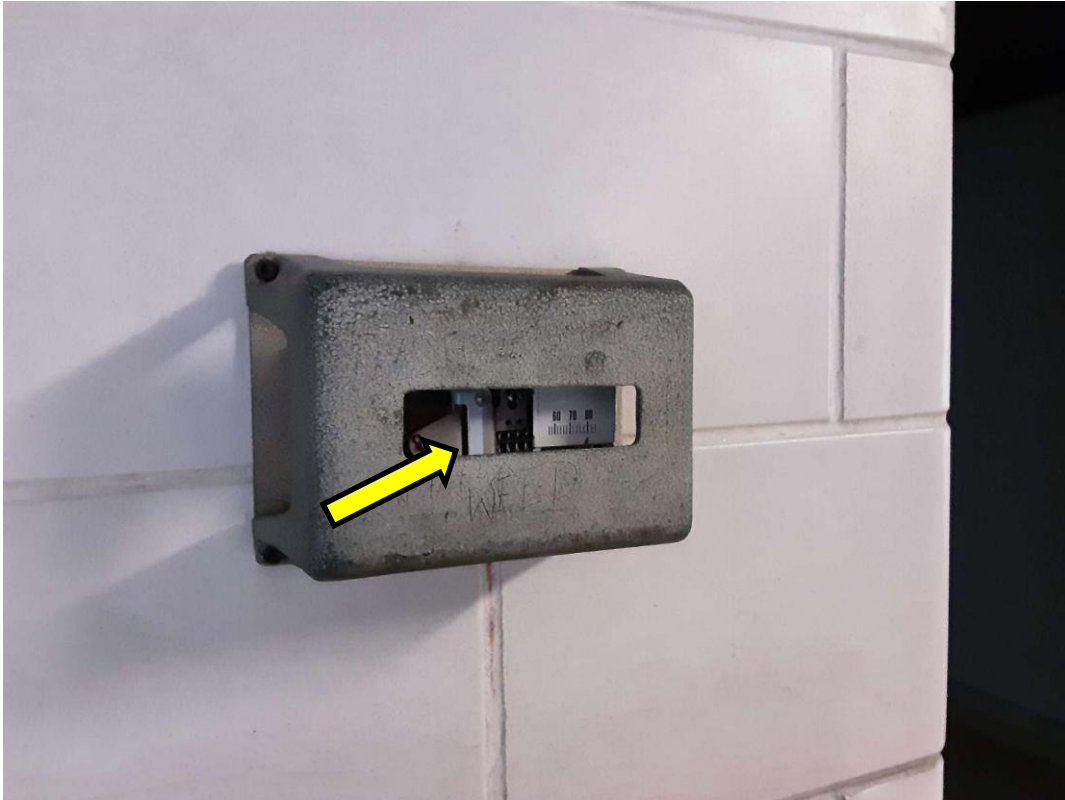
Mercury, V9000(Presumed), Thermostat, Corridor (Location #: 7708)
