## Addendum #1

Issued April 21, 2026

## **Hazardous Building Materials Assessment (Pre-construction)**

Window Replacement  
Renovations

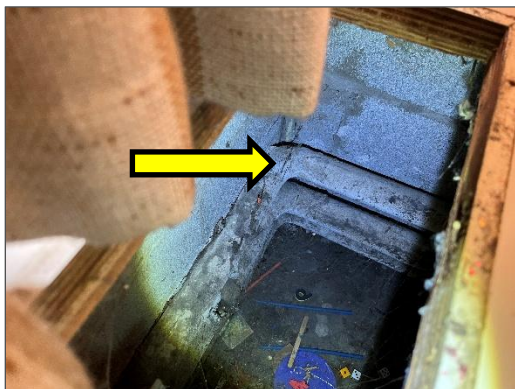
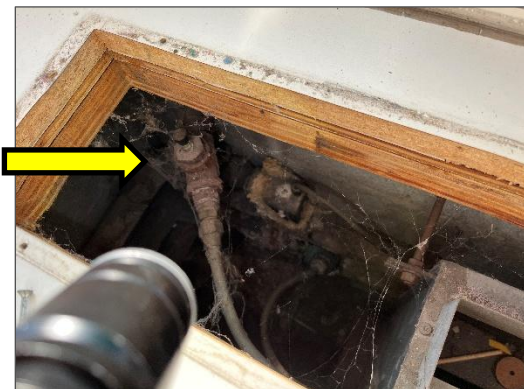
Remaining pipes in the assessed area are either uninsulated or insulated with non-asbestos fibreglass or other non-asbestos insulation such as mineral fibre or elastomeric foam insulation.

Pipes insulated with asbestos-containing insulations are present in inaccessible spaces such as above solid ceilings, in chases, in column enclosures and within shafts.

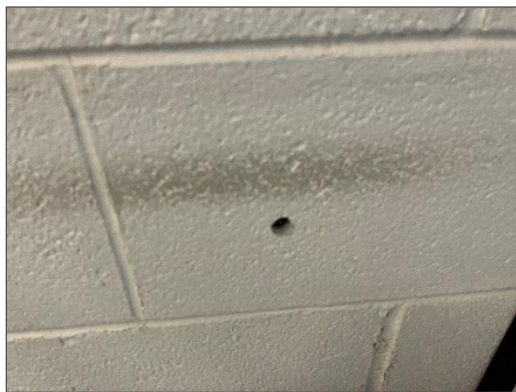
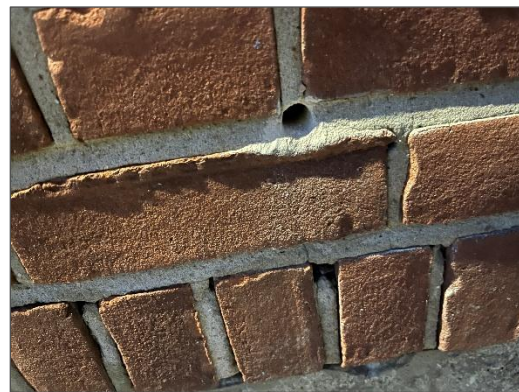
Destructive testing was conducted of a representative selection of masonry block walls, including creating penetrations at seven locations (photos 1 and 2). The locations of destructive testing have been indicated on the drawings in Appendix I.

Loose fill vermiculite was not observed within the cavities.

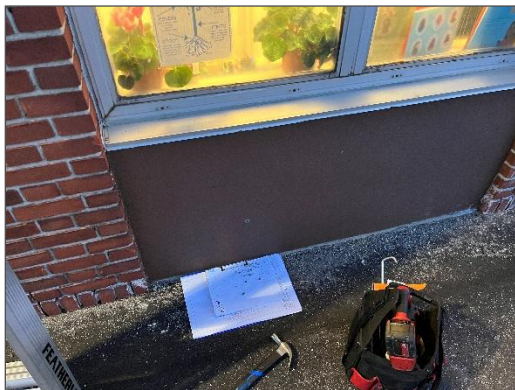
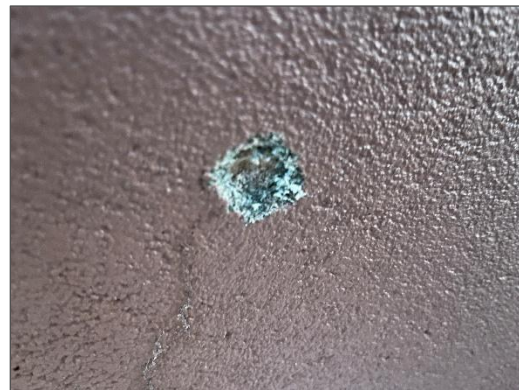
Stucco present below windows as exterior cladding does not contain asbestos (samples S0031A-C, photos 1-2). Transite paneling is presumed to be present behind the stucco.

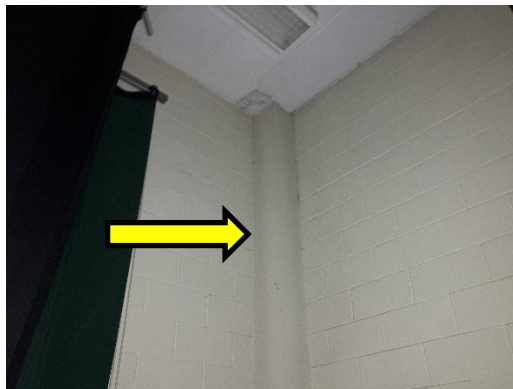
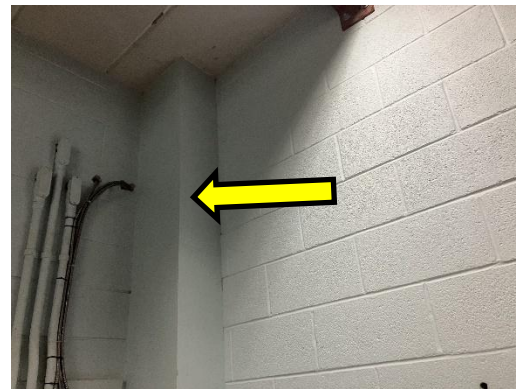
Drywall joint compound present as pipe chases throughout the assessed area does not contain asbestos (samples S0007A-C, photos 1 and 2).

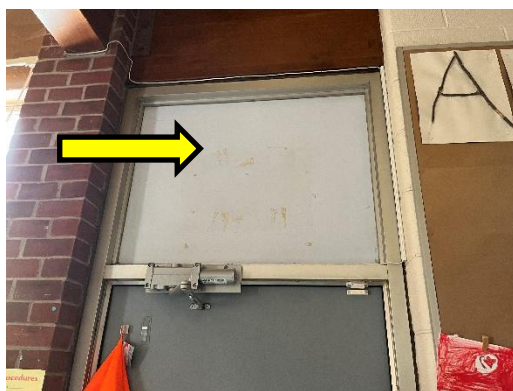
Photo 1

Cement board (i.e. Transite), containing asbestos (samples S0022A-C and S0034A-C), is present as follows:

- Above exterior doors and windows (photo 1)
- Between window frames and interior walls (photo 2)
- Below windows (photo 3)
- Presumed present concealed behind stucco and wood panelling (photos 4, 5 and 6)

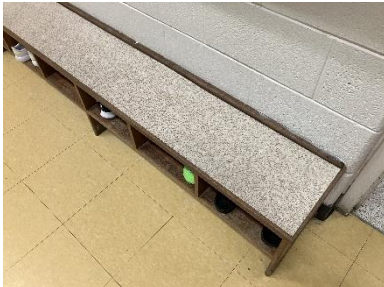
Description	Sample Location (Loc #)	Sample Number	Asbestos	Photo
Beige, square pattern	Kindergarten Classrooms on benches (Location 1670 and 1675)	S0011A-C	Yes

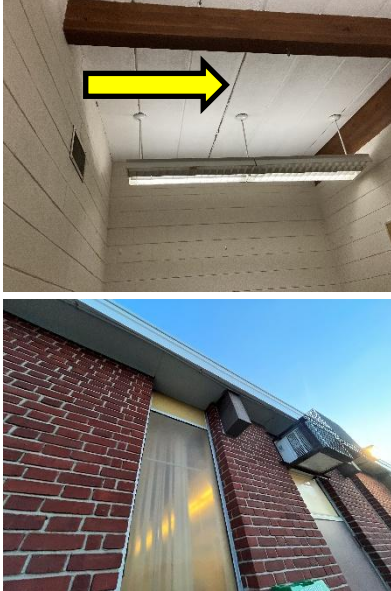
Material, Description and Application	Sample Location (Location #)	Sample Number	Asbestos	Photo
Caulking, white on expansion joints of siporex decking	Kindergarten Classroom and Exterior	S0018A-C	Yes

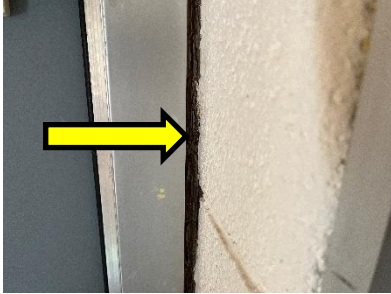
Caulking, brown on door frames	Kindergarten Classroom 1 (Location 1670)	S0023A-C	Yes

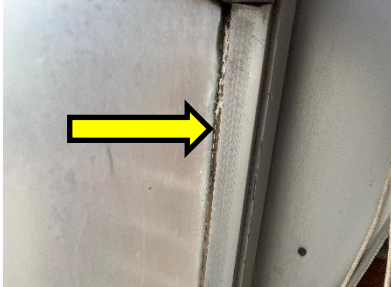
Sealant, white on windows	Kindergarten Classroom 1 (Location 1670)	S0024A-C	Yes

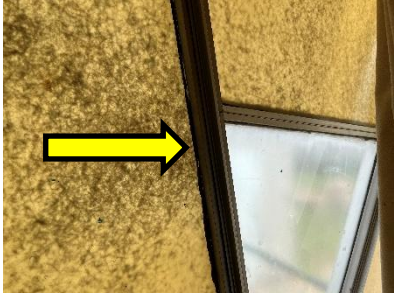
Material, Description and Application	Sample Location (Location #)	Sample Number	Asbestos	Photo
Sealant (butyl sealant), black on windows	Kindergarten Classroom 1 (Location 1670)	S0025A-C	Yes

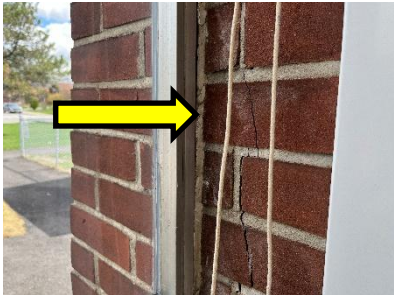
Caulking, grey on window frames	Kindergarten Classroom 1 (Location 1670)	S0026A-C	Yes

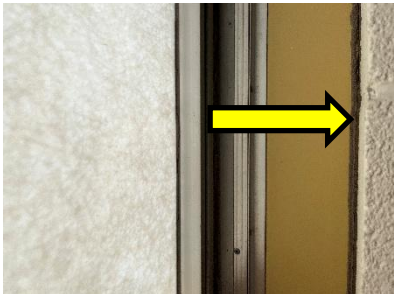
Caulking, grey on window and door frames	Offices (Location 1)	S0028A-C	Yes

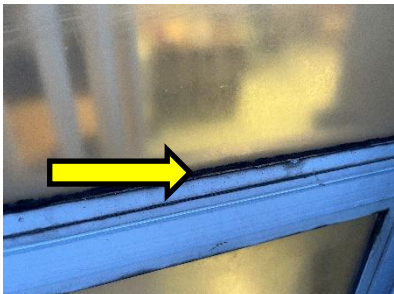
Butyl sealant, black on windows	Exterior (Location 8)	S0029A-C	Yes

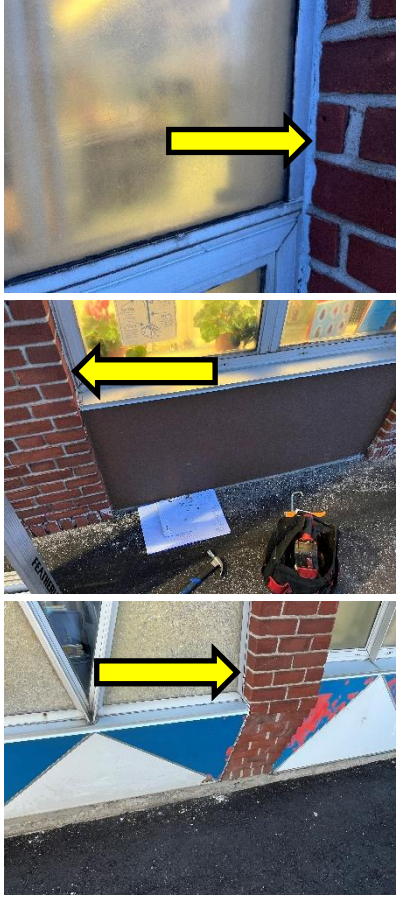
Material, Description and Application	Sample Location (Location #)	Sample Number	Asbestos	Photo
Caulking, grey/brown/white on door and window frames, transite, stucco, wood panelling, windows sills and flashing	Exterior (Location 8)	S0030A-C	Yes

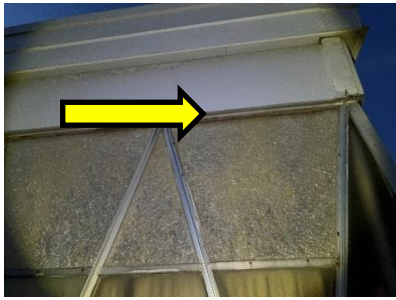
Caulking, white on door and window frames	Exterior by Kindergartens (Location 9)	S0032A-C	No*

\*Asbestos-containing caulking is presumed to be present below non-asbestos caulking and sealants.

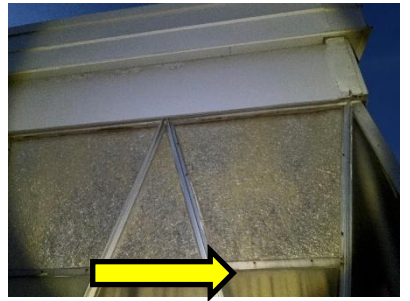
Material, Description and Application	Sample Location (Location #)	Sample Number	Asbestos	Photo
Butyl sealant, black on windows	Exterior by Kindergartens (Location 9)	S0033A-C	No *

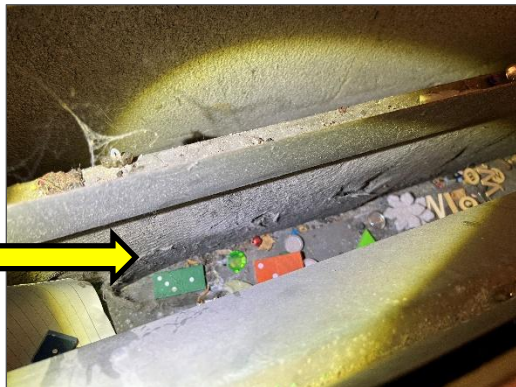
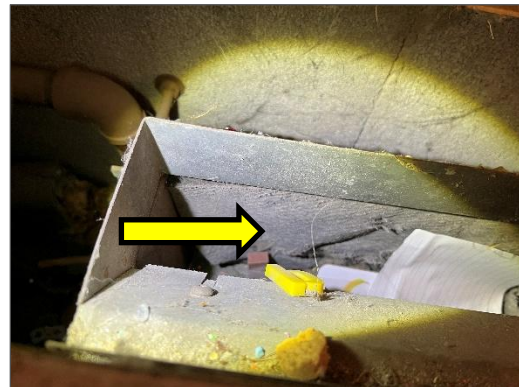
Tar paper present in radiators of Kindergarten Classrooms (Locations 1670 and 1675) does not contain asbestos (samples S0021A-C, photos 1-2).

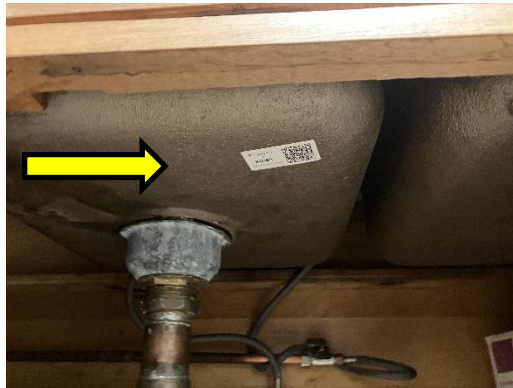
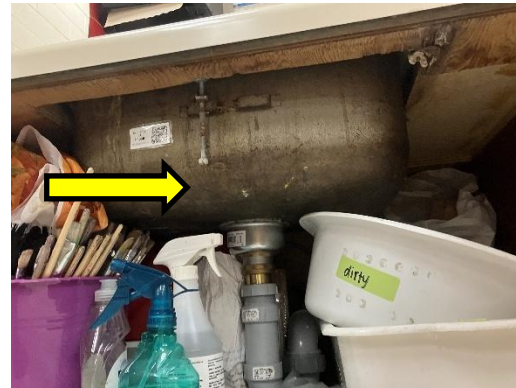
Silver mastic, containing asbestos, is present on the underside of the sinks in the Kindergarten Classrooms (Locations 1670 and 1675) (samples S0010A-C, photos 1 and 2).

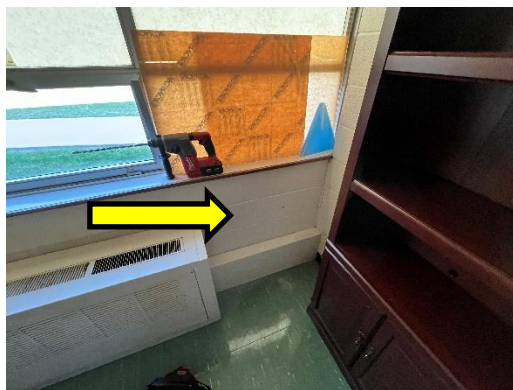
Photo 3

Paint present on concrete block walls throughout the assessed area does not contain asbestos (samples S0005A-G and S0027A-F, photo 3).

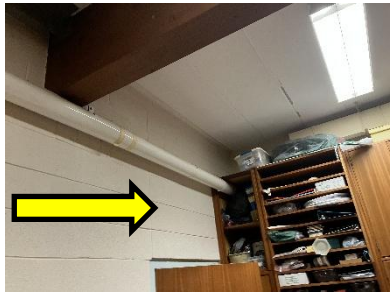
Sample Number	Colour, Substrate Description	Sample Location	Lead (%)	Photo
L0004	Cream on masonry block walls	Kindergarten Classroom 1 (Location 1670)	0.032

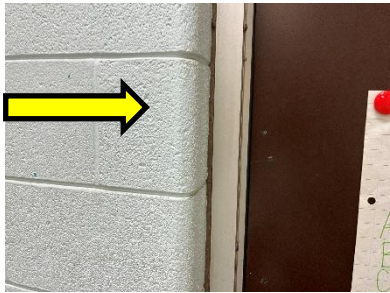
L0006	Blue on masonry block	Classrooms (Location 3)	0.015

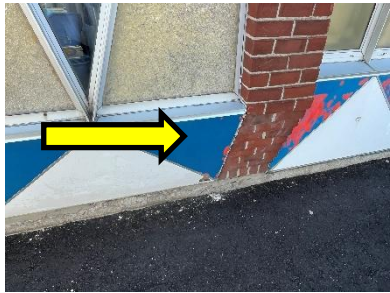
L0007	Blue on panels beneath windows	Exterior by Kindergartens (Location 9)	0.068

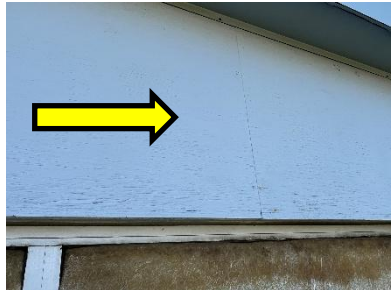
Sample Number	Colour, Substrate Description	Sample Location	Lead (%)	Photo
L0008	White on wood panels	Exterior (Location 8)	0.36

Results above 0.1% (1,000 mg/kg) are considered lead-containing, and over 0.5% (5,000 mg/kg) are considered lead-based.

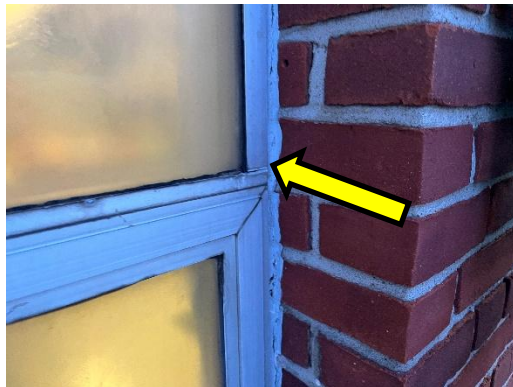
Photo 1

Caulking is present at exterior window and door frames (sample P0002, photo 1) and contains 1.7 mg/kg PCBs. The material is a non-PCB solid based on the threshold (50 mg/kg).

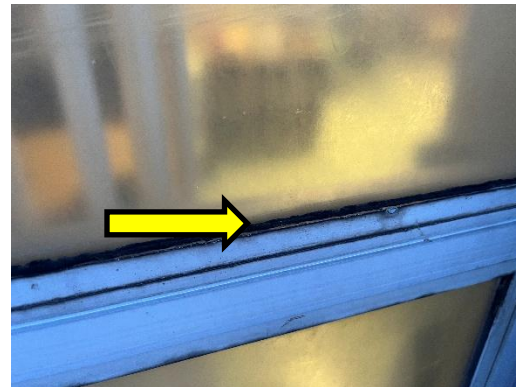
Photo 2

Butyl sealant is present at exterior windows (sample P0001, photo 2) and contains 3.5 mg/kg PCBs. The material is a non-PCB solid based on the threshold (50 mg/kg).
