## **Hazardous Building Materials Assessment (Pre-construction)**

Roof Assembly Replacement  
Regina Mundi Catholic  
Elementary School  
675 Mohawk Road West,  
Hamilton, Ontario

April 10, 2026

Pinchin File: 368268.003

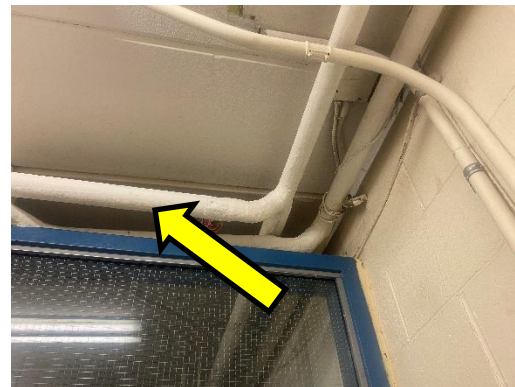
Photo 2

Remaining pipes in the assessed area are either uninsulated or insulated with non-asbestos fiberglass or (photo 2).

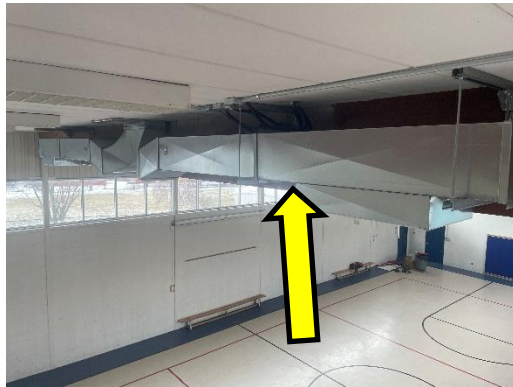
Photo 1

Ducts are either uninsulated or insulated with non-asbestos fiberglass (foil-faced or canvas jacketing) (photo 1).

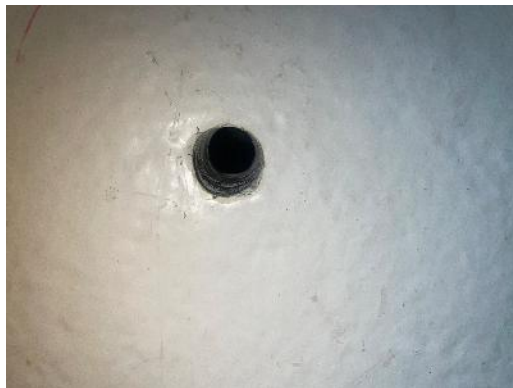
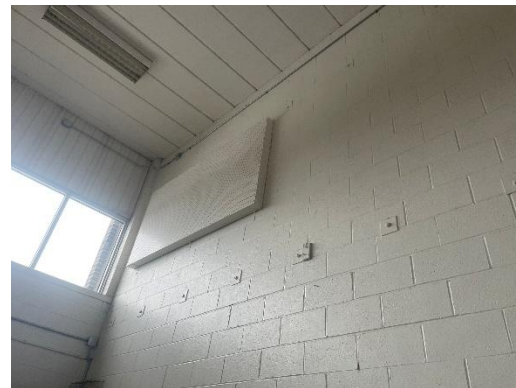
Loose fill vermiculite was not observed within the cavities (photos 1 and 2).

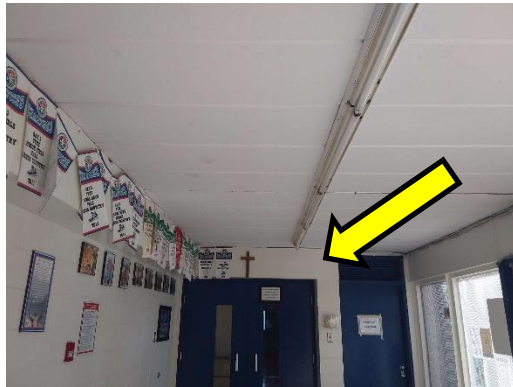
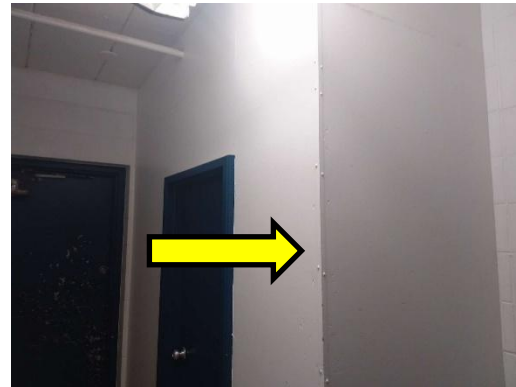
Drywall joint compound, containing asbestos, is present on wall and ceiling finishes in the assessed area (samples S0004A-C).

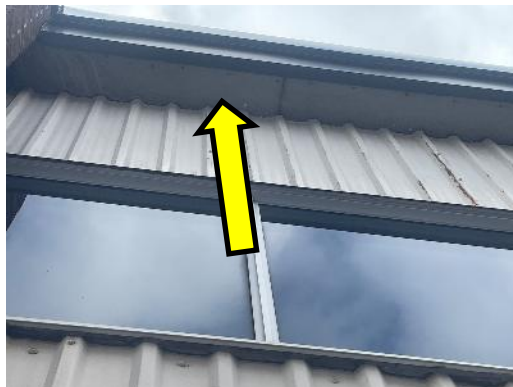
Photo 1

Cement board (e.g. Transite), presumed to contain asbestos based on visual observation, is present as soffits on the exterior of the Gymnasium (Location 1, photo 1).

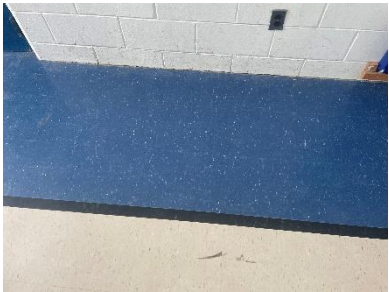
Description	Sample Location (Location #)	Sample Number	Asbestos (Tile / Adhesive)	Photo
12" blue	Gymnasium (Location 2030)	S0013A-C	No / No

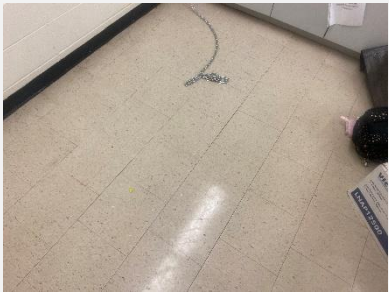
12" tan with brown streaks and mastic	Kitchen (Location 2028) Foyer (Location 2029)	V9500	Presumed/ Presumed

Presumed vinyl floor tile and mastics were not sampled as they are not expected to be disturbed by the renovation activities.

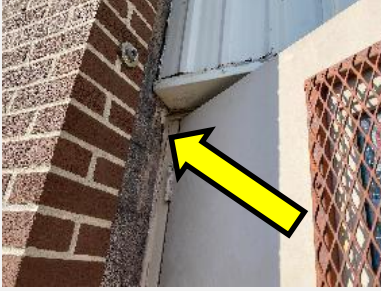
Caulking, grey at doors	Exterior (Location 1)	S0015A-C	Yes

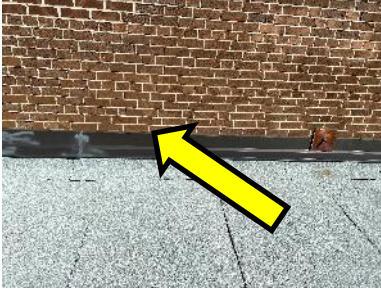
Caulking, Brown on flashing	Roof (Location 3000)	S0018A-C	No

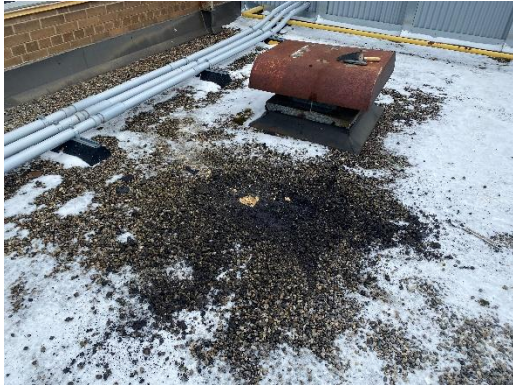
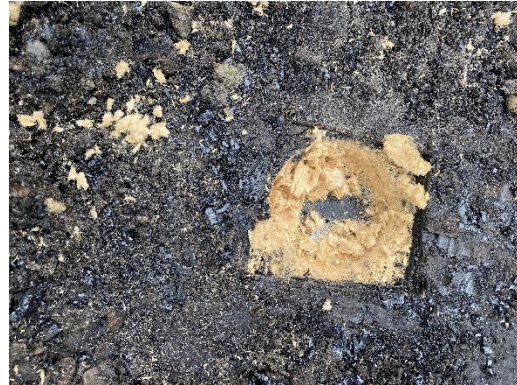
Tar, containing asbestos, is present in the bottom layer of the built-up roofing materials over the Breezeway (samples S0006C-D, photos 1 and 2). Tar will be present on the roof decking. The materials associated with the rolled roofing over the Gymnasium and Kitchen do not contain asbestos (samples S0006A-B, photos 3 and 4). However, asbestos-containing residual tar will be present below the roofing over the entire roof decking of the Gymnasium.

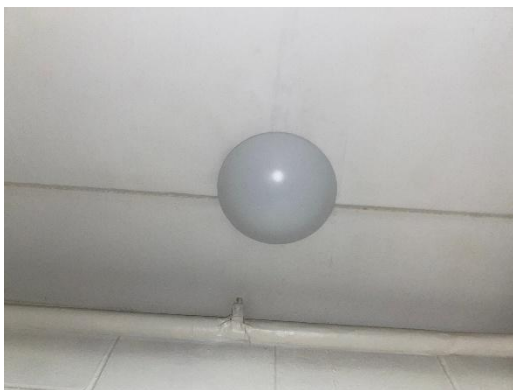
Photo 1

Paper heat shields, presumed to contain asbestos, are present within incandescent light fixtures in the foyers (Locations 2027 and 2029, photo 1).

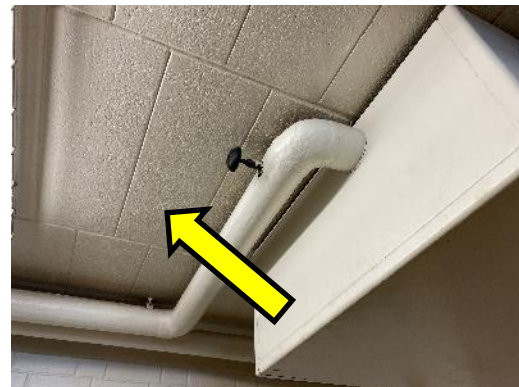
Photo 6

Paint/compound (block filler), containing asbestos, is present on concrete structure block decking in the assessed area (samples S0017A-C, photo 6).

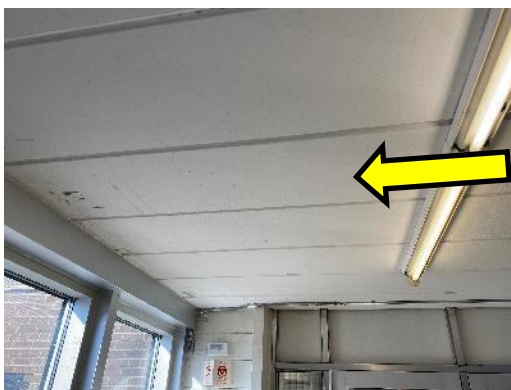
Photo 7

Paint/compound (block filler), present on Siporex decking throughout the assessed area, does not contain asbestos (samples S0019A-C, photo 7).

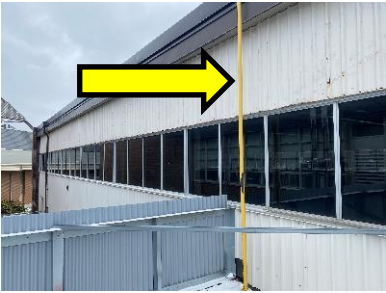
Sample Number	Colour, Substrate Description	Sample Location	Lead (%)	Photo
L0001	Yellow on metal gas line	Roof (Location 3000)	0.045

Results greater than 0.009% (90 mg/kg) but less than or equal to 0.1% (1,000 mg/kg) are considered low-level lead paints or surface coatings in accordance with the EACC guideline.

For paints identified as having low levels of lead (i.e., greater than 0.009% (90 mg/kg) but less than or equal to the EACC guideline of 0.1% (1,000 mg/kg) for lead-containing paints) special precautions are not recommended unless aggressive disturbance (grinding, blasting, torching) is planned.

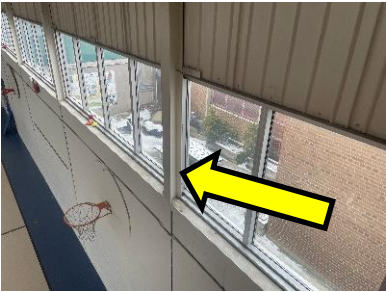
L0002	White on metal column	Gymnasium (Location 2030)	0.43

Results above 0.1% (1,000 mg/kg) are considered lead-containing, and over 0.5% (5,000 mg/kg) are considered lead-based in accordance with the EACC guideline.

Items painted with paints containing elevated levels of lead may be a hazardous waste. Test lead-painted materials for leachable lead and other metals prior to disposal. Metallic components coated with lead paint do not require leachate testing and can be disposed of as non-hazardous construction and demolition (C&D) waste.

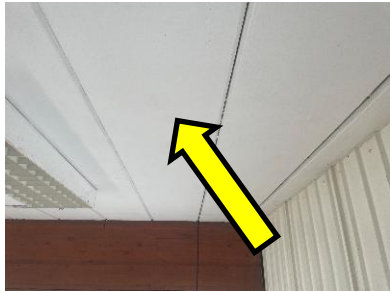
Sample Number	Colour, Substrate Description	Sample Location	Lead (%)	Photo
L0003	White on Siporex deck	Gymnasium (Location 2030)	0.072

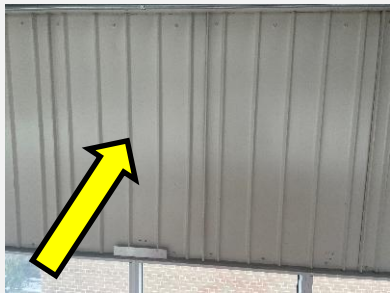
L0004	White on metal wall	Gymnasium (Location 2030)	3.2

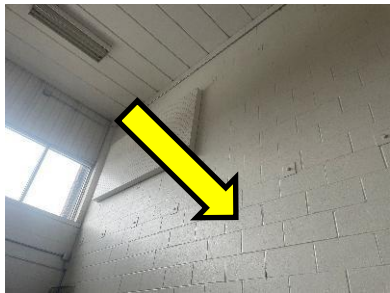
L0005	White on block wall	Gymnasium (Location 2030)	0.099

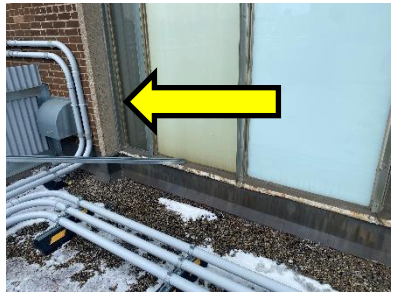
Material, Colour, Application	Sample Location (Location #)	Sample Number	PCB (mg/kg)	Photo
Caulking, composite	Roof (Location 3000)	P0001	4.3

Results greater than or equal to 50 mg/kg is considered a PCB-containing solid.

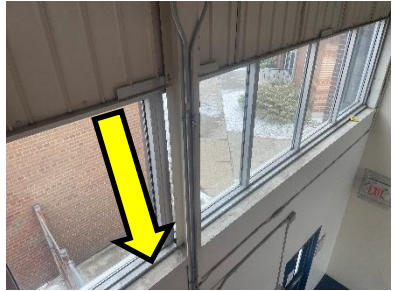
Caulking, composite	Gymnasium (Location 2030)	P0002	0.8
