Hazardous Building Materials Assessment (Pre-construction)

Roof Assembly Replacement
St. Martin of Tours
60 Gray Road South, Stoney
Creek, Ontario

April 10, 2026

Pinchin File: 368268.005

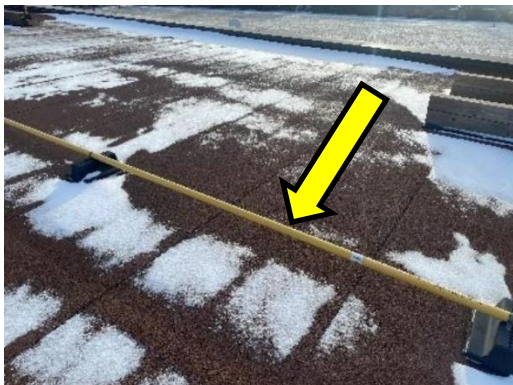
Photo 1

Pipes in the assessed area are either insulated with non-asbestos fibreglass or are uninsulated (photo 1).

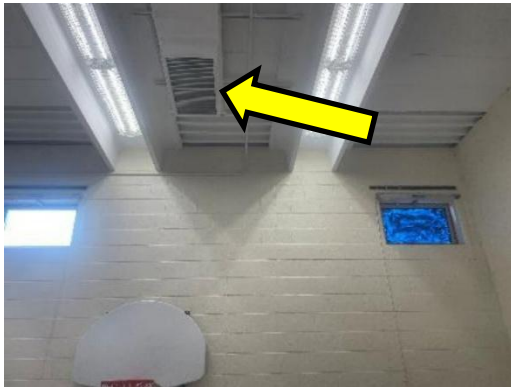
Photo 1

Ducts are uninsulated (photo 1).

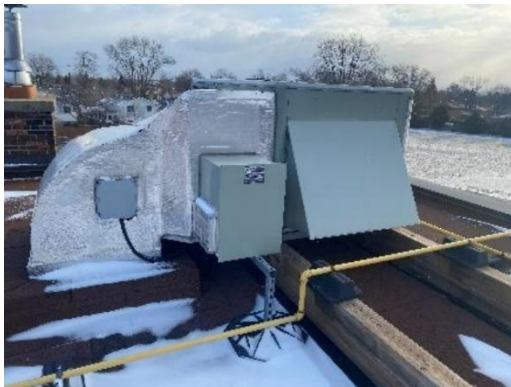
Photo 1

Mechanical equipment (HVAC unit) is insulated with non-asbestos fibreglass and foil-face (photo 1).

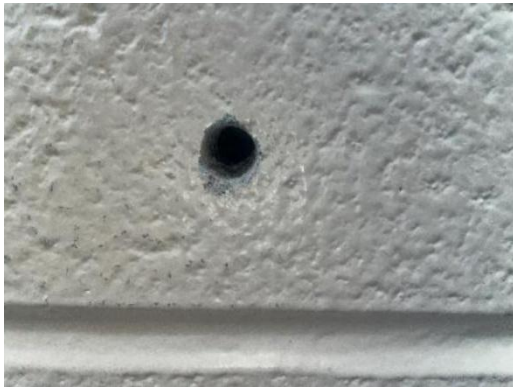
Photo 1

Loose fill vermiculite was not observed within the cavities (photos 1 and 2).

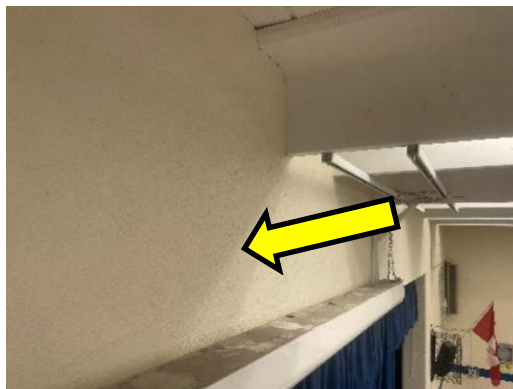
Photo 1

Plaster present on walls in the assessed area does not contain asbestos (samples S0008A-C, photo 1).

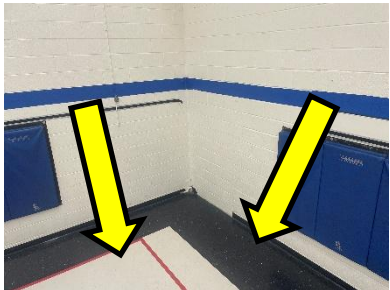
Description	Sample Location (Location #)	Sample Number	Asbestos (Tile / Adhesive)	Photo
12x12 beige with dark flecks 12x12 black with white streaks Floor mastic	Gymnasium (Location 1009)	V0000 V9000	No/Yes

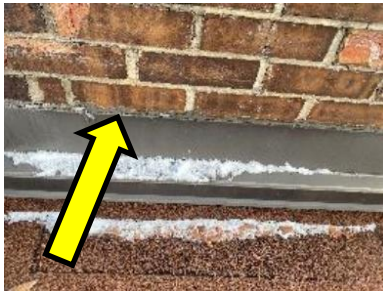
Material, Description and Application	Sample Location (Location #)	Sample Number	Asbestos	Photo
Caulking, grey on brick	Roof (Location 2000)	S0005A-C	No

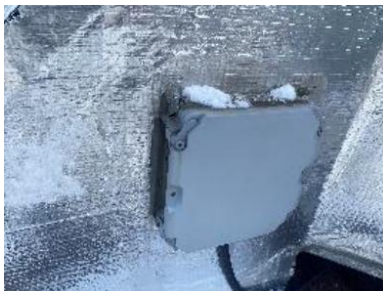
Mastic, grey and tar paper	Roof (Location 2000)	S0006A-C	No

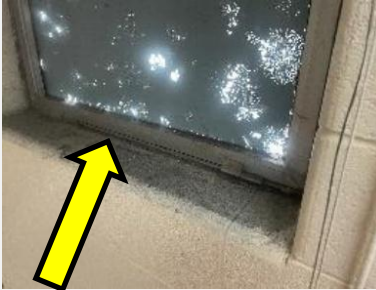
Caulking, grey on window frame	Gymnasium (Location 1009)	S0007A-C	Yes

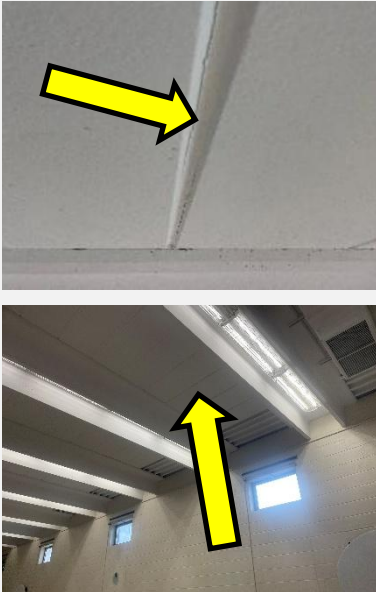
Caulking, grey at seams of Siporex decking	Gymnasium (Location 1009)	S0010A-C	Yes

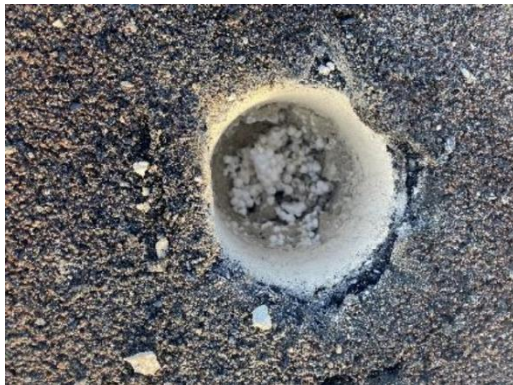
Photo 1

The materials associated with the roofing do not contain asbestos (samples S0004A-C, photos 1 and 2).

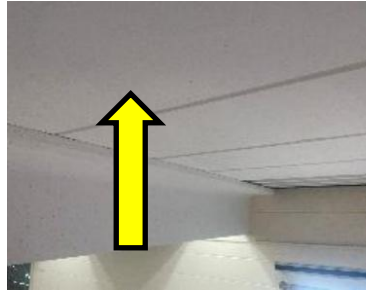
Description	Sample Location (Location #)	Sample Number	Asbestos	Photo
Siporex decking	Gymnasium (Location 1009)	S0009A-C	No

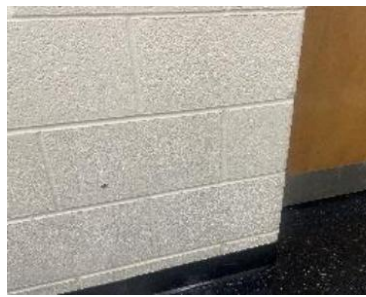
Paint on concrete block walls	Gymnasium (Location 1009)	S0012A-G	No

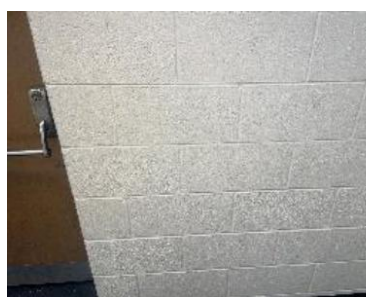
Mortar in concrete block walls	Gymnasium (Location 1009)	S0013A-C	No

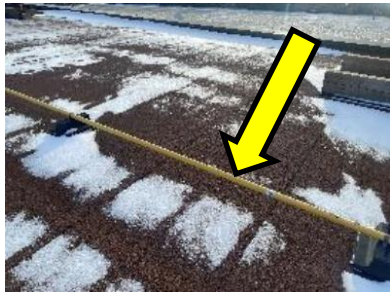
Sample Number	Colour, Substrate Description	Sample Location	Lead (%)	Photo
L0001	Yellow on gas pipe line	Roof (Location 2000)	0.0032

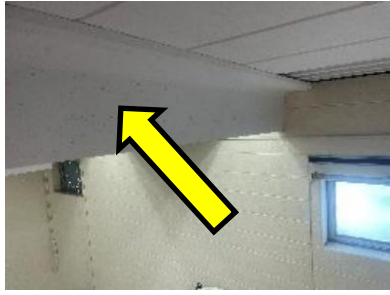
L0002	Paint on pre-cast beam	Gymnasium (Location 1009)	0.00087

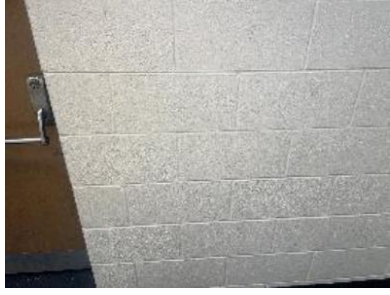
L0003	Paint on block wall	Gymnasium (Location 1009)	0.0054

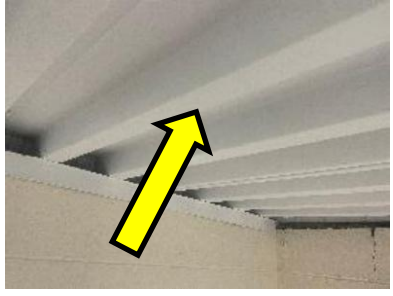
Sample Number	Colour, Substrate Description	Sample Location	Lead (%)	Photo
L0004	Paint on metal deck	Gymnasium (Location 1009)	0.00023

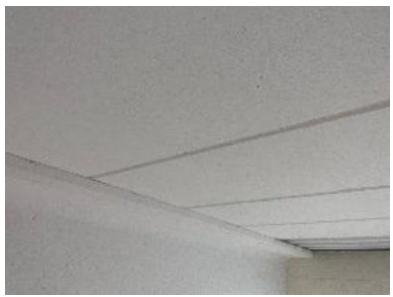
L0005	White on Siporex decking	Gymnasium (Location 1009)	0.00048

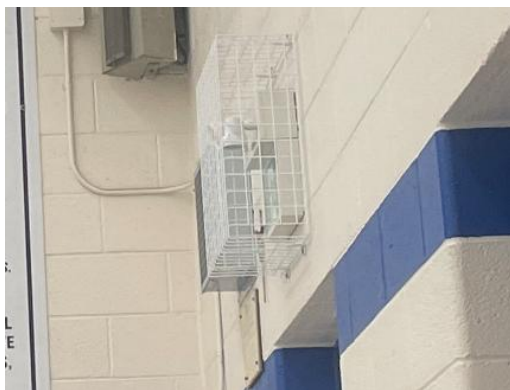
Photo 1

Lead-containing batteries are present in emergency lighting (photo 1).
