**PRE-RENOVATION
HAZARDOUS BUILDING MATERIALS SURVEY**

**Units F1, F7, F11, G2, G5 and G8
Fir Hall and Grey Pines Hall
Phase 2 Residences
1275 Military Trail
Toronto, Ontario
M1C 1A5**

**University of Toronto Scarborough
1265 Military Trail
Toronto, Ontario
M1C 1A4**

OHE Project No.: 31878

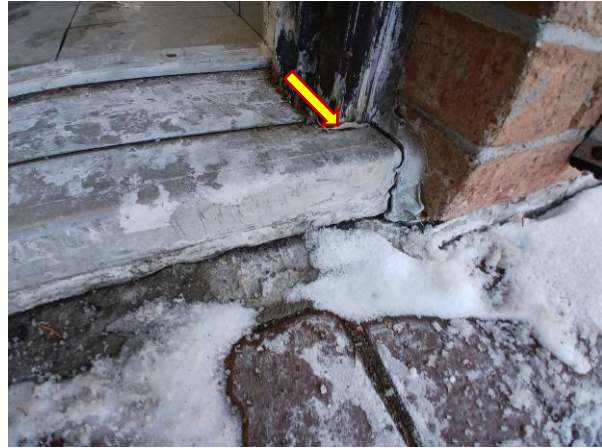
| Material Description | Observed (yes/no) | Sample(s) Numbers | Asbestos % And Type | Friable/ Non-Friable | Condition | Location |
|---|---|---|---|---|---|---|
| Caulking, White with rough texture | Yes | 31878-8A-C | 1% Chrysotile | Non-Friable | Good | Gap between the base of the door frame and foundation base, West exterior wall, Units G2, G5 and G8, Grey Pines Hall; East exterior wall, Units F1, F7 and F11, Fir Hall, Phase 2 Residences |

| OHE Sample Number | Sample Description | Sample Location | Analysis Results (% and Type of Asbestos) |
|---|---|--|---|
| 31878-8A | Caulking, White with rough texture | Gap between the base of the door frame and foundation base, West exterior wall, Unit G5, Phase 2 Residence | 1% Chrysotile |

Photograph 1. View of the asbestos-containing caulking between the base of the door frame and foundation base on the east exterior wall of Unit G5 at the Subject Location.

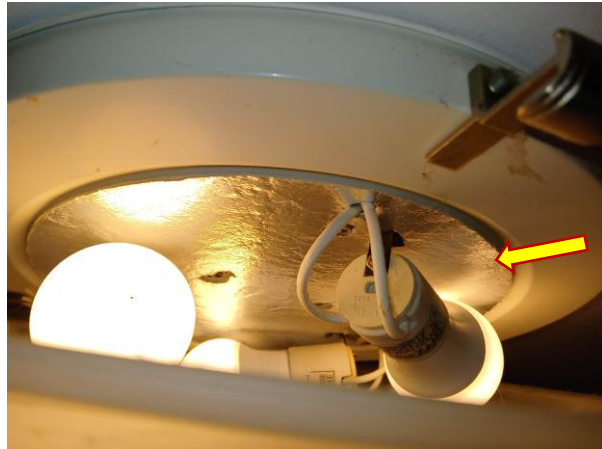
Photograph 2. View of the presumed asbestos-containing incandescent heat shield in the light fixture on the ceiling of the living room in Unit G2 at the Subject Location.

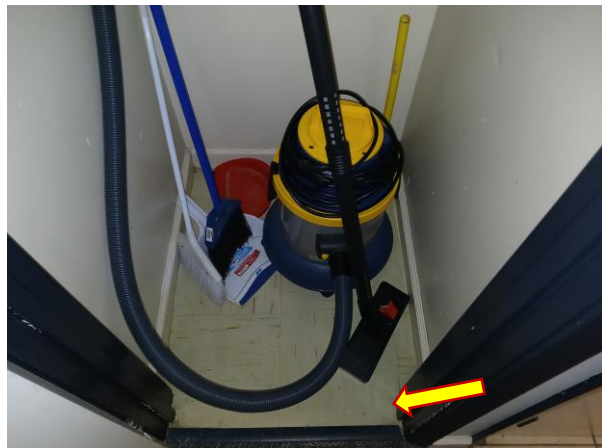
Photograph 2. View of the previously tested asbestos-containing vinyl floor tiles in the small closet of the main floor in the entrance corridor in Unit F1 at the Subject Location.
