Hazardous Building Materials Assessment (Pre-construction)

River Grove Community Centre
5800 River Grove Avenue,
Mississauga, Ontario

February 27, 2026

Pinchin File: 369272.000

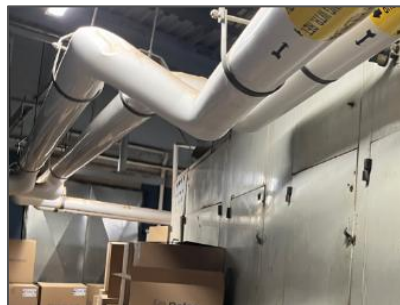
Fibreglass insulation on pipe, Mechanical Room 1 (Loc.57).

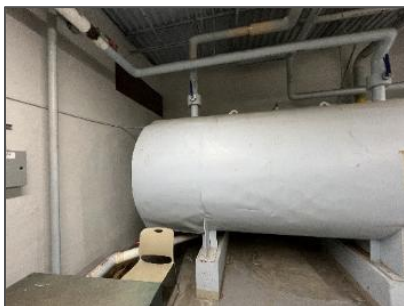
Fibreglass insulation on hot water tank, Mechanical Room 2 (Loc.55).

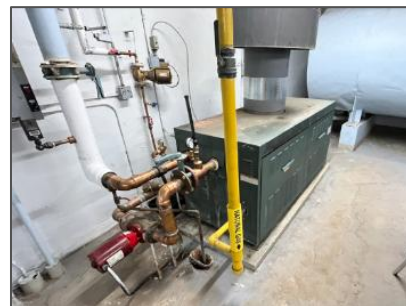
Uninsulated Boiler, Mechanical Room 2 (Loc.55).

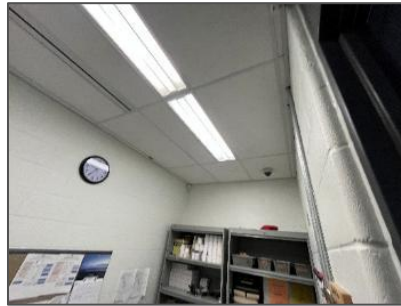
Ceiling tiles are presumed to be non-asbestos based on the age of the materials determined from the age of the building construction. The tiles were manufactured after asbestos stopped being used in acoustic ceiling tiles.

24"x48" textured, Renovated back of house Facilities (Loc.67).
