## **Hazardous Building Materials Assessment (Pre-construction)**

Roof Assembly Replacement  
Blessed Sacrament Catholic  
Elementary School  
315 East 37th Street, Hamilton,  
Ontario

Pinchin File: 368268.003

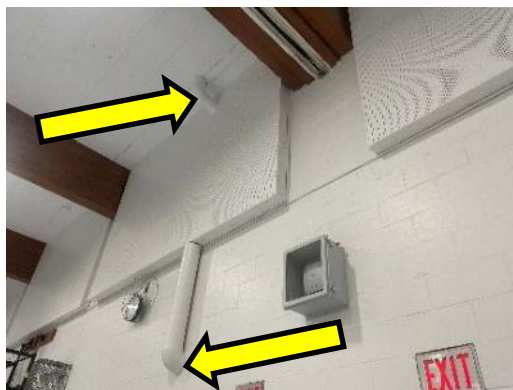
Photo 1

Sweatwrap insulation (brown layered paper) present on straight sections of rainwater system pipes in the assessed area does not contain asbestos (samples S0020A-C, photos 1 and 2).

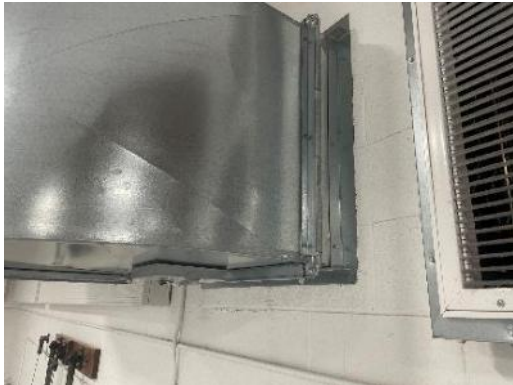
Photo 1

Ducts are either uninsulated or insulated with non-asbestos fibreglass (foil-faced or canvas jacketing) (photo 1).

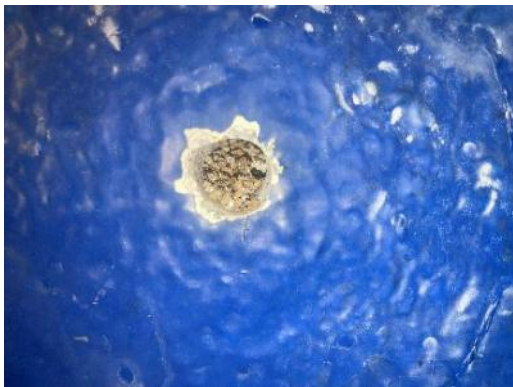
Photo 1

Vermiculite present within the block wall cavities was analyzed, and no asbestos was detected (samples S0026A-C, photos 1 and 2).

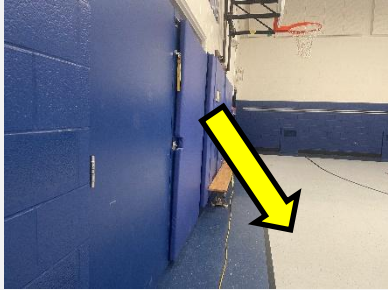
Description	Sample Location (Location #)	Sample Number	Asbestos (Tile / Adhesive)	Photo
12"x12" beige and blue	Gymnasium (Location 1014)	V0000 V9000	No / Yes

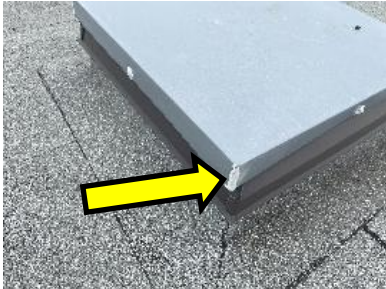
Material, Description and Application	Sample Location (Location #)	Sample Number	Asbestos	Photo
Caulking, white on flashing	Roof (Location 3000)	S0018A-C	No

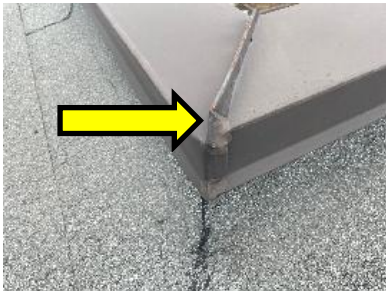
Caulking, brown on flashing	Roof (Location 3000)	S0019A-C	No

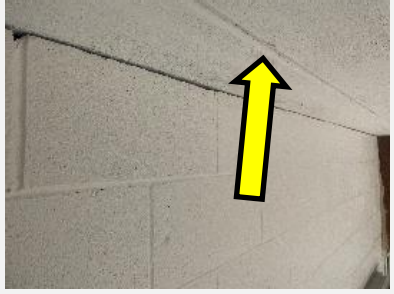
Material, Description and Application	Sample Location (Location #)	Sample Number	Asbestos	Photo
Caulking, white at Siporex decking seams and joints	Gymnasium (Location 1038)	S0021A-C	Yes

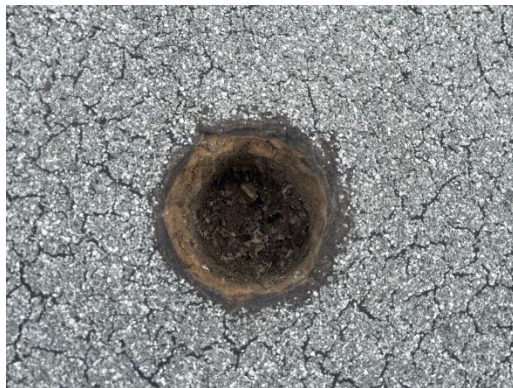
Photo 1

The materials associated with the roof do not contain asbestos (samples S0017A-C, photos 1 and 2).

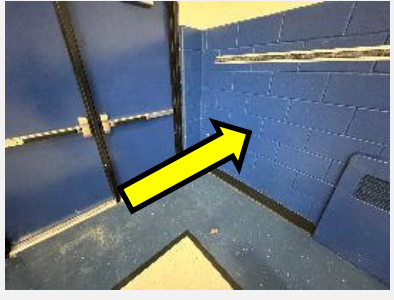
Description	Sample Location (Location #)	Sample Number	Asbestos	Photo
Paint on concrete block walls (block filler)	Gymnasium (Location 1038)	S0025A-G	Yes

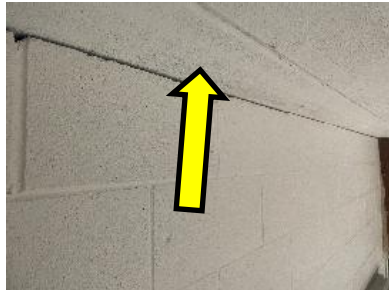
Description	Sample Location (Location #)	Sample Number	Asbestos	Photo
Siporex decking	Gymnasium (Location 1038)	S0023A-C	No

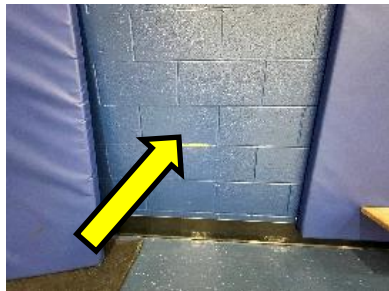
Concrete block mortar	Gymnasium (Location 1038)	S0024A-G	No

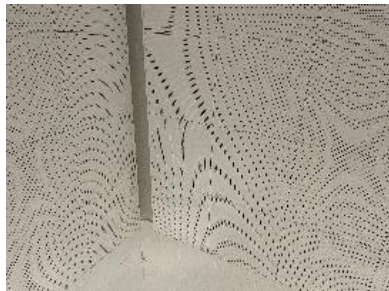
Wood, sound attenuation panels	Gymnasium (Location 1038)	V0000	No

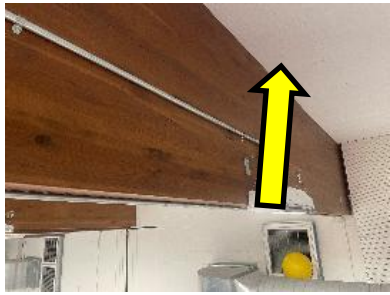
Sample Number	Colour, Substrate Description	Sample Location	Lead (%)	Photo
L0001	White on Siporex decking	Gymnasium (Location 1038)	0.00018

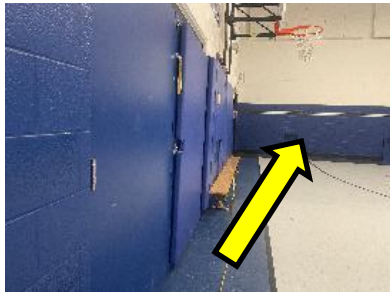
L0002	Blue on concrete block wall	Gymnasium (Location 1038)	0.024

Results greater than 0.009% (90 mg/kg) but less than or equal to 0.1% (1,000 mg/kg) are considered low-level lead paints or surface coatings in accordance with the EACC guideline.

For paints identified as having low levels of lead (i.e., greater than 0.009% (90 mg/kg) but less than or equal to the EACC guideline of 0.1% (1,000 mg/kg) for lead-containing paints) special precautions are not recommended unless aggressive disturbance (grinding, blasting, torching) is planned.

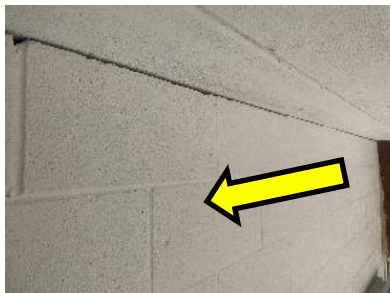
L0003	White on concrete block wall	Gymnasium (Location 1038)	0.18

Results above 0.1% (1,000 mg/kg) are considered lead-containing, and over 0.5% (5,000 mg/kg) are considered lead-based in accordance with the EACC guideline.

Items painted with paints containing elevated levels of lead may be a hazardous waste. Test lead-painted materials for leachable lead and other metals prior to disposal. Metallic components coated with lead paint do not require leachate testing and can be disposed of as non-hazardous construction and demolition (C&D) waste.

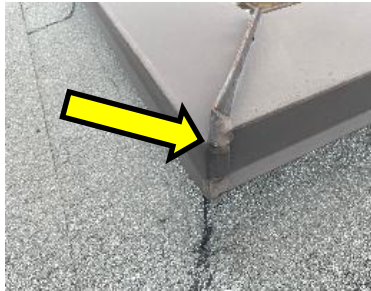
Material, Colour, Application	Sample Location (Location #)	Sample Number	PCB (mg/kg)	Photo
Caulking, composite	Roof (Location 3000)	P0001	<0.3
