**Designated Substances and
Hazardous Materials Survey**

17150 Yonge Street
Newmarket, ON L3Y 8V3

Submitted To:	Regional Municipality of York
Issued:	March 21, 2024
Revision:	1 of 1 April 2024
OESN Project No.	00310.005

Report Title: Designated Substances and Hazardous Materials Survey -
17150 Yonge Street, Newmarket, Ontario

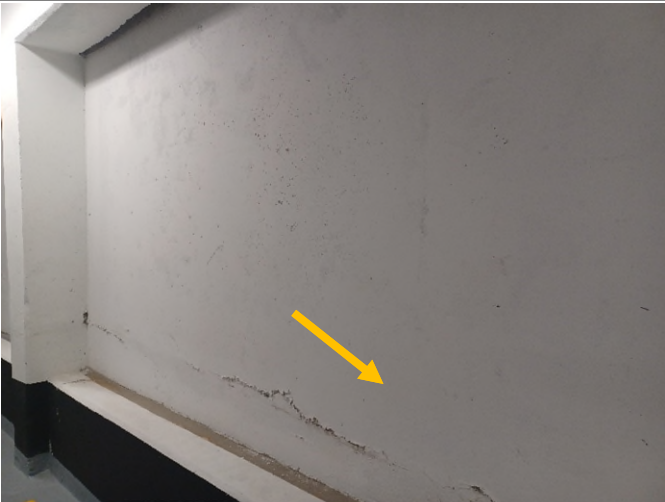
P01	
	Sample #s	00310.005-P01
	Sample Description	White
	Substrate	Concrete
	Condition	Good
Lead (µg/g)	8 µg/g

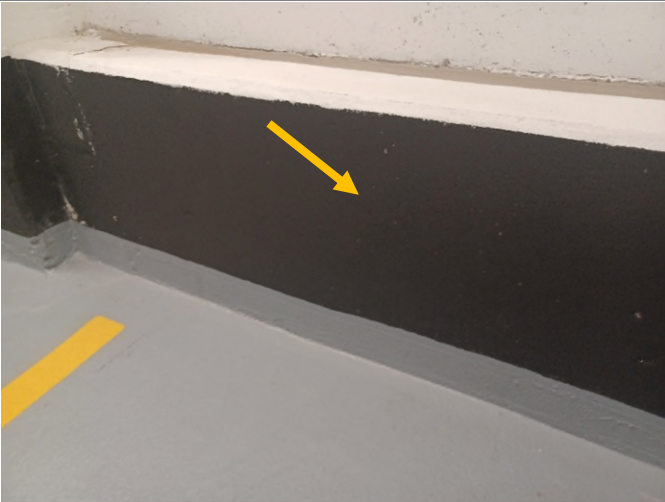
P02	
	Sample #s	00310.005-P02
	Sample Description	Black
	Substrate	Concrete
	Condition	Good
Lead (µg/g)	7 µg/g

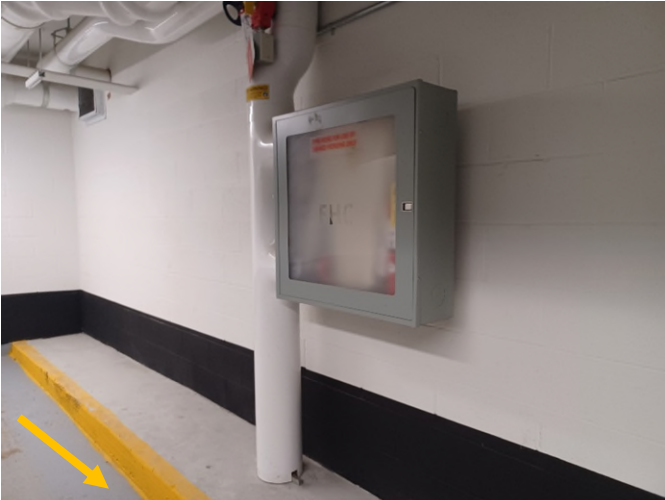
P03	
	Sample #s	00310.005-P03
	Sample Description	Grey
	Substrate	Concrete
	Condition	Good
Lead (µg/g)	<MDL

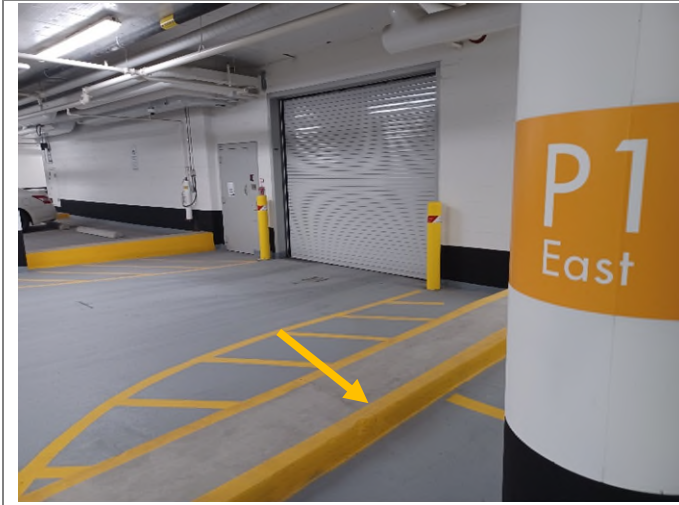
n/a	
Sample #s	n/a
Sample Description	Yellow
Substrate	Concrete/steel
Condition	Good
Lead ($\mu\text{g/g}$)	Suspected

Note: OESN did not disturb the yellow caution paint to maintain the integrity of the system. Yellow paint used in this application is suspected to contain lead.

- Where repair or replacement of yellow caution paint is required, contractor to complete work in accordance with Ministry of Labour Lead on Construction Projects Guidelines.

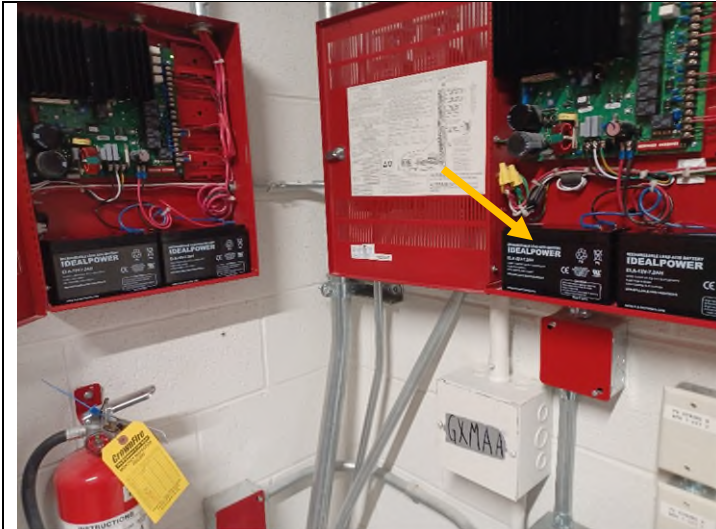
Lead Items

Lead acid batteries were observed in the fire system control panels when opened. Mechanical systems utilize lead acid batteries as uninterrupted power sources. Lead acid batteries are not considered regular construction waste. If encountered, they shall either be stored off site or brought to a facility where lead acid battery recycling programs exist. OESN did not open all electrical panels and equipment casings to review for lead acid batteries. Several locations have battery back-up power systems present; this equipment is suspected to contain lead acid batteries.

Lead acid batteries are present within emergency systems.

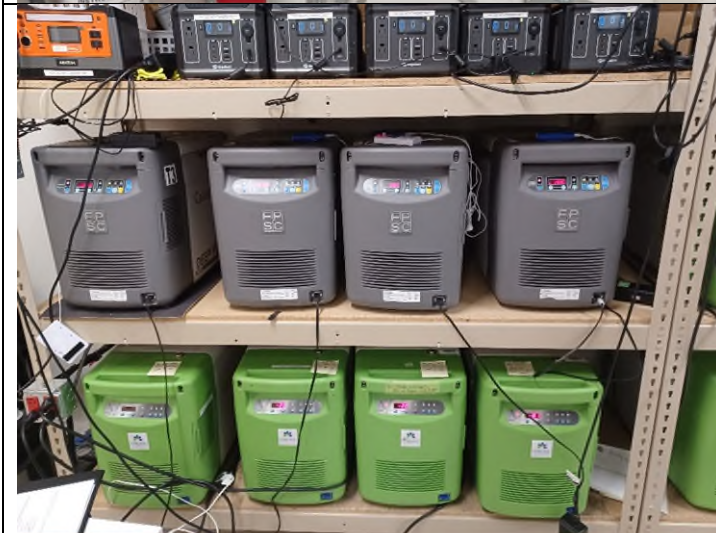
Lead Acid Batteries

Building locations have battery back-up power systems present, this equipment is suspected to contain lead acid batteries.

When disposal of equipment required, batteries should be brought to a facility that recycles lead acid batteries.

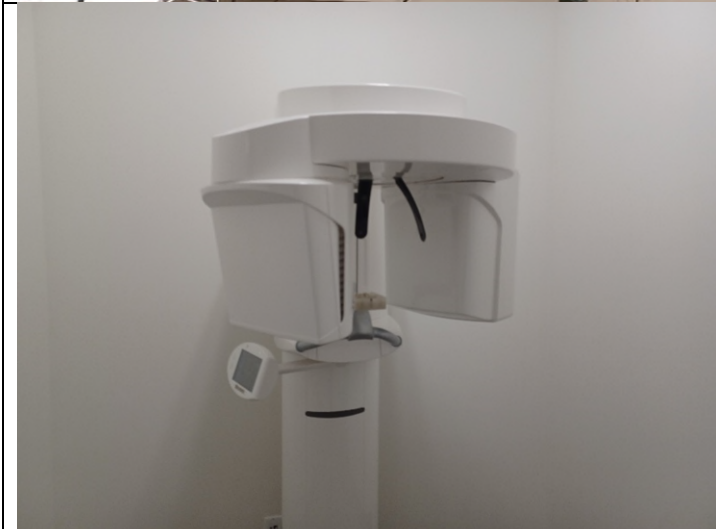
Lead Sheeting

Lead sheeting (0.8mm thickness) is present in wall cavities in the third floor dental area x-ray room.

Lead sheeting is present within wall cavities in the third floor dental office area.

- Contractors conducting work in the third floor dental area should be made aware of lead paneling within walls where x-ray equipment is used.
- Equipment with lead acid batteries present should be identified. When disposal of equipment is required, batteries should be brought to a facility that recycles lead acid batteries.

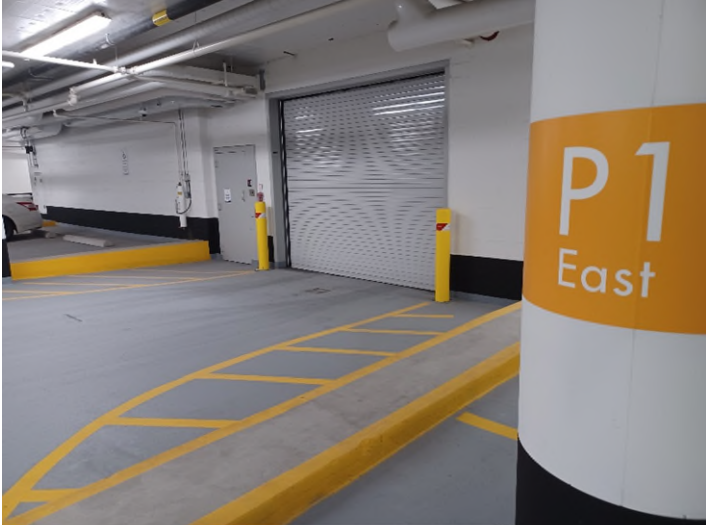
<p>Lead Coatings</p> <p>Yellow caution paint applied to concrete and steel in the parking garage suspected to contain lead.</p> <p>OESN did not bulk sample the coating at the time of evaluation to maintain the integrity of the caution paint.</p>

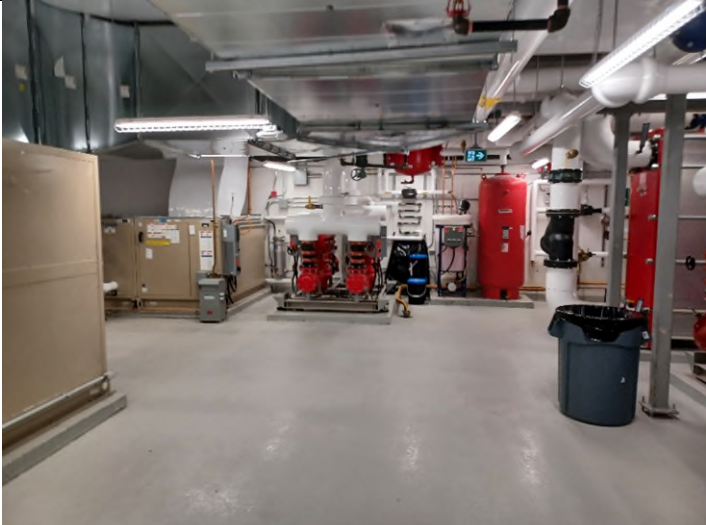
<p>Cooling Systems</p> <p>OESN reviewed label information for cooling systems present in the building.</p> <p>Where available, labels indicated that ozone depleting substances are not present.</p>

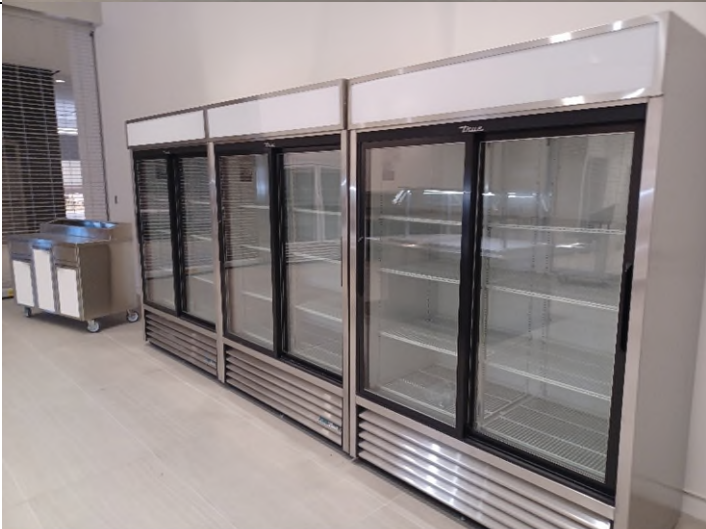
<p>Cooling Systems</p> <p>OESN reviewed label information for cooling systems present in the building.</p> <p>Where available, labels indicated that ozone depleting substances are not present.</p>

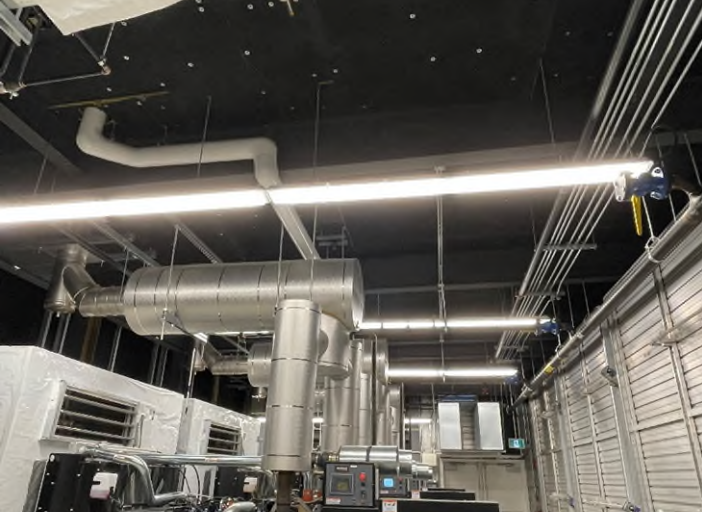
<p>Mechanical Spaces</p> <p>Surface coatings with low levels of lead, and lead acid batteries observed in building spaces including the parking garage.</p> <p>OESN Ltd. did not observe any other materials or equipment suspected to contain designated substances at the time of evaluation.</p>

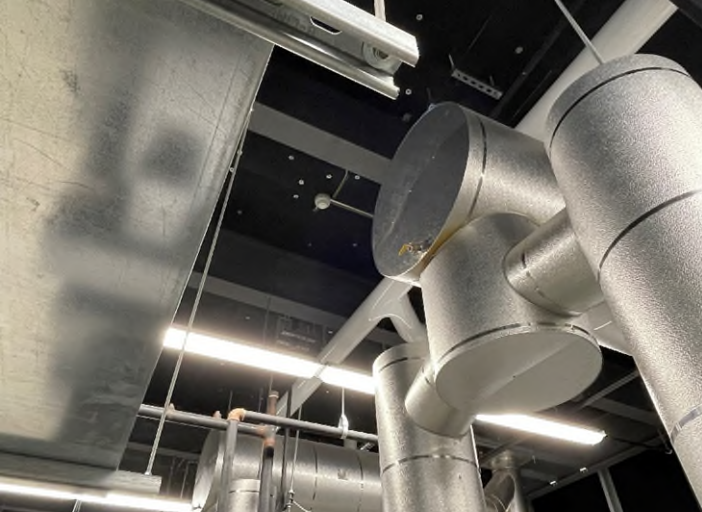
<p>Mechanical Spaces</p> <p>Surface coatings with low levels of lead, and lead acid batteries observed in building spaces including the parking garage.</p> <p>OESN Ltd. did not observe any other materials or equipment suspected to contain designated substances at the time of evaluation.</p>

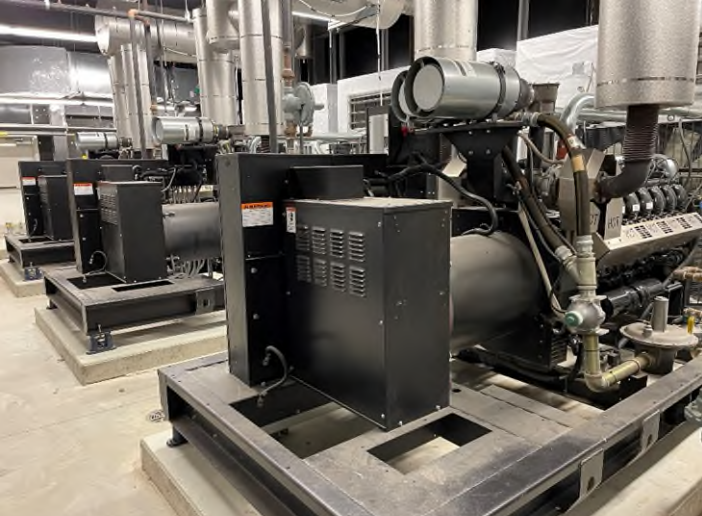
<p>Mechanical Spaces</p> <p>Surface coatings with low levels of lead, and lead acid batteries observed in building spaces including the parking garage.</p> <p>OESN Ltd. did not observe any other materials or equipment suspected to contain designated substances at the time of evaluation.</p>

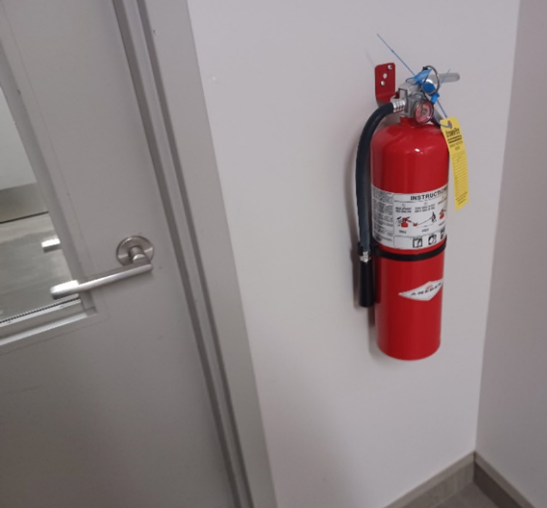
<p>Fire Extinguishers</p> <p>Where available, fire extinguisher labels indicated that ozone depleting substances are not present.</p>

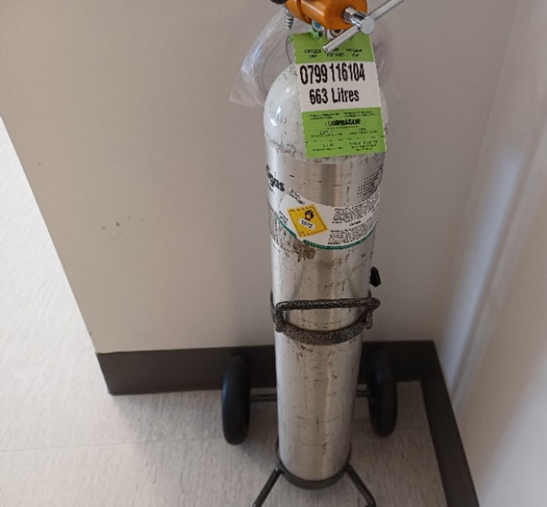
<p>Gasses Stored</p> <p>Gas cylinders with compressed oxygen stored in the third-floor dental office. Containers clearly labelled and stored safely at the time of evaluation.</p>

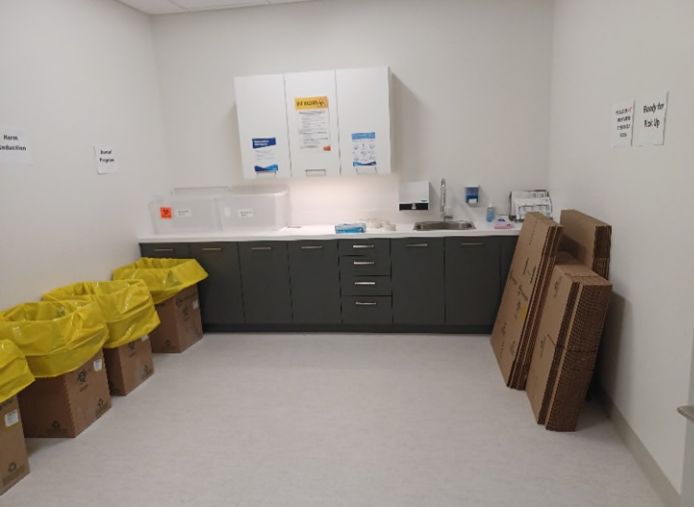
<p>Bio-Hazard</p> <p>OESN did not observe bio-hazards such as mould growth or animal droppings.</p> <p>A bio-hazard disposal site was located on the third floor.</p>
