Guelph General Hospital

2023 Asbestos Audit Report

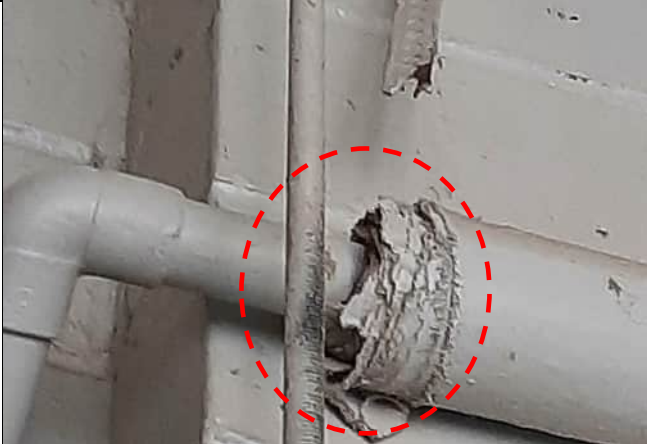
Repair in accordance with O. Reg. 278/05 as a Type 2 Operation.	Repair (lag ends) in accordance with O. Reg. 278/05 as a Type 2 Operation. Removal in accordance with O. Reg. 278/05 as a Type 3 Operation.
Asbestos Friable	G02 - Security Office Closet	Insulation on Pipe Fittings	4 Units

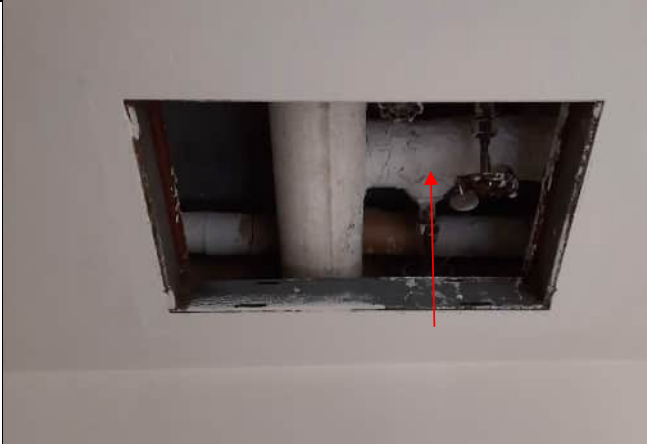
In place management in accordance with O. Reg. 278/05	Removal in accordance with O. Reg. 278/05 < 1m ² as a Type 2 or Type 2 Glove Bag Operation and for > 1m ² as a Glove Bag or Type 3 Operation

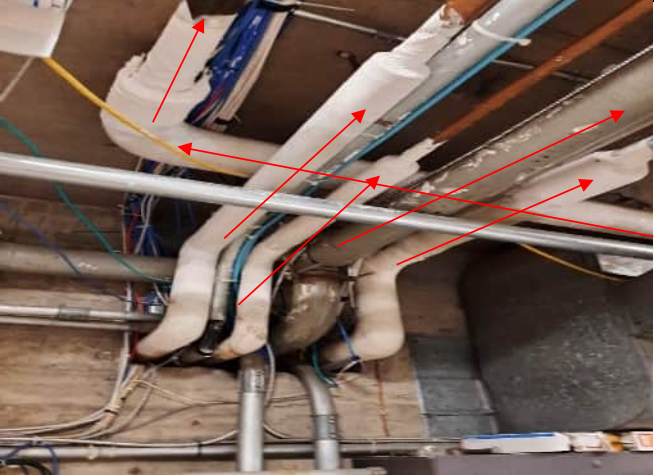
In place management in accordance with O. Reg. 278/05	Removal in accordance with O. Reg. 278/05 < 1m ² as a Type 2 or Type 2 Glove Bag Operation and for > 1m ² as a Glove Bag or Type 3 Operation
Asbestos Friable	G09 - Storage Room	Insulation on Pipe Fittings	10 Units	-	In place management in accordance with O. Reg. 278/05	Removal in accordance with O. Reg. 278/05 < 1m ² as a Type 2 or Type 2 Glove Bag Operation and for > 1m ² as a Glove Bag or Type 3 Operation
Asbestos Friable	G10 - Janitorial Closet	Insulation on Pipe Fittings	11 Units	-	In place management in accordance with O. Reg. 278/05	Removal in accordance with O. Reg. 278/05 < 1m ² as a Type 2 or Type 2 Glove Bag Operation and for > 1m ² as a Glove Bag or Type 3 Operation

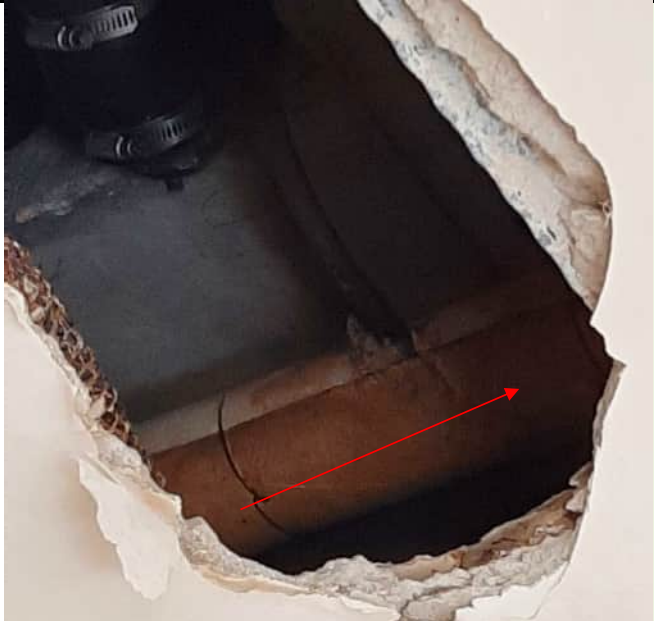
In place management in accordance with O. Reg. 278/05	Removal in accordance with O. Reg. 278/05 < 1m ² as a Type 2 or Type 2 Glove Bag Operation and for > 1m ² as a Type 2 Glove Bag or Type 3 Operation

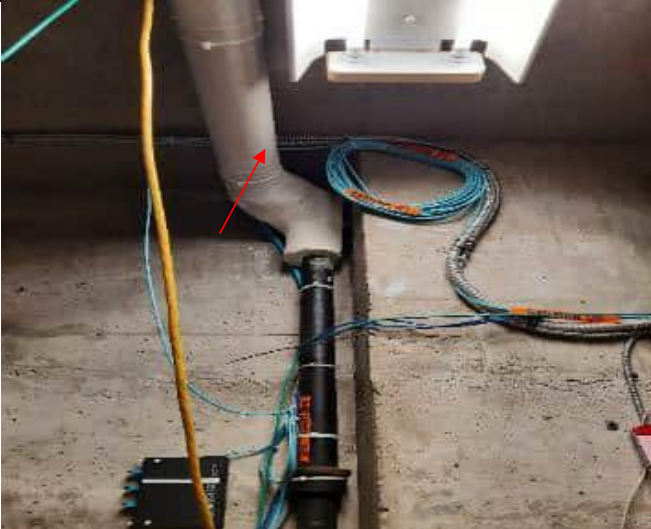
In place management in accordance with O. Reg. 278/05	Removal in accordance with O. Reg. 278/05 < 1m ² as a Type 2 or Type 2 Glove Bag Operation and for > 1m ² as a Type 2 Glove Bag or Type 3 Operation
Asbestos Friable	G08 (Two Rooms) - Workshop/Storage Rooms	4" - 6" O.D. Air Cell Insulation on Piping	91 m (300 ft.)

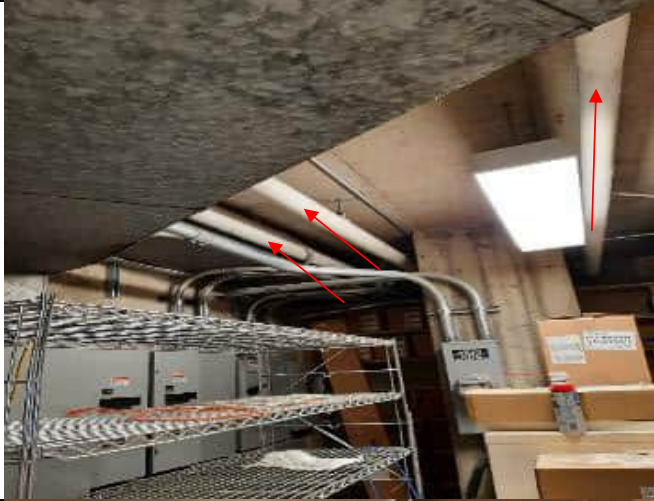
In place management in accordance with O. Reg. 278/05	Removal in accordance with O. Reg. 278/05 < 1m ² as a Type 2 or Type 2 Glove Bag Operation and for > 1m ² as a Type 2 Glove Bag or Type 3 Operation
Asbestos Friable	Assembly Room Storage	4" O.D. Air Cell Insulation on Piping	6 m (20 ft.)

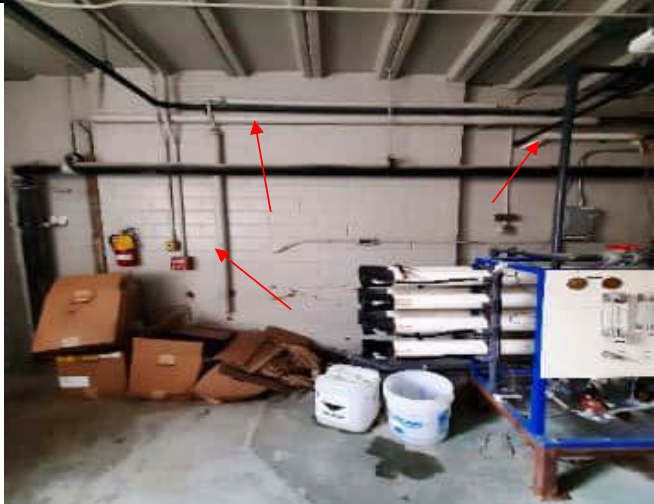
In place management in accordance with O. Reg. 278/05	Removal in accordance with O. Reg. 278/05 < 1m ² as a Type 2 or Type 2 Glove Bag Operation and for > 1m ² as a Type 2 Glove Bag or Type 3 Operation

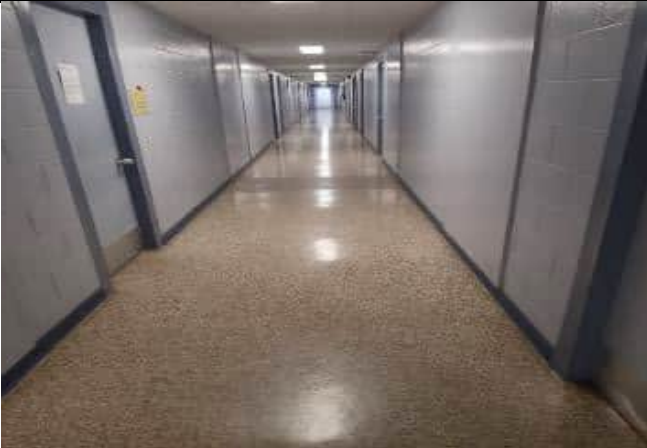
In place management in accordance with O. Reg. 278/05	Due to the unknown condition of the paper layer, adhesion to the underlying concrete and the potential for fibre release during extraction, removal should be conducted in accordance with O. Reg. 278/05 as a Type 2 or 3 Operation. <u>This material should be evaluated prior to removal.</u>
Asbestos Non-Friable	G01 - Facilities Offices and Reception	9"x9" Vinyl Floor Tile - Brown with White Streaks Floor Tile & Associated Mastic	Unknown due to multiple floor covering layers

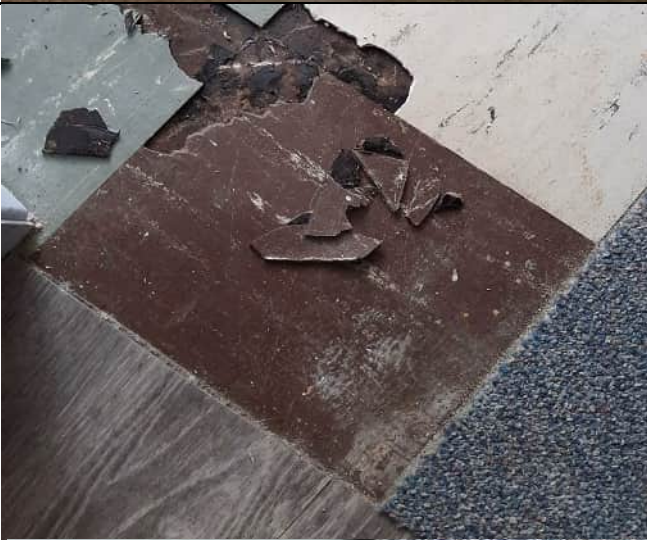
In place management in accordance with O. Reg. 278/05	Removal in accordance with O. Reg. 278/05 as a Type 1 Operation

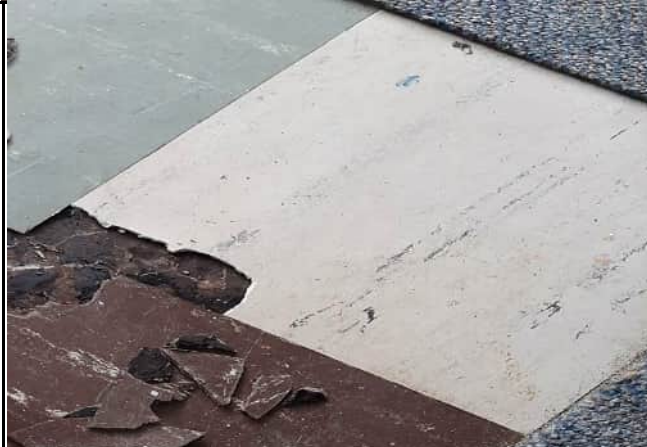
In place management in accordance with O. Reg. 278/05	Removal in accordance with O. Reg. 278/05 as a Type 1 Operation

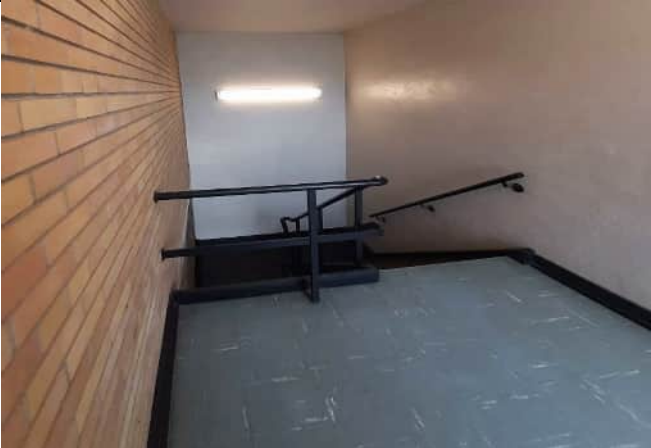
In place management in accordance with O. Reg. 278/05	Removal in accordance with O. Reg. 278/05 as a Type 1 Operation
Asbestos Non-Friable	G10 - Staff Washroom	12" x12" Vinyl Floor Tile Light Grey Mottled Pattern - Contaminated with asbestos-containing black mastic	1.4 m ² (15 ft ²)	-	In place management in accordance with O. Reg. 278/05	Removal in accordance with O. Reg. 278/05 as a Type 1 Operation

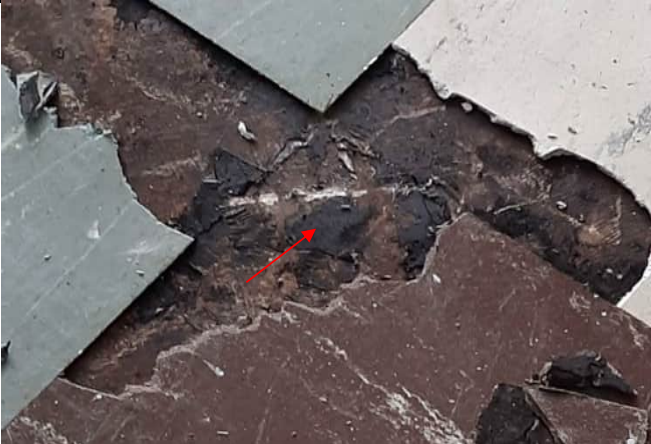
In place management in accordance with O. Reg. 278/05	Removal in accordance with O. Reg. 278/05 as a Type 1 Operation

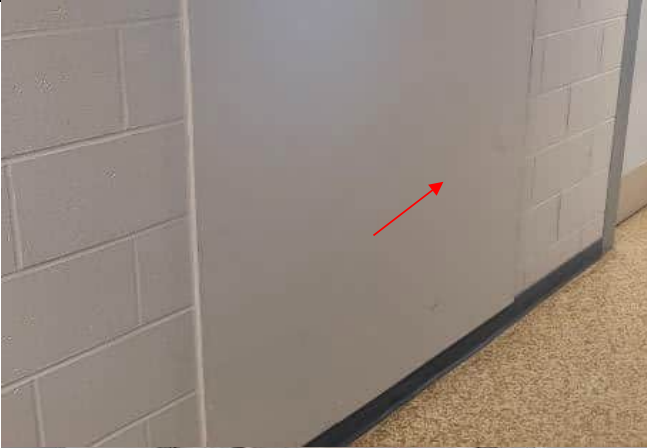
In place management in accordance with O. Reg. 278/05	Removal in accordance with O. Reg. 278/05 < 1m ² as a Type 1 Operation and for > 1m ² as a Type 2 Operation - Hand tools only in conjunction with dust suppression. It should be noted that only 1 of 7 samples reported asbestos content ≥ 0.5% and additional sampling is recommended prior to disturbance.
Asbestos Non-Friable	4th Floor Janitorial Closet 411	Light Dome Heat Shield (Silver Paper)	0.09 m ²

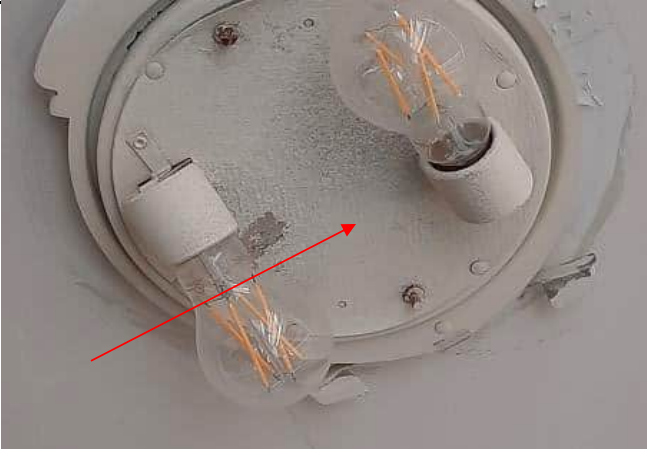
In place management in accordance with O. Reg. 278/05	Removal in accordance with O. Reg. 278/05 as a Type 1 Operation

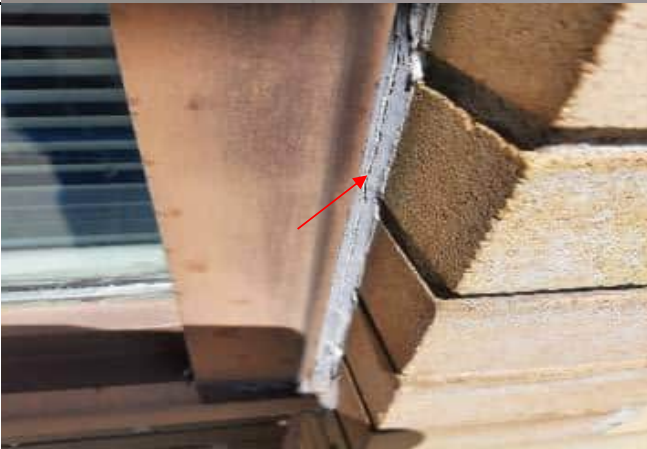
In place management in accordance with O. Reg. 278/05	Removal in accordance with O. Reg. 278/05 as a Type 1 Operation

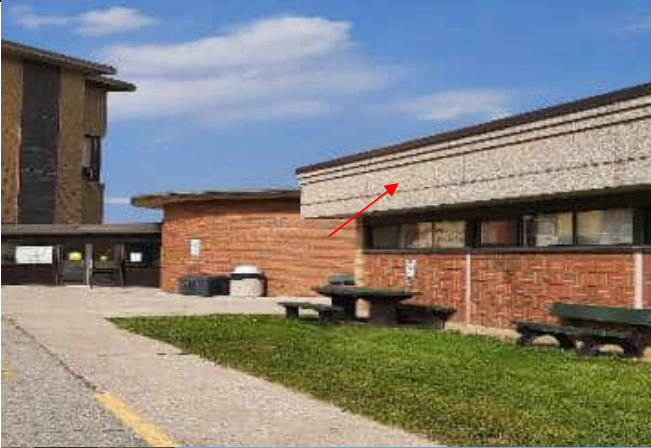
In place management in accordance with O. Reg. 278/05	Removal in accordance with O. Reg. 278/05 as a Type 1 Operation
Asbestos Non-Friable	Exterior of Building	Asbestos Cement Soffit Panels (Rotunda)	18.6 m ² (200 ft ²)

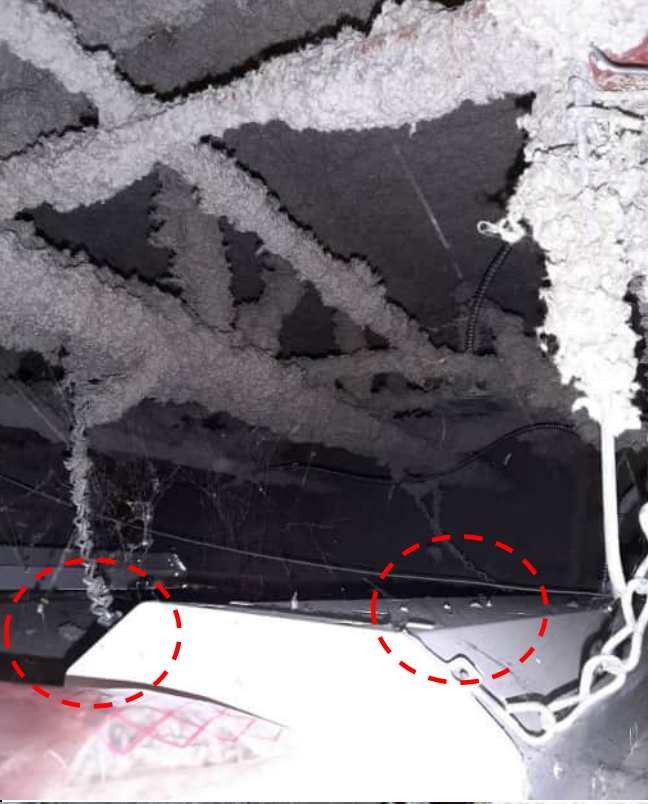
Clean-up in accordance with O. Reg. 278/05 as a Type 2 Operation. Access into ceiling spaces with known asbestos debris is classified as a Type 2 Operation.	Clean-up in accordance with O. Reg. 278/05 as a Type 2 Operation. Removal in accordance with O. Reg. 278/05 as a Type 3 Operation.
Asbestos Friable	Emergency Entrance Exterior Overhang	Spray-applied Fireproofing on deck structural beams, open web steel joists and conduits	74 m ² (800 ft ²)

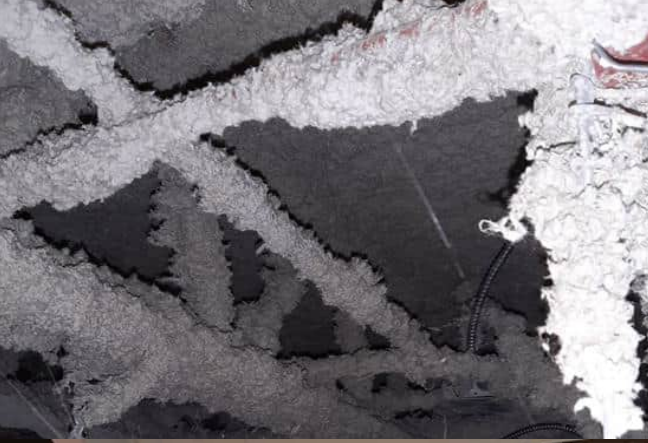
In place management in accordance with O. Reg. 278/05	Removal in accordance with O. Reg. 278/05 < 1m ² as a Type 2 Operation and for > 1m ² as a Type 3 Operation

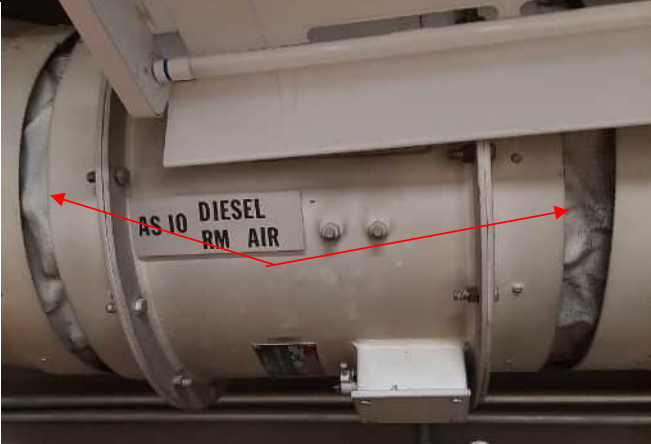
In place management in accordance with O. Reg. 278/05	Due to the unknown condition of the paper layer, adhesion to the underlying concrete and the potential for fibre release during extraction, removal should be conducted in accordance with O. Reg. 278/05 as a Type 3 Operation. This material should be evaluated prior to removal.
Asbestos Non-Friable	7th Floor Mechanical Corridor	Tar on Concrete block Wall	3m ²

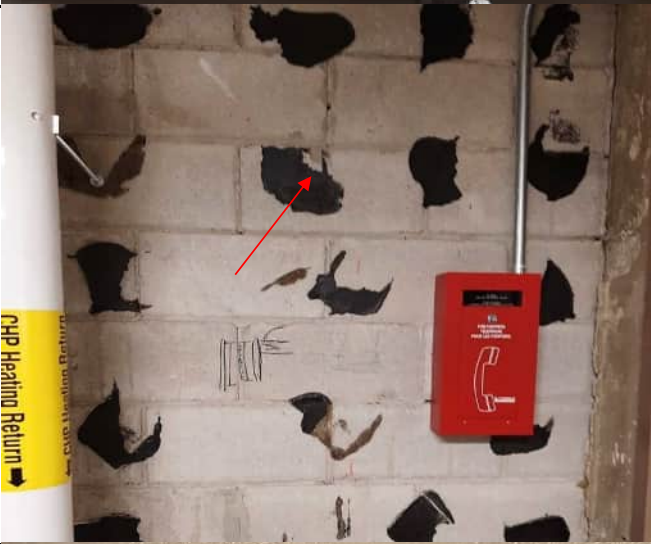
In place management in accordance with O. Reg. 278/05	Removal in accordance with O. Reg. 278/05 as a Type 1 Operation

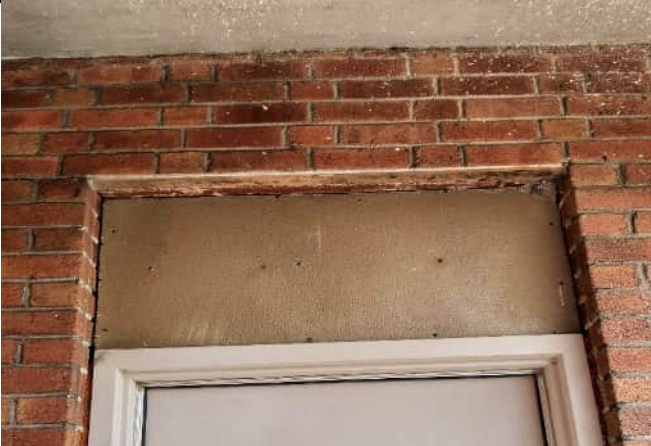
In place management in accordance with O. Reg. 278/05	Removal in accordance with O. Reg. 278/05 as a Type 1 Operation

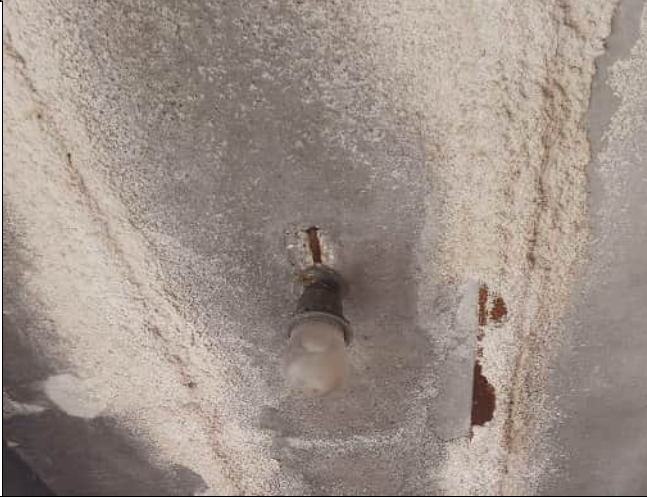
In place management in accordance with O. Reg. 278/06	Sample prior to maintenance/renovations/ construction/demolition activities and if confirmed ACM, removal in accordance with O. Reg. 278/05
Suspect Asbestos Non-Friable	Roof	Roofing Materials (Paper/Felts/Mastics/Sealants)	-	-	In place management in accordance with O. Reg. 278/05	Sample prior to maintenance/renovations/ construction/demolition activities and if confirmed ACM, removal in accordance with O. Reg. 278/05
Suspect Asbestos Non-Friable	Interior	Interior Sealants in Windows	-	-	In place management in accordance with O. Reg. 278/05	Sample prior to maintenance/renovations/ construction/demolition activities and if confirmed ACM, removal in accordance with O. Reg. 278/05

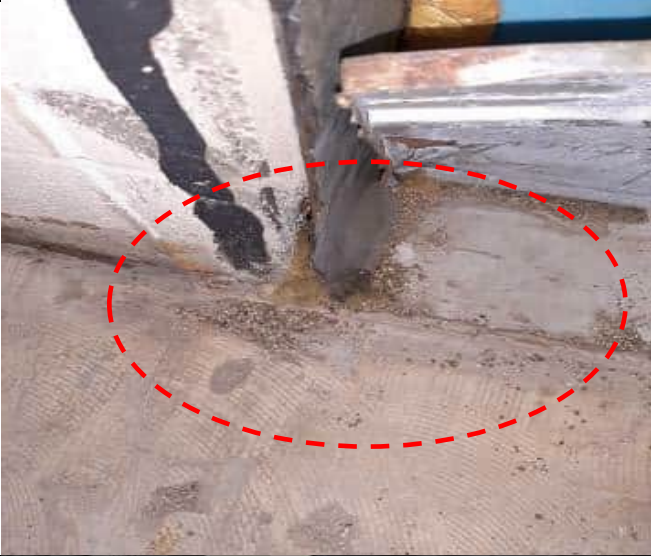
Repair in accordance with O. Reg. 278/05 as a Type 2 Operation.	Repair (lag ends) in accordance with O. Reg. 278/05 as a Type 2 Operation. Removal in accordance with O. Reg. 278/05 as a Type 3 Operation.
Asbestos Non-Friable	Throughout building interior	Drywall with Asbestos-containing Drywall Joint Compounds	-

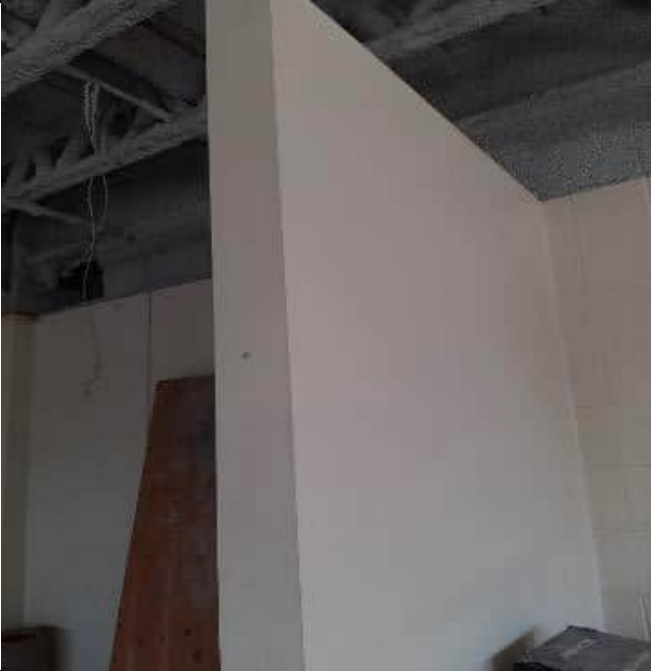
In place management in accordance with O. Reg. 278/05	Removal in accordance with O. Reg. 278/05 < 1m ² as a Type 1 Operation and for > 1m ² as a Type 2 Operation - Hand tools only in conjunction with dust suppression. It should be noted that only 2 of 7 samples reported asbestos content ≥ 0.5% and additional sampling is recommended prior to disturbance.

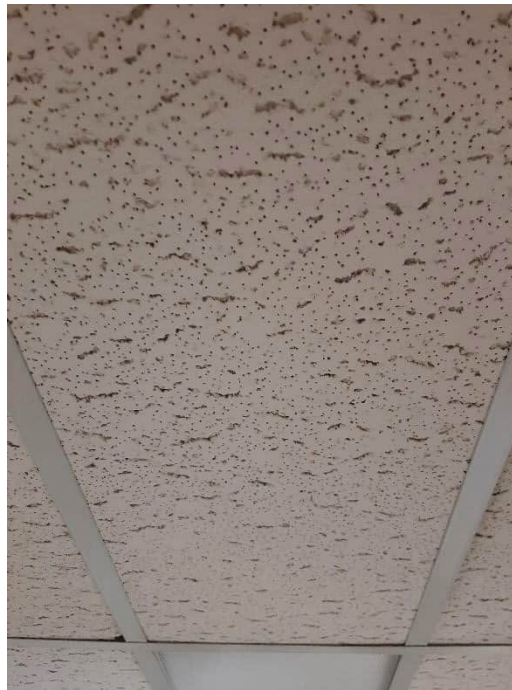
Photograph No. 2 – 73 Delhi Street – 4th Floor Administrative Offices, June 26, 2023 – One of four types of 2’x4’ and 2’x2’ ceiling tiles found within the building. All tested ceiling tiles returned negative for asbestos content at or above 0.5% asbestos content and are not classified as asbestos-containing.

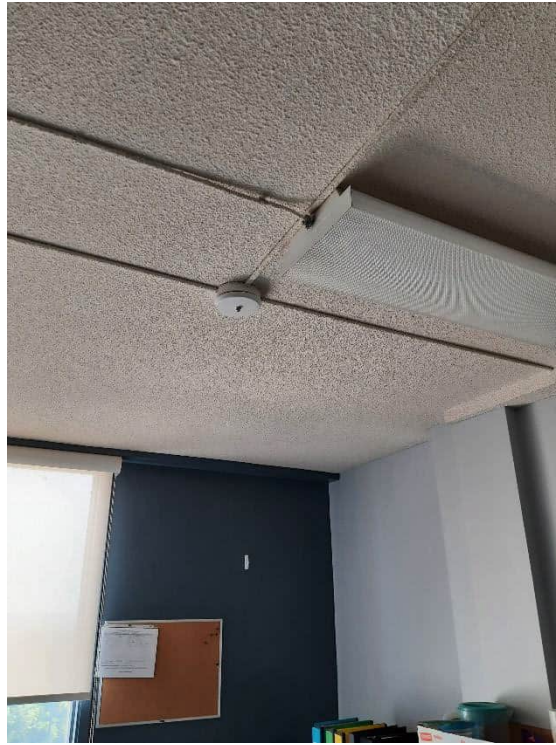
Photograph No. 3 – 73 Delhi Street – 1st Floor Print/Staff Room, June 26, 2023 – Textured “paint” on concrete slab ceilings reported non-detect for asbestos content above the laboratory detection limit of 0.5% and are not classified as asbestos-containing (S12A, B, C).

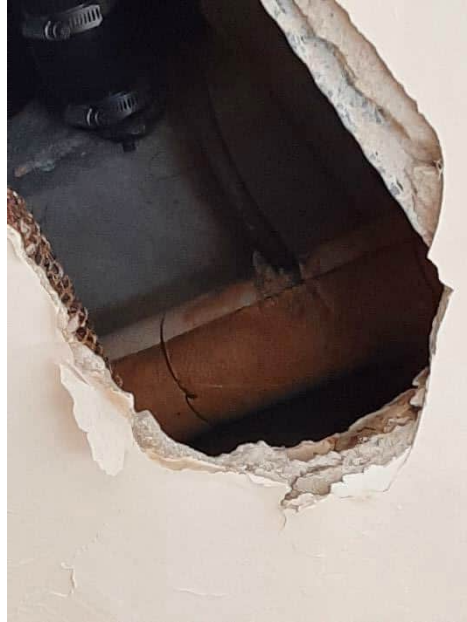
Photograph No. 5 – 73 Delhi Street – Ground Floor Security Office Storage Closet, June 26, 2023. One of several locations where asbestos pipe insulation was discovered above solid plaster ceilings. It is likely that additional asbestos-containing pipe and fitting insulation will be found above such surfaces including plumbing risers and wall cavities. Care should be taken when accessing solid ceiling and wall spaces due to the possibility of asbestos debris. Sample analysis confirmed the plaster as non-asbestos containing (S19B).

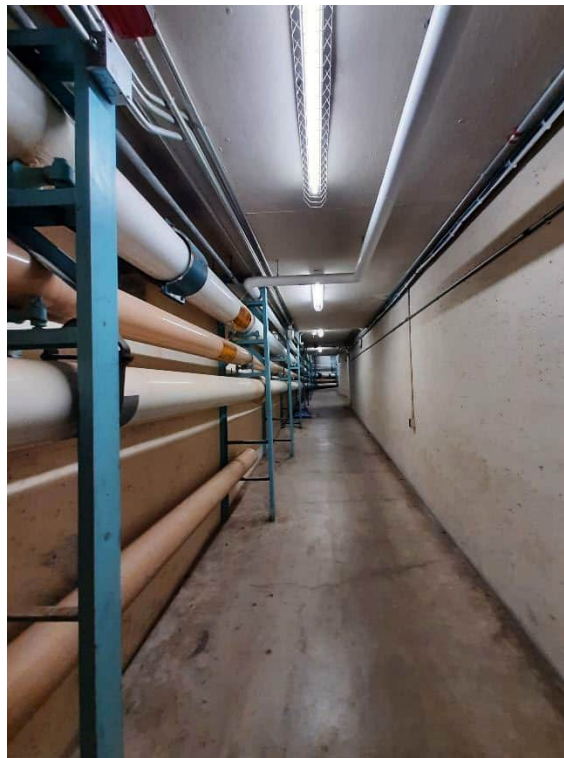
Photograph No. 6 – 73 Delhi Street – Ground Floor Steam Tunnel, June 26, 2023. Inspected steam, hot water and chilled water pipes were visually confirmed as fiberglass with canvas or PVC cladding. No asbestos-containing pipe or fitting insulation was confirmed.

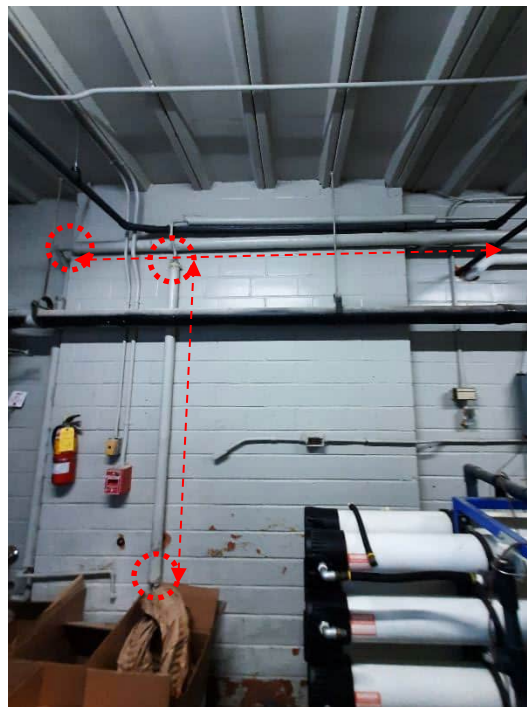
Photograph No. 8– 73 Delhi Street – Ground Floor Power Plant – “Generator Room”, June 26, 2023. Air-cell type asbestos containing pipe insulation visually confirmed on the west wall. Most cementitious fittings had been removed and only one was confirmed at ceiling height. Many of the pipe insulation ends were damaged or had exposed ends and will require either removal or repair.

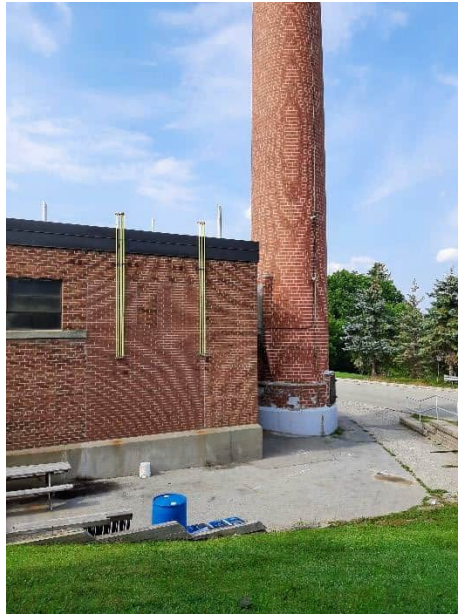
Photograph No. 9– 73 Delhi Street – Power Plant Exterior, June 26, 2023. Chimney stack interior could not be accessed at the time of the inspection. Asbestos-containing refractory materials may be present and should be sampled and analyzed for asbestos content prior to disturbance during maintenance or demolition activities.

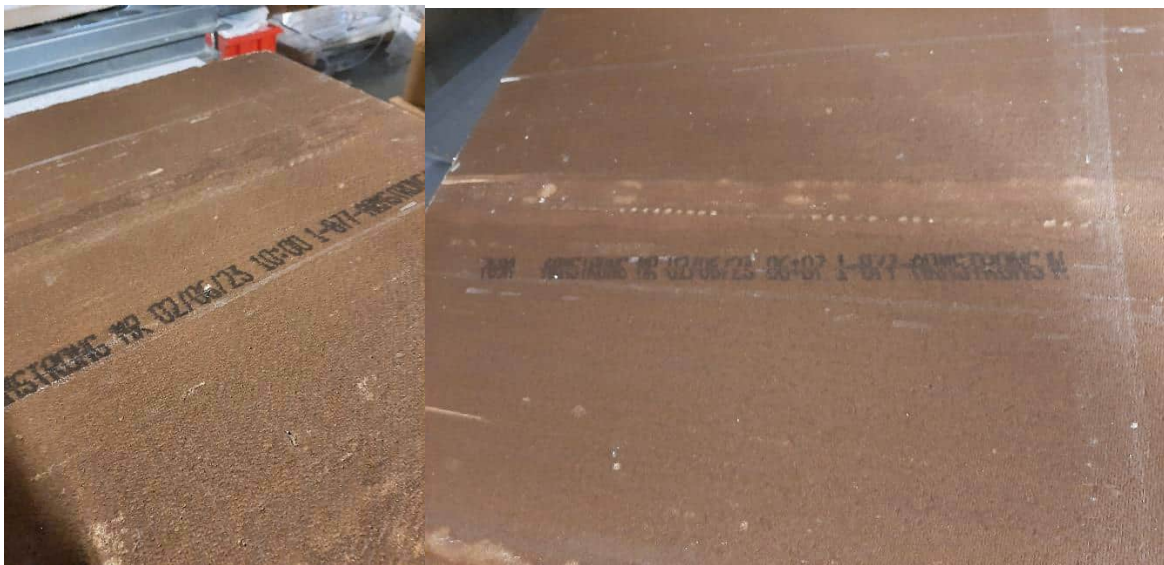
Photograph No. 19 & 20 – 115 Delhi Street – Level 2 - September 23, 2023. Two inspected 2'x4' short fissure pinhole pattern acoustic tiles showing 2023 date stamps confirmed as non-asbestos containing.

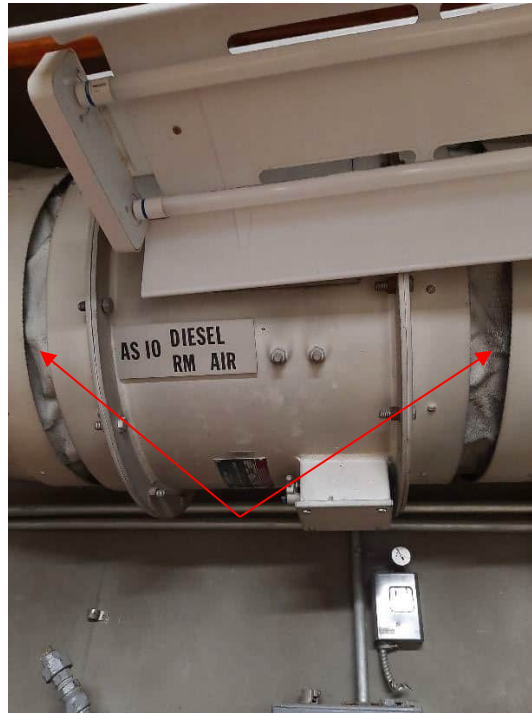
Photograph No. 21 – 115 Delhi Street – Level 1 Diesel Generator Room - September 23, 2023.
Suspect asbestos containing duct expansion joints on a diesel generator exhaust fan.

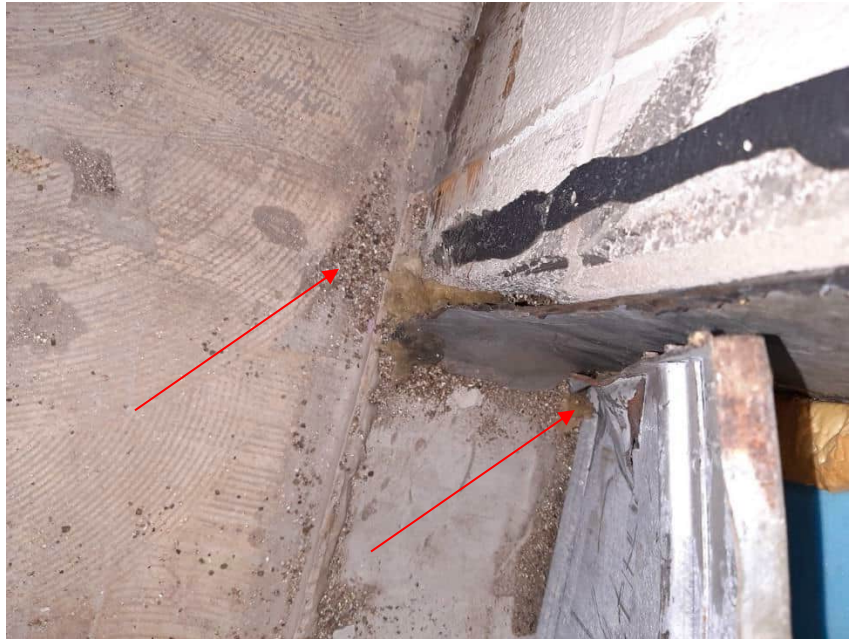
Photograph No. 28 – 125 Delhi Street – 2nd Floor Shell Space – June 27, 2023. Vermiculite loose-fill insulation in block wall behind register confirmed to be contaminated with asbestos (S10A - 1% Tremolite). All exterior walls should be treated with caution due to the presence of vermiculite. Debris found at a register “blank” on the south wall west of the lobby corridor.

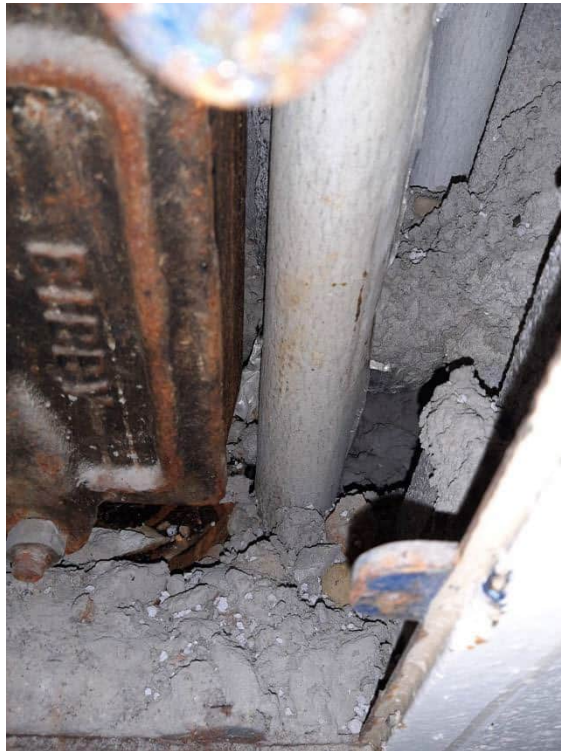
Photograph No. 29 – 125 Delhi Street – 2nd Floor Shell Space – June 27, 2023. No vermiculite loose-fill insulation discovered in block wall in the Men' s Washroom.

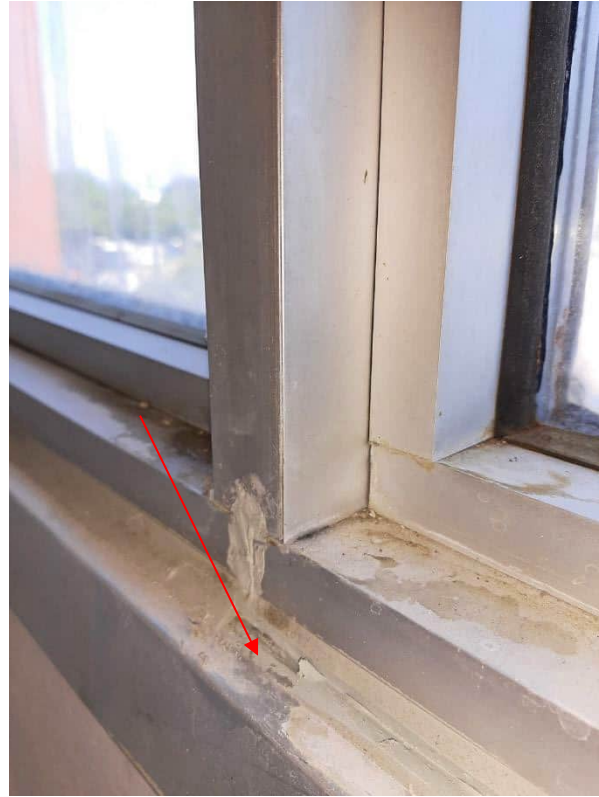
Photograph No. 30 – 125 Delhi Street – 2nd Floor Shell Space – June 27, 2023. Interior sealant reported as non-asbestos-containing (S06A, B, C).

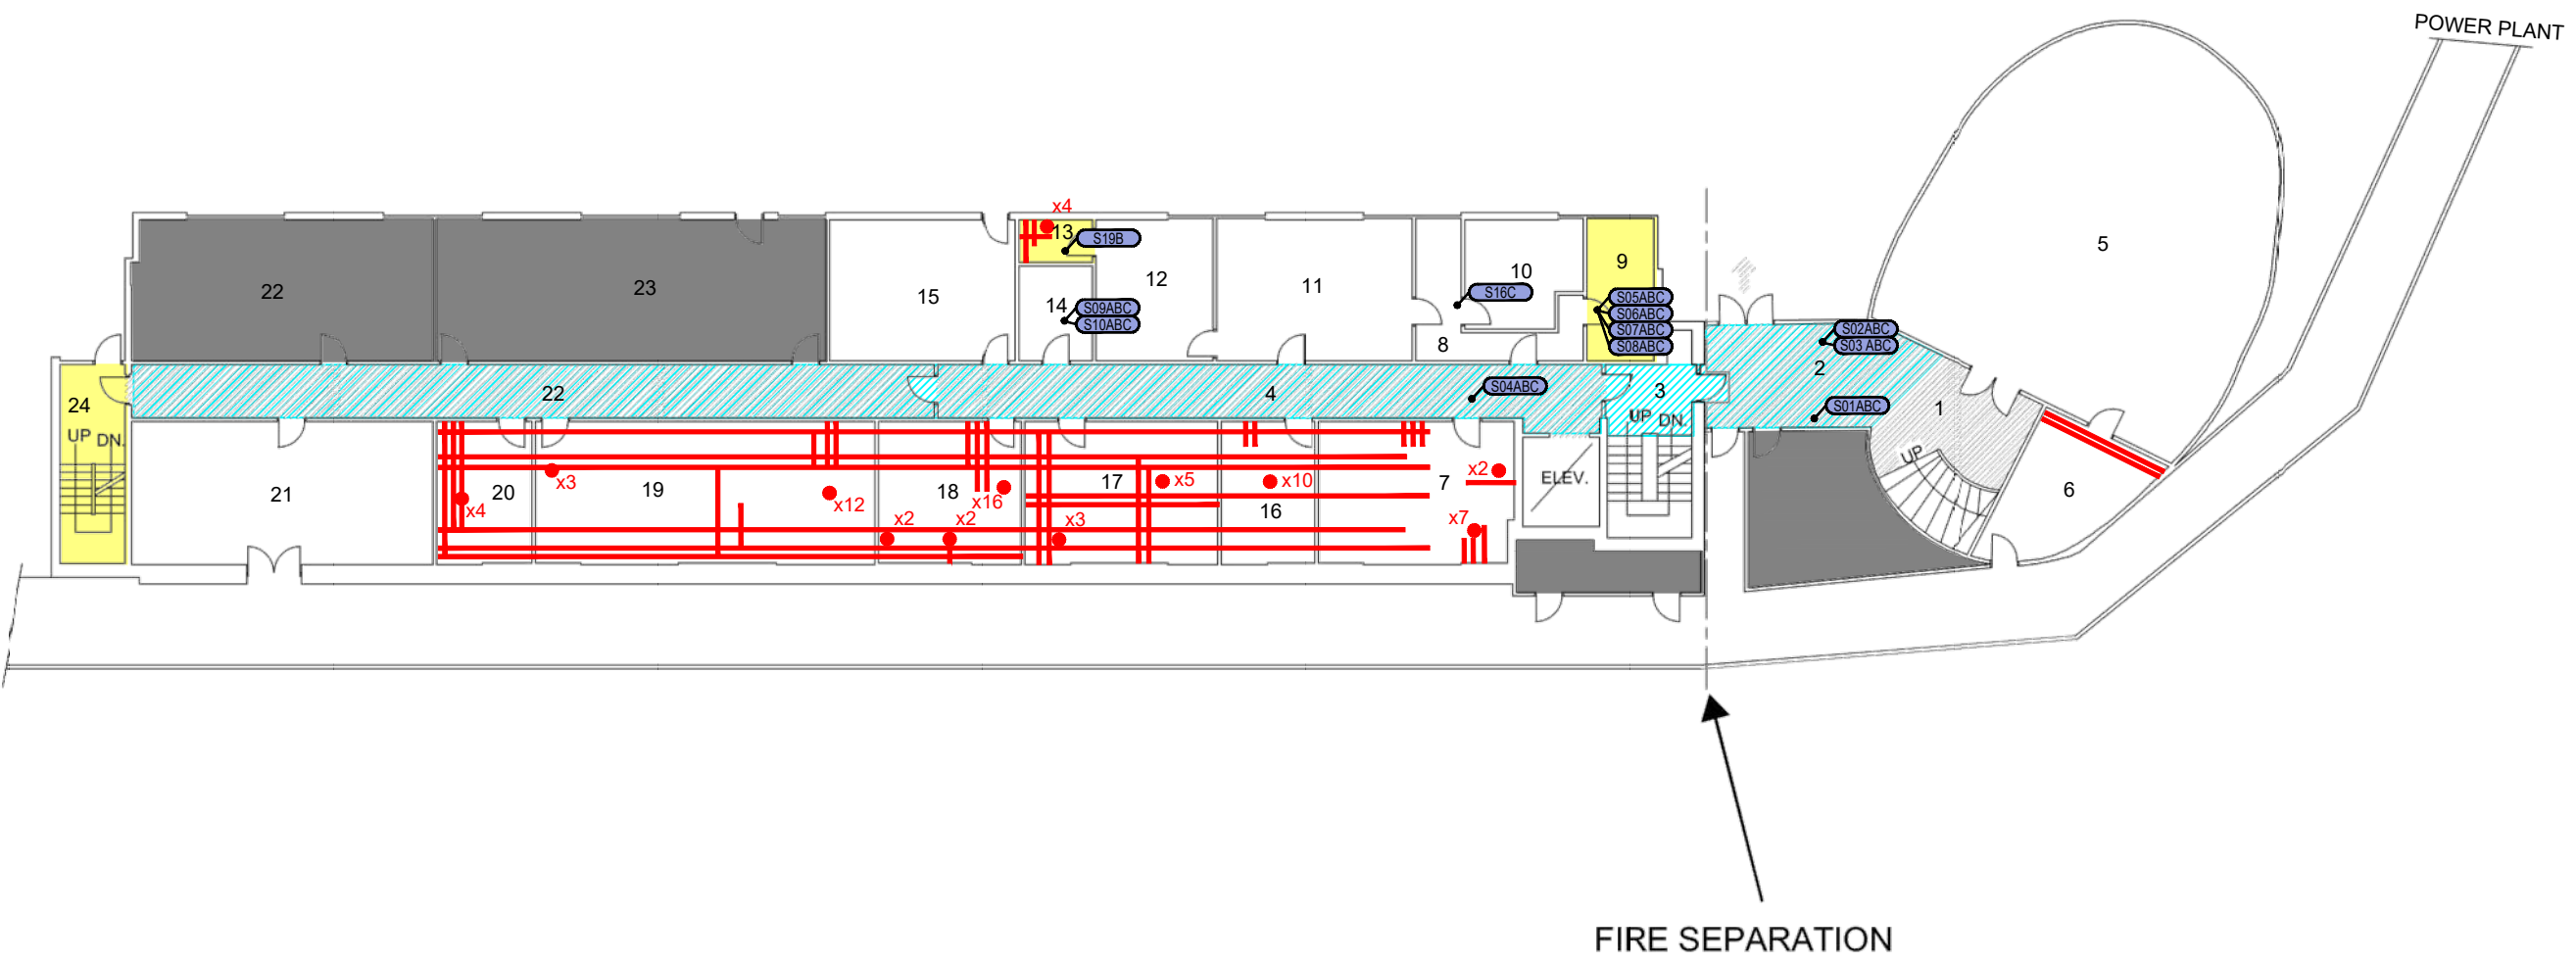
CLIENT
 GUELPH GENERAL HOSPITAL

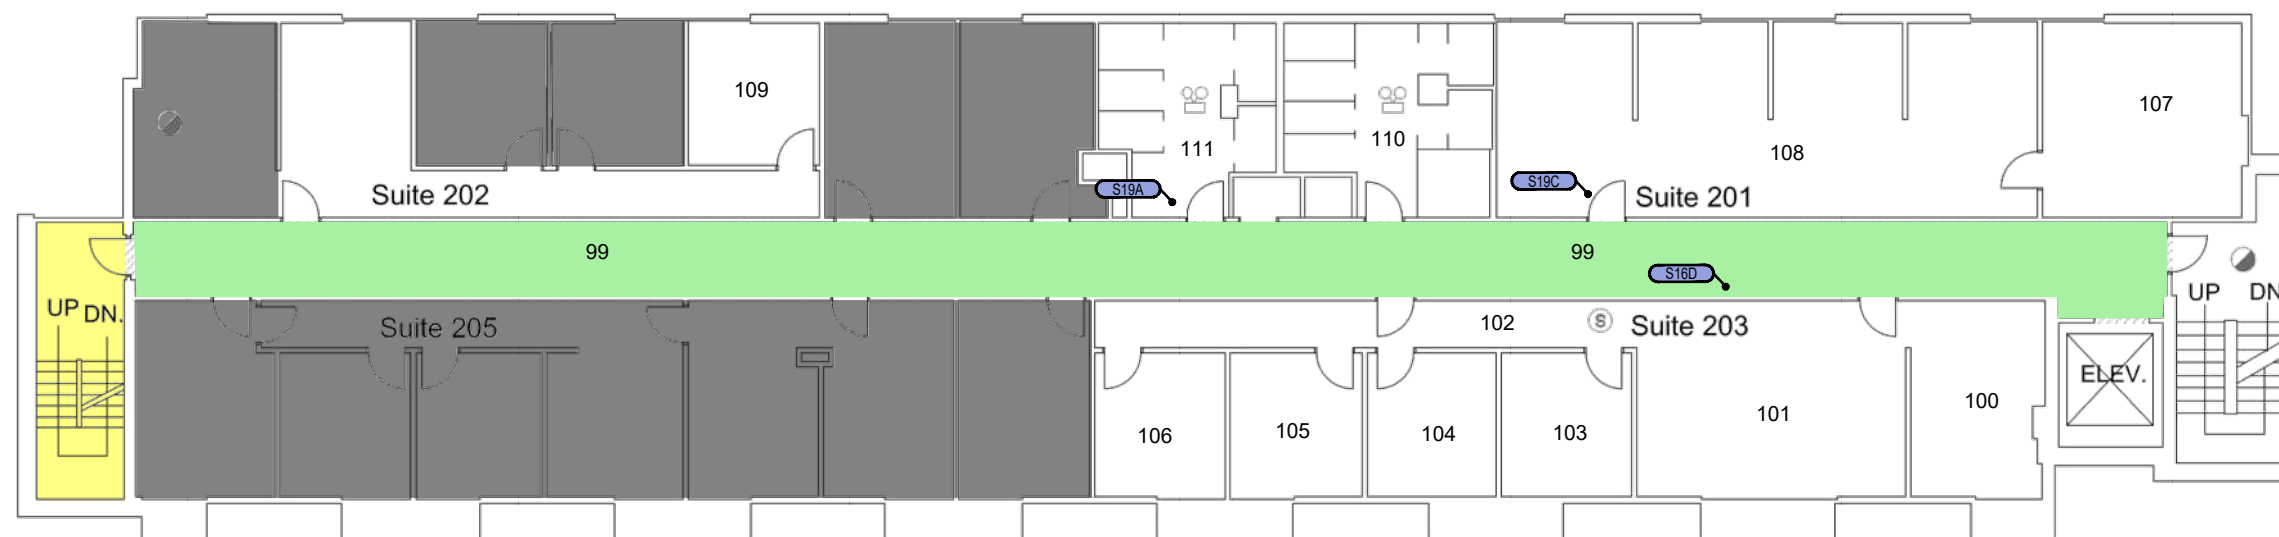
Ph. (519) 743-6500 www.mte85.com

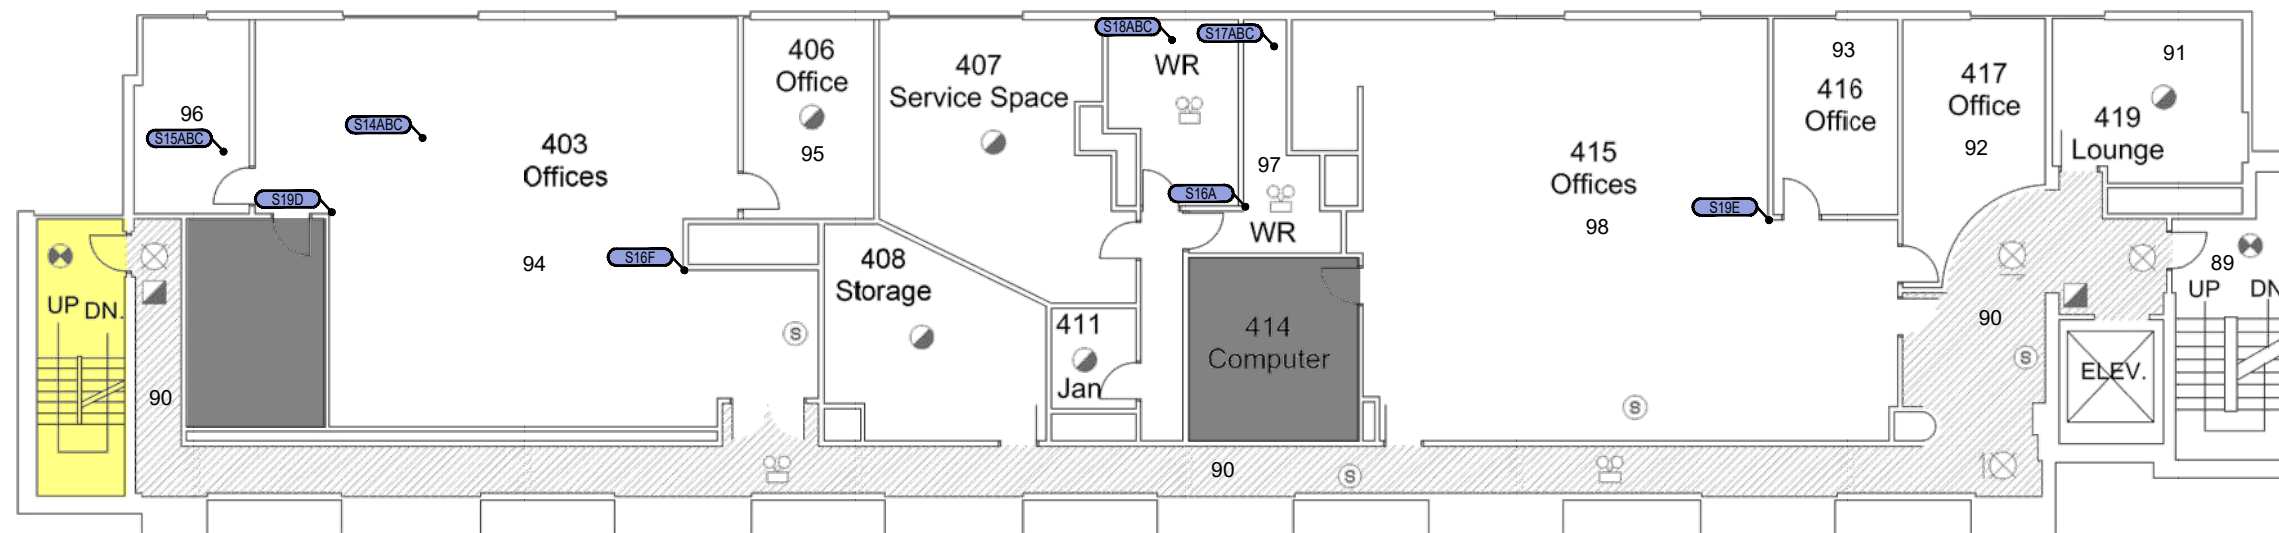
Ph. (519) 743-6500 www.mte85.com
