Guelph General Hospital

2023 Asbestos Audit Report

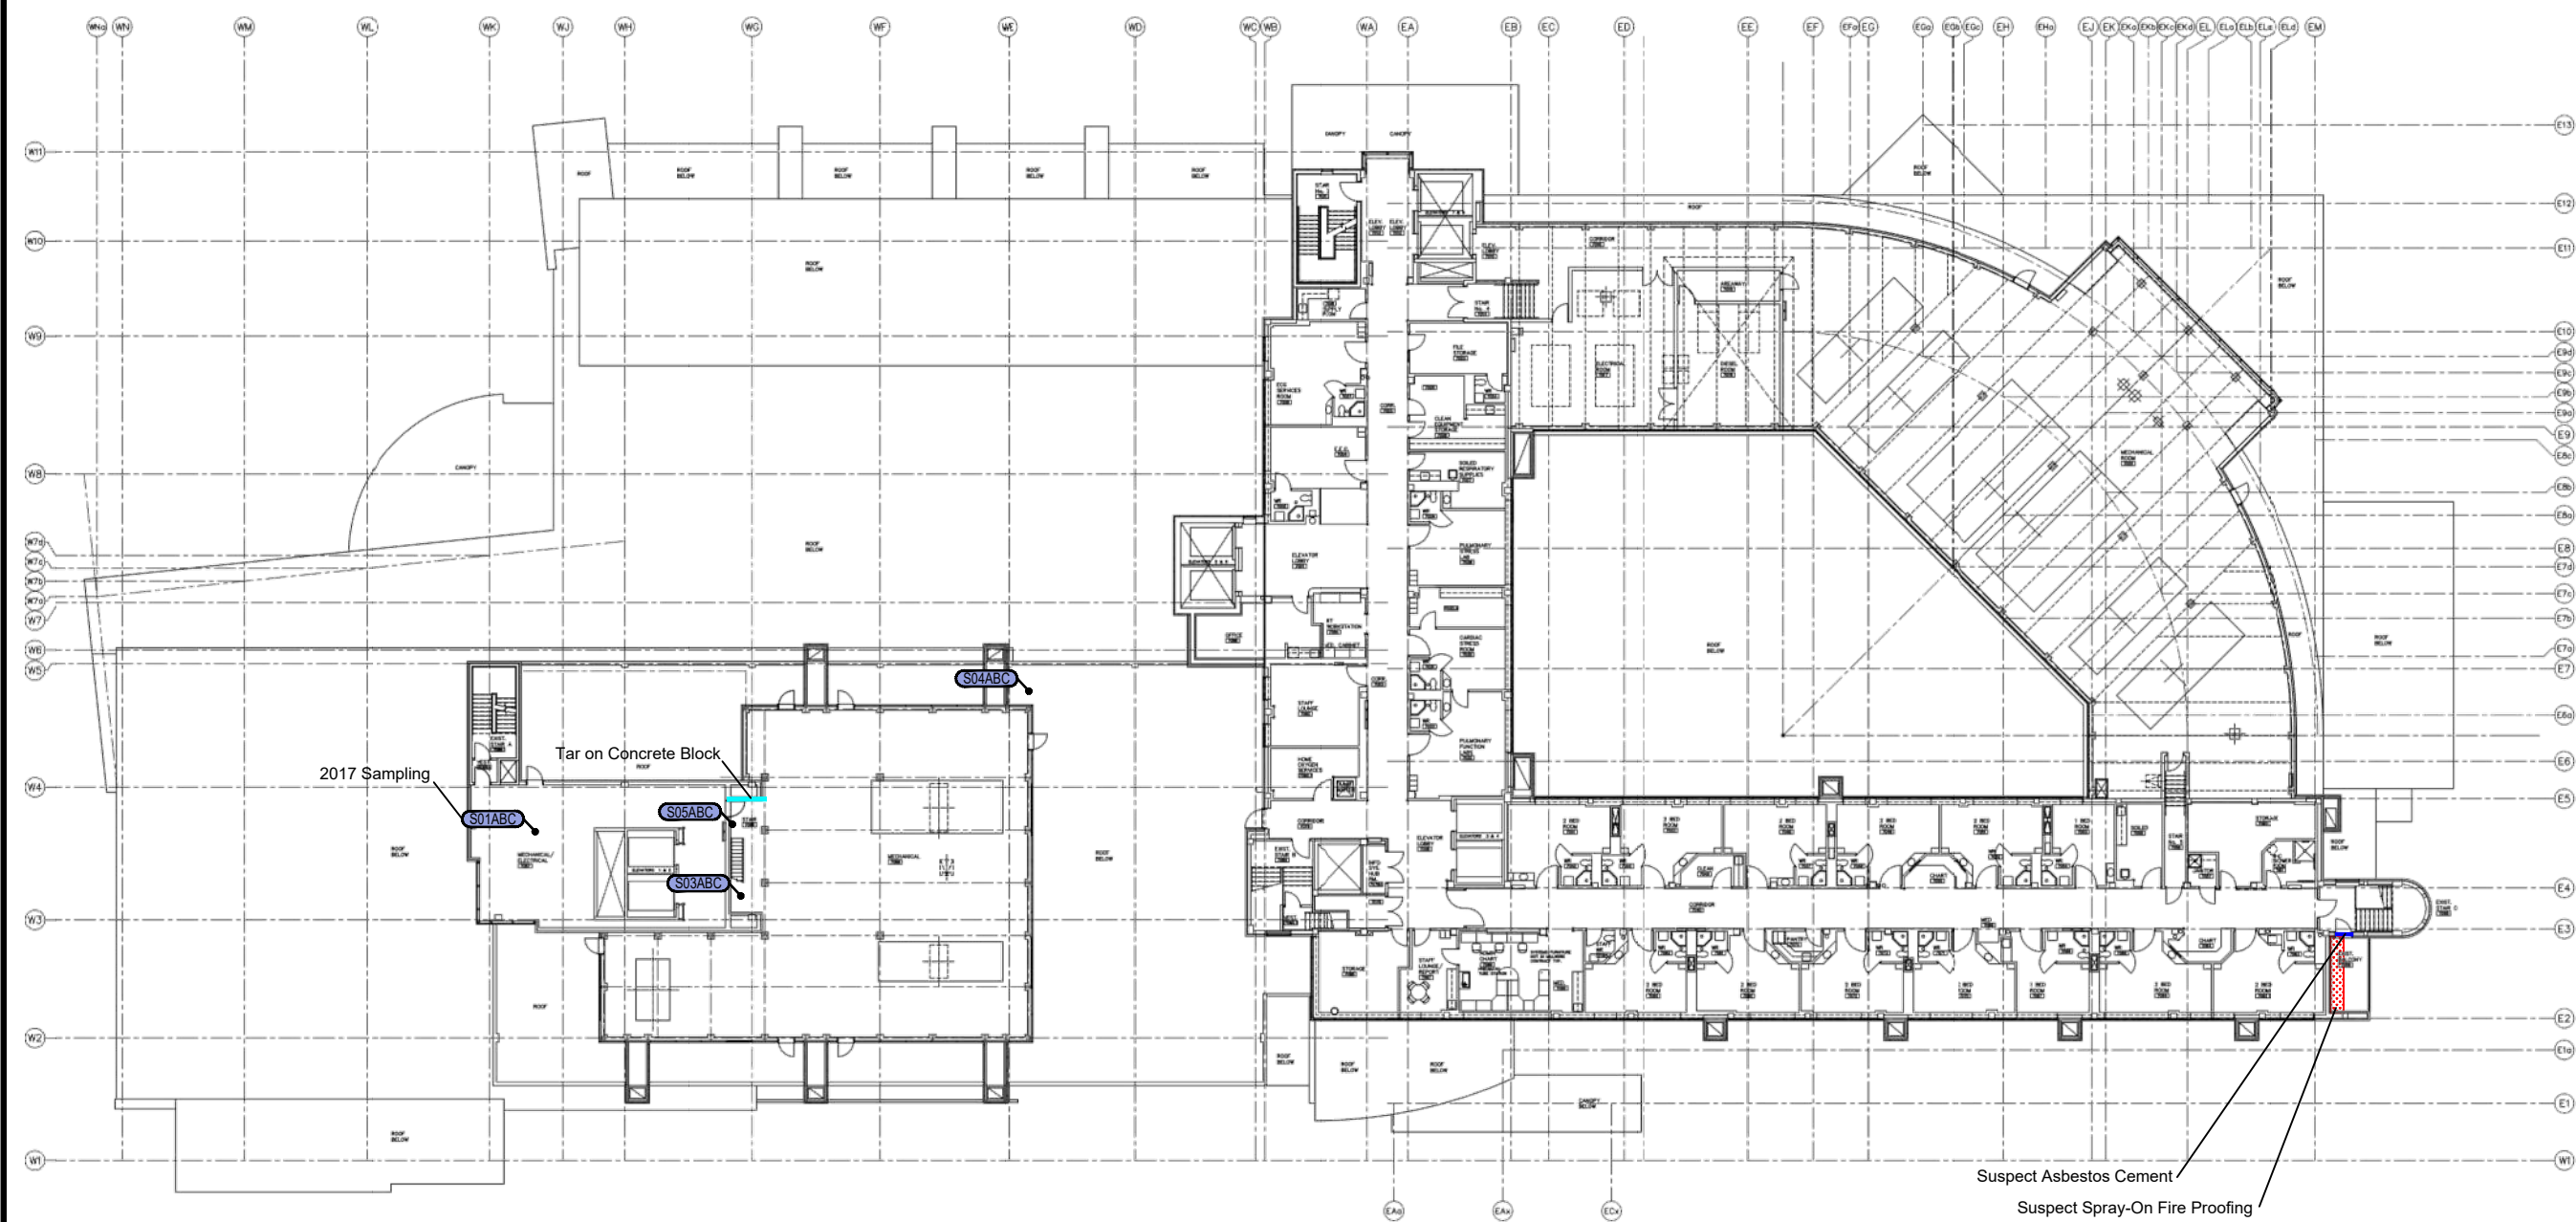
Ph. (519) 743-6500 www.mte85.com
