**Re: 40 Rossmore Road – William Bolton Arena (Ward 11)**

## Arborist Report

Central Tree Care Ltd. has been retained by the City of Toronto. to provide a professional arborist report for the proposed work at 40 Rossmore Road at the William Bolton Arena.

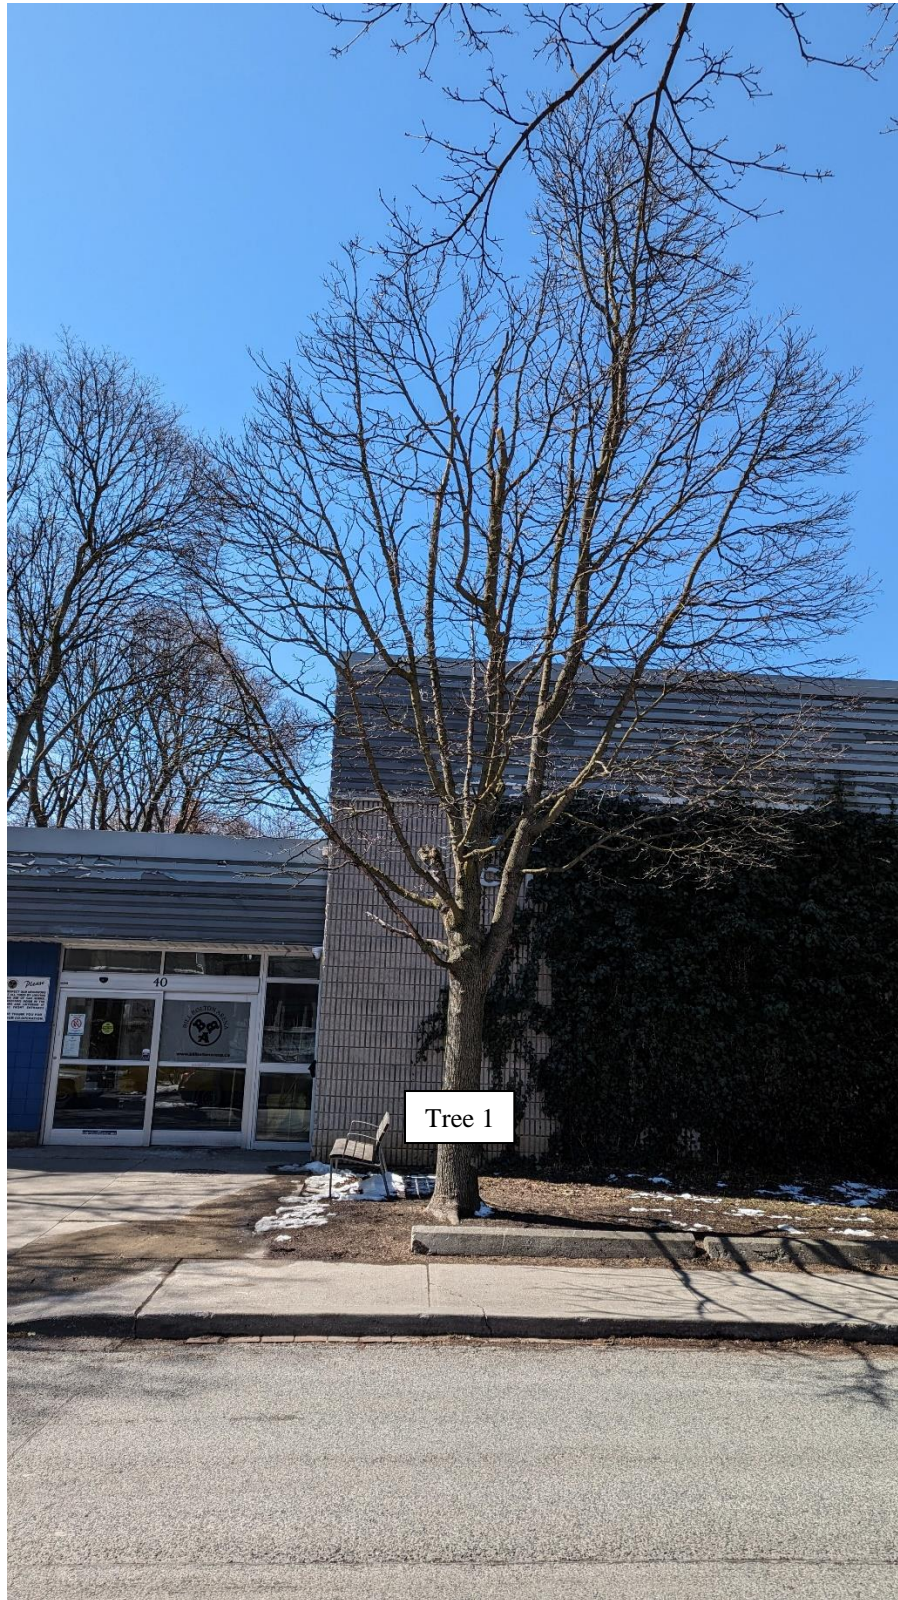
**Figure 1.** Tree 1 (facing west).

#	Species	Latin Name	DBH (cm)	TPZ (m)	Health	Structure	Assessment	Comment	Category
*1	Norway maple	<i>Acer platanoides</i>	37.5	2.4	Fair poor	Poor	Large deadwood, no reaction wood around deadwood. Epicormic growth. Central leader is dead.	Requires pruning	5
*2	Norway maple	<i>Acer platanoides</i>	43	3	Good fair	Good	Seam on a limb, forming into a crack, decay is present, possible woodpecker holes from decay. Small deadwood in canopy.	Requires pruning	5
*3	Norway maple	<i>Acer platanoides</i>	40	2.4	Good	Fair	Included bark for union, suspect soil cavity forming. Co-dominant stem. Small deadwood.	Requires pruning	5
*4	Norway maple	<i>Acer platanoides</i>	38	2.4	Fair	Fair	Lateral branch almost dead. Broken branch in canopy of tree. Small deadwood in canopy.	No pruning required	5
*5	Norway maple	<i>Acer platanoides</i>	36	2.4	Poor	Poor	Co-dominant stem, included bark in main union. Suspected insect holes on stem. Decay on one branch attachment point. A lot of deadwood throughout the tree.	Requires pruning	5

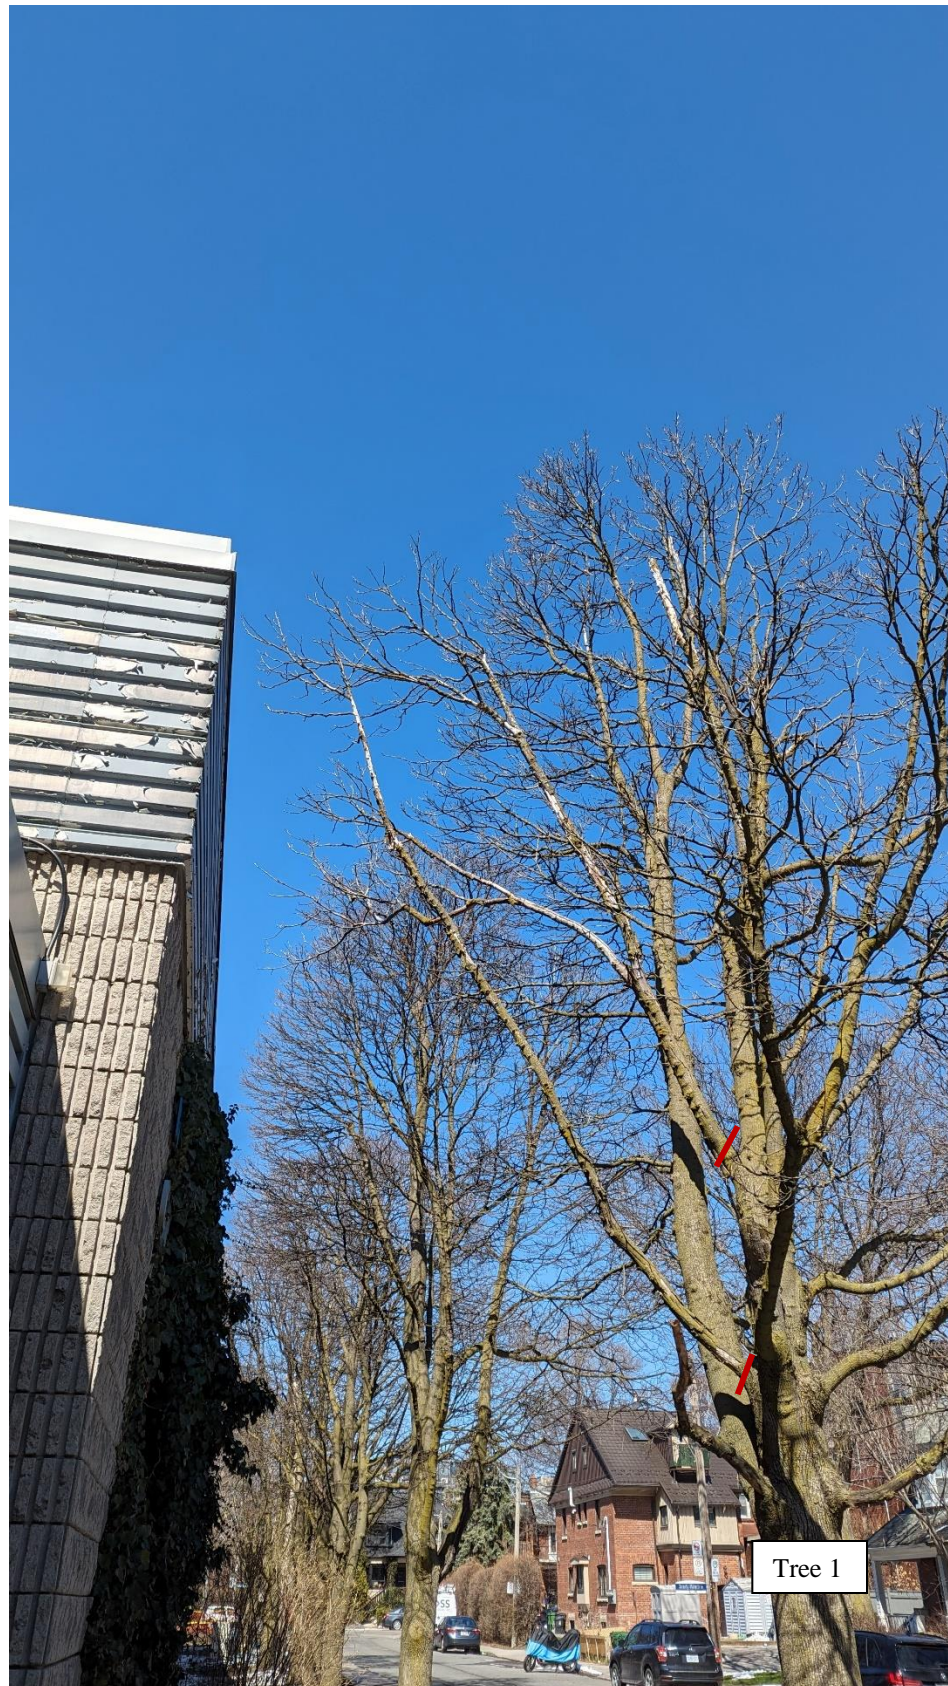
**Figure 2.** Red lines indicate which branches should be pruned back from the building (facing north).

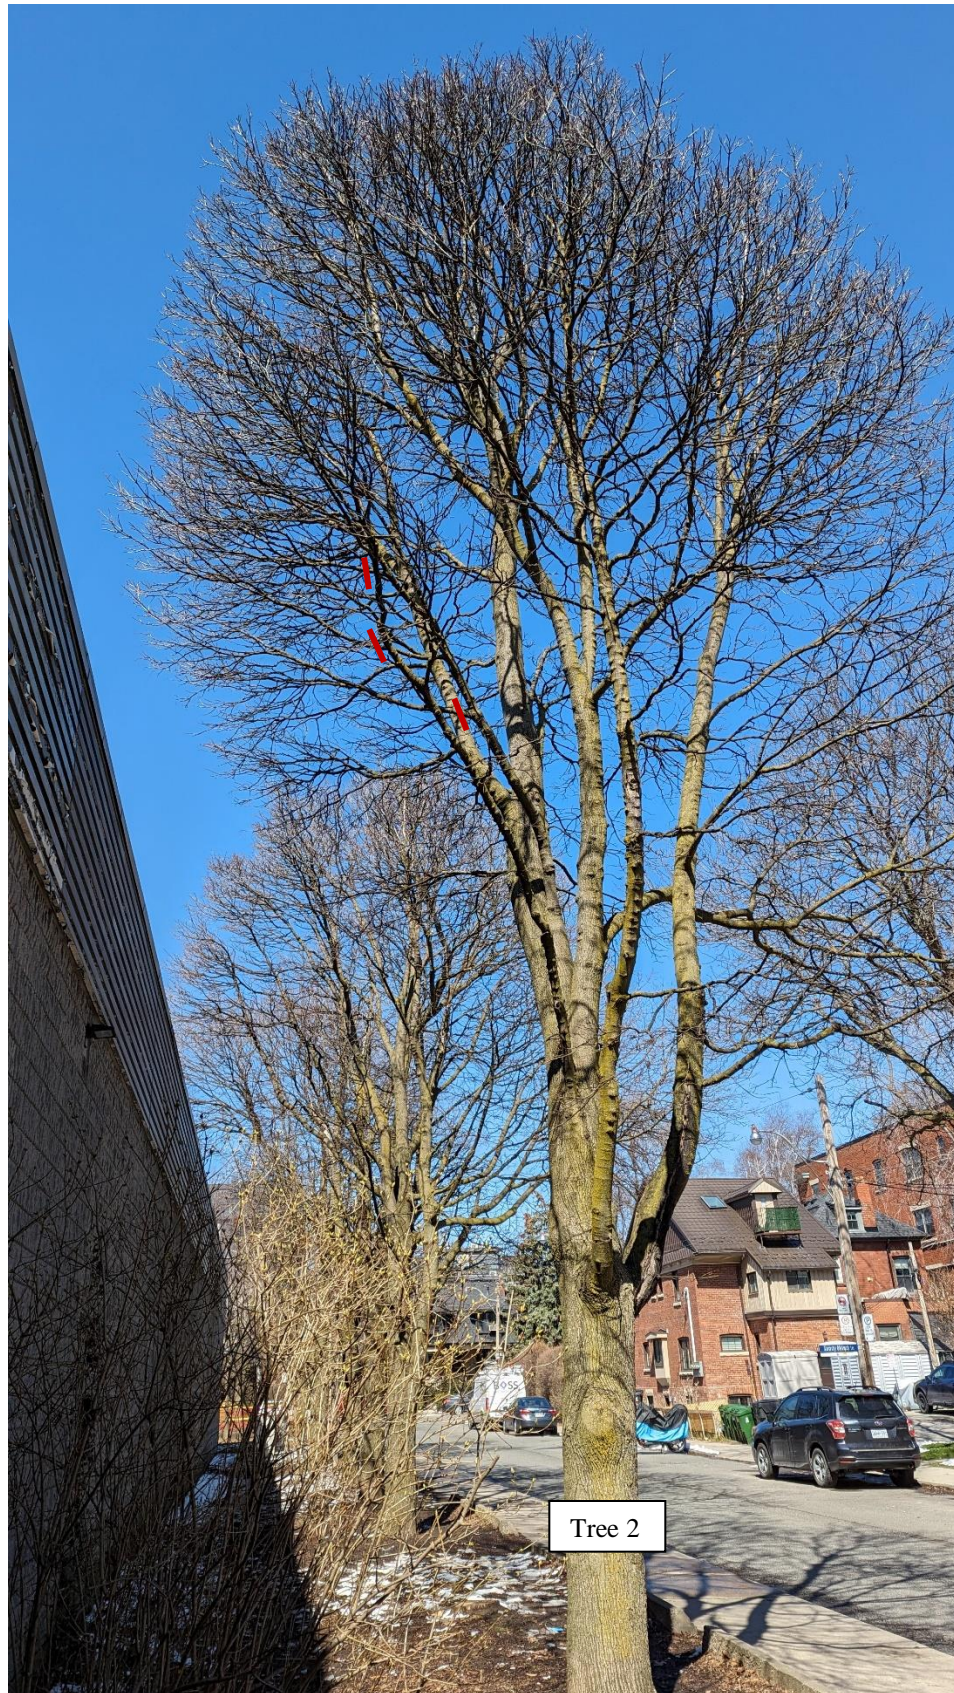
**Figure 4.** Red lines indicate which branches should be pruned back from the building (facing north).

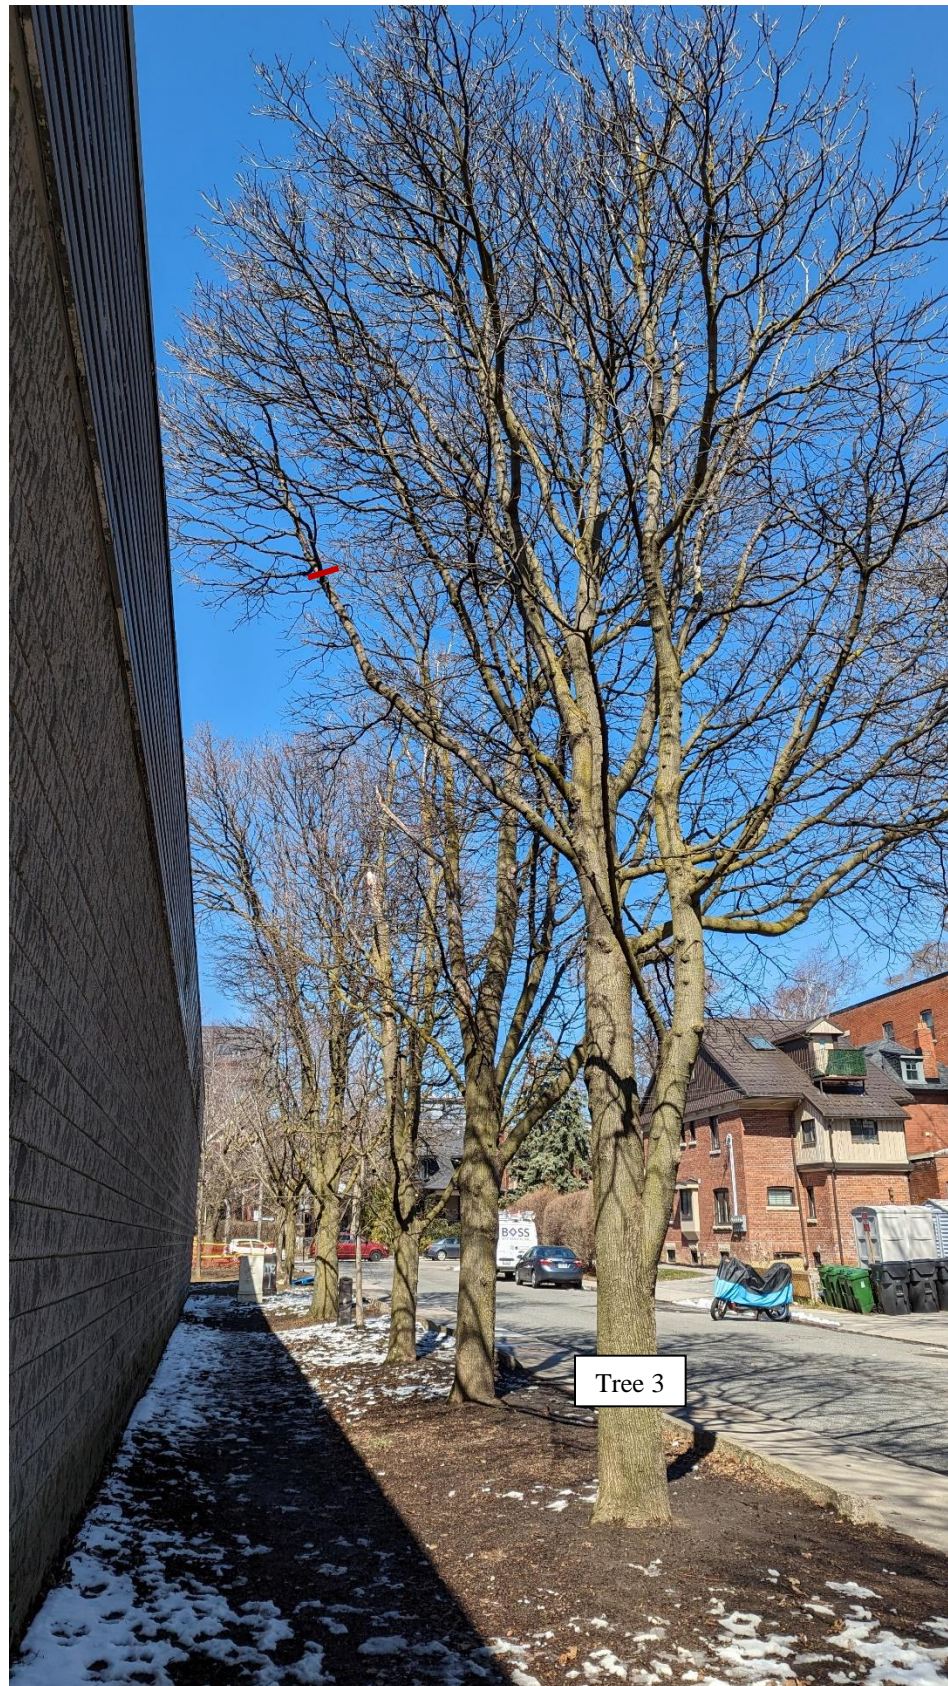
**Figure 6.** Red lines indicate which branches should be pruned back from the building (facing north).

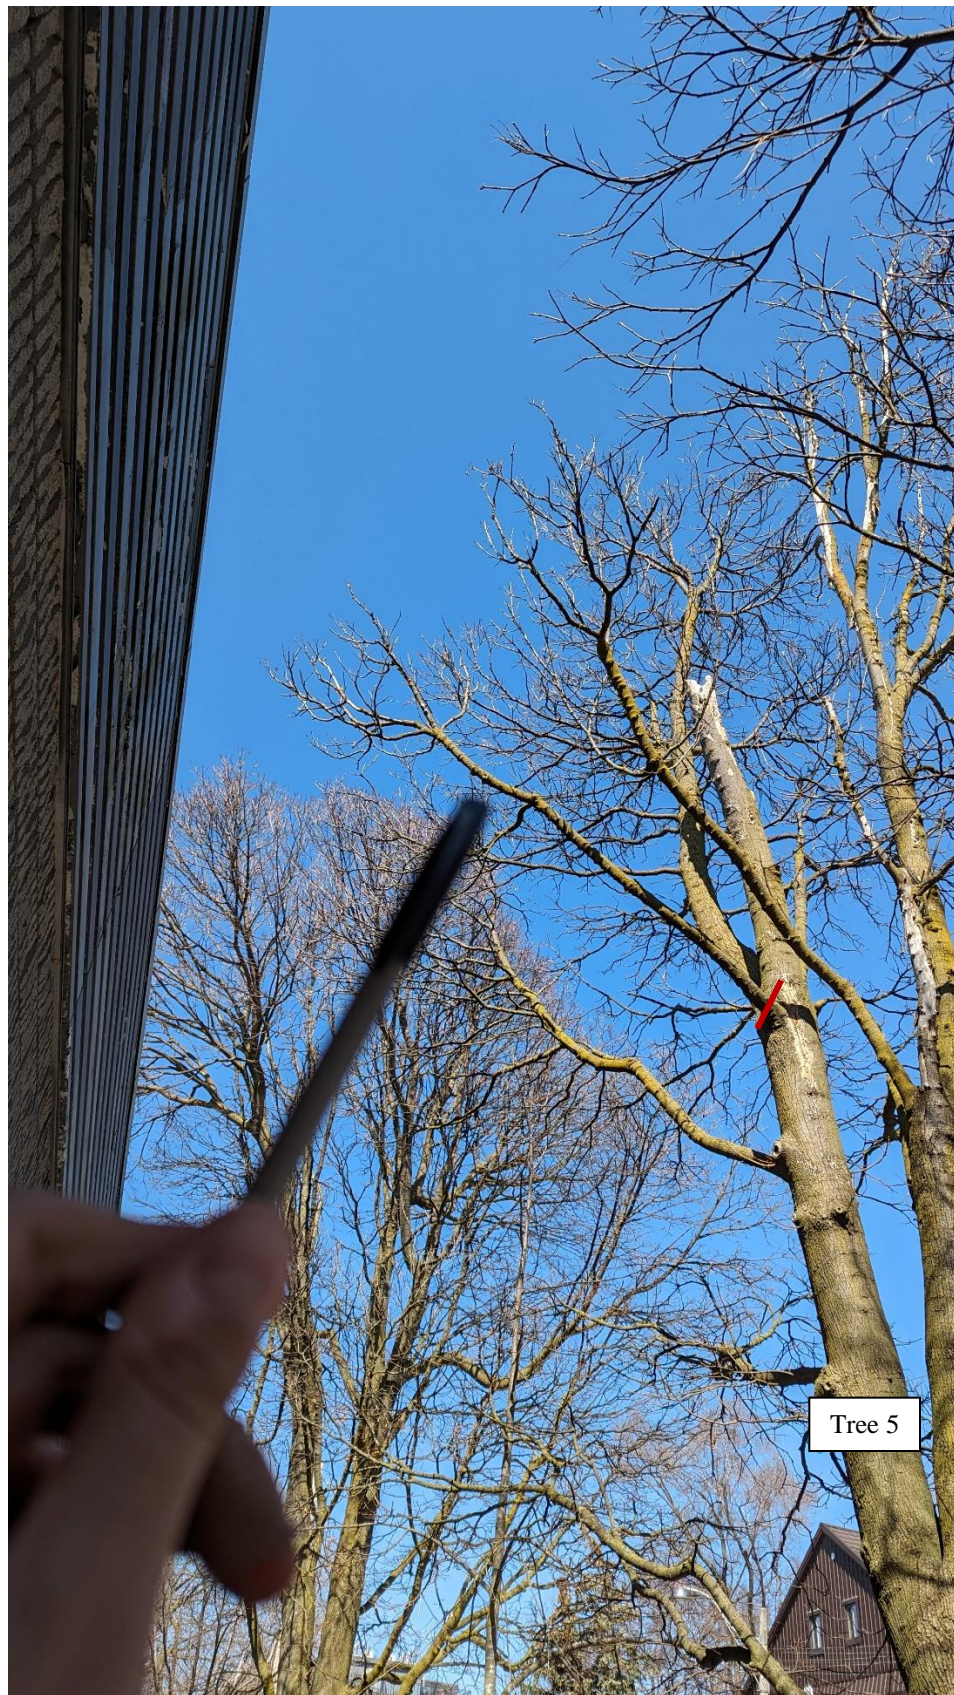
**Figure 9.** Red lines indicate which branches should be pruned back from the building (facing north).

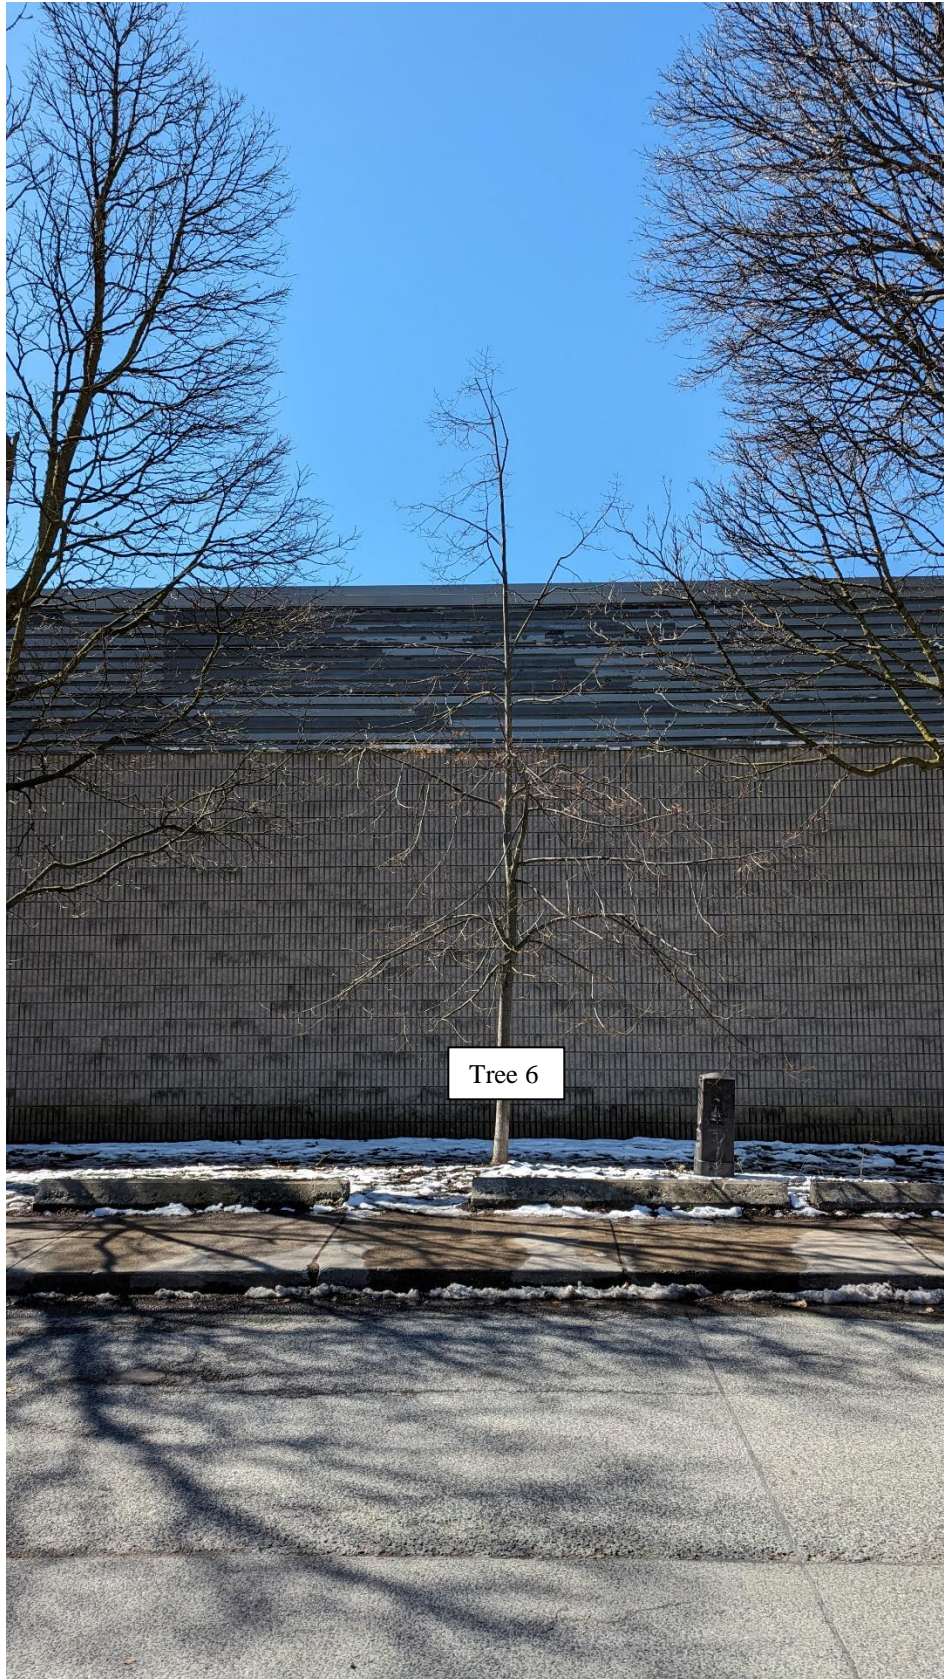
**Figure 10.** Tree 6 (facing west).

*6	Littleleaf linden	<i>Tilia cordata</i>	11	1.8	Good	Good	Epicormic growth. Was cutback from sidewalk. Torn branch in canopy.	Requires pruning	5

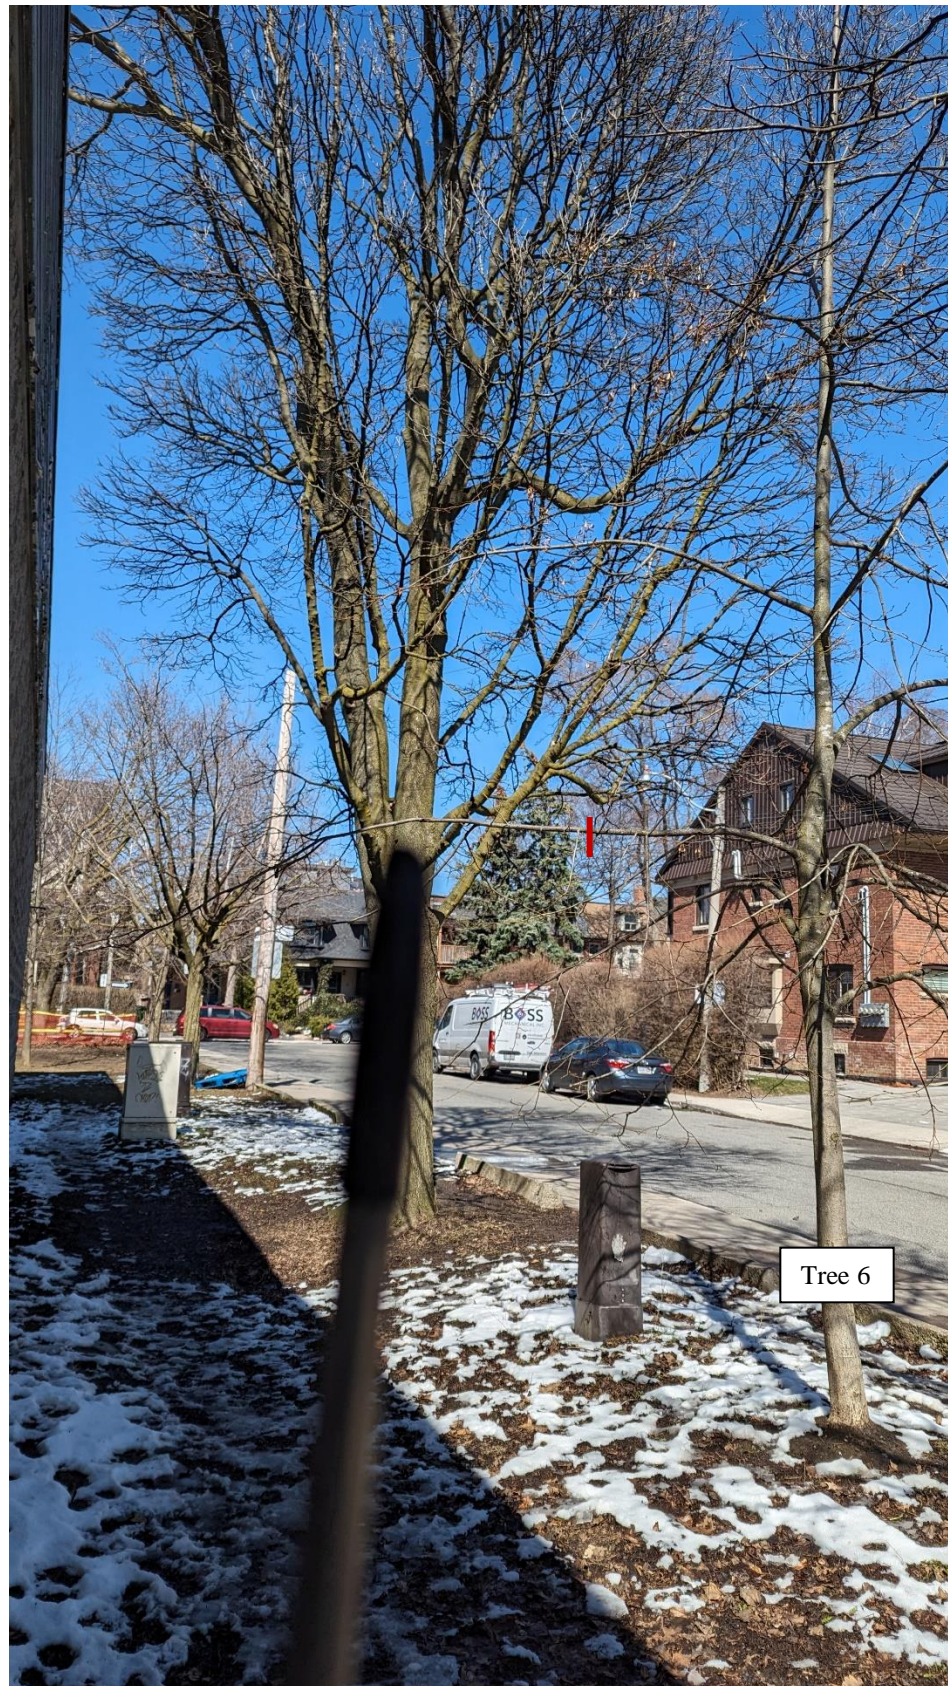
**Figure 11.** Red lines indicate which branches should be pruned back from the building (facing north).

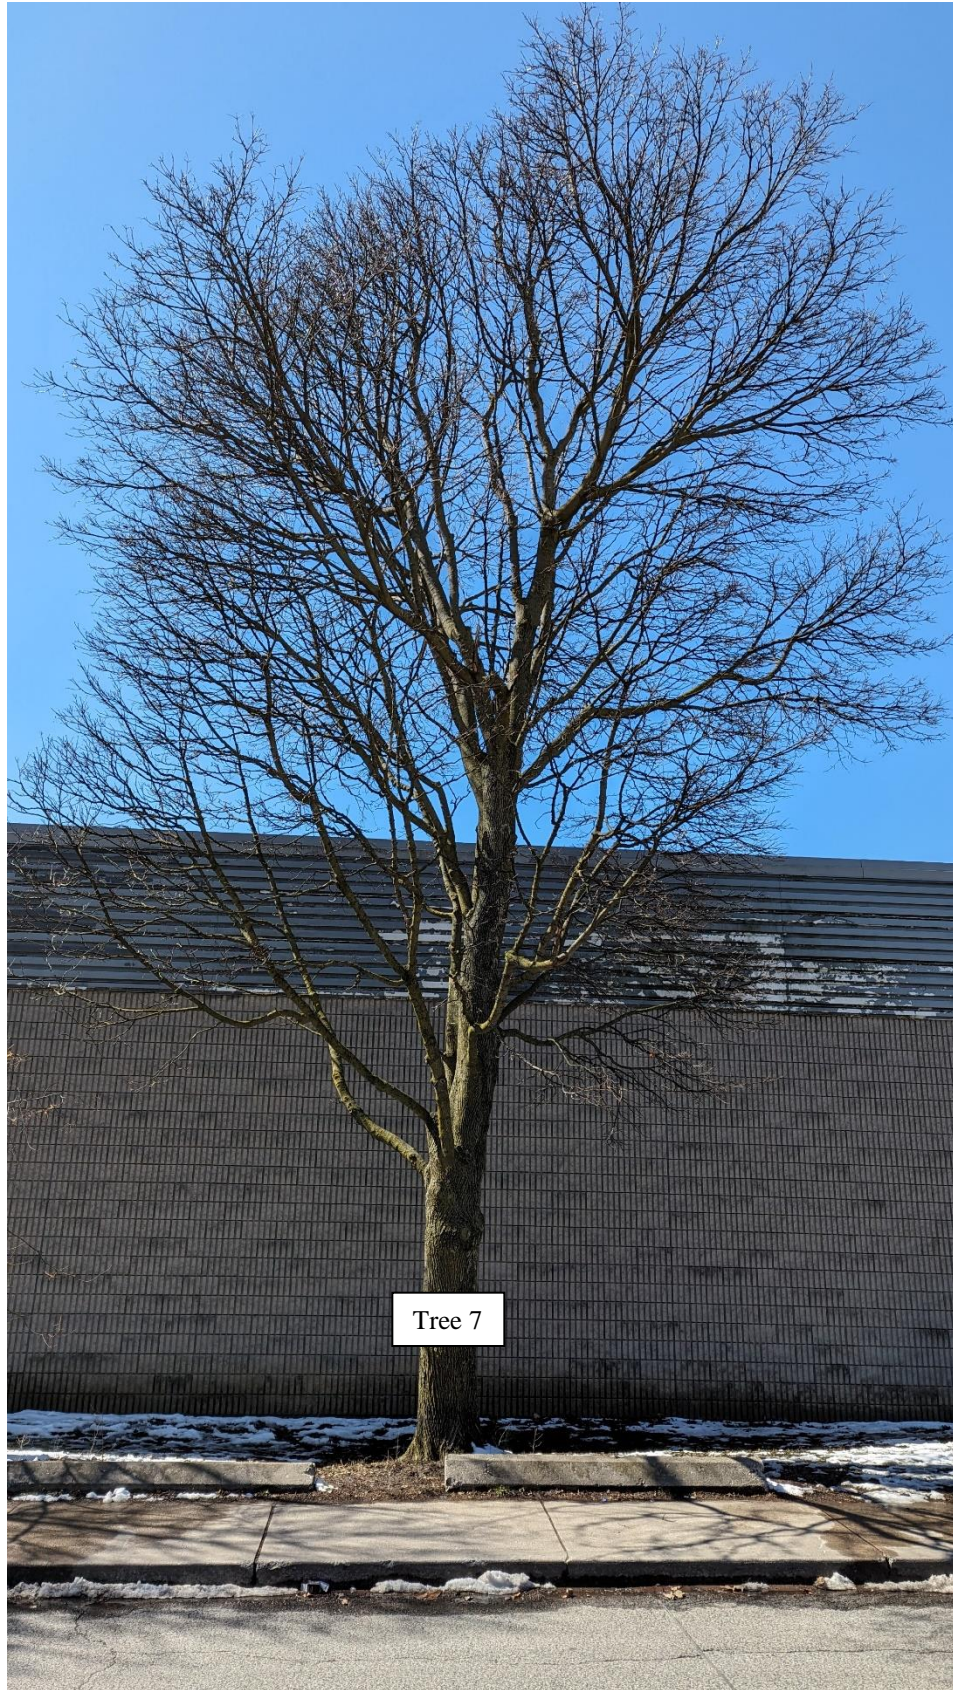
**Figure 12.** Tree 7 (facing west).

*7	Sugar maple	<i>Acer saccharum</i>	51.5	3.6	Good fair	Fair	Co-dominant stem, included bark in main union. Good reaction wood growing around wounds on stem of tree. 2 decay shadows on one of the stems. Small deadwood in canopy of tree.	Requires pruning	5
*8	Sugar maple	<i>Acer saccharum</i>	34	2.4	Poor	Poor	Flat root flare. Bassal decay. Canopy is 50% deadwood. Central leader is dead. Fruiting bodies on a dead lateral limb. Small 5cm diameter on main stem of tree.	Requires pruning	5
*9	Red oak	<i>Quercus rubra</i>	16.5	1.8	Good	Good	Small deadwood in canopy of tree.	No pruning required	5
*10	Red oak	<i>Quercus rubra</i>	16	1.8	Good	Good	Small deadwood in canopy of tree.	No pruning required	3
*11	Norway maple	<i>Acer platanoides</i>	49.5	3	Fair	Fair	Girdling roots at base of tree. Mechanical damage on surface roots. Large internal deadwood. Torsion growth on the main stem. Canopy is growing onto building; branches appear to be chaffing on roof edge.	Requires pruning	3

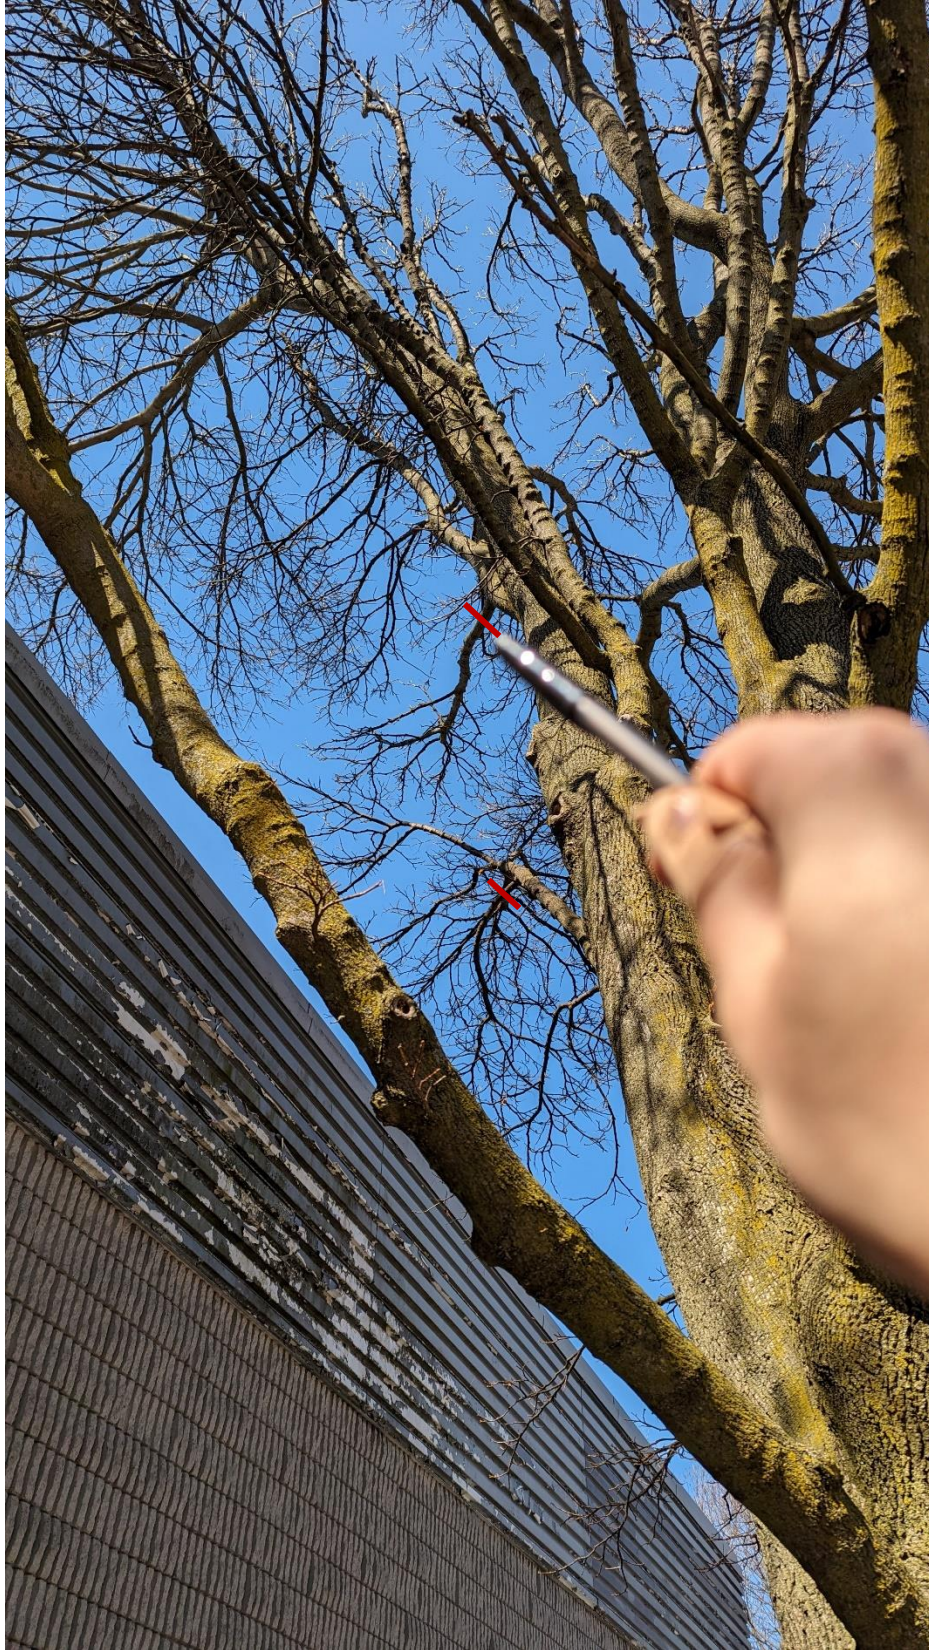
**Figure 13.** Red lines indicate which branches should be pruned back from the building (facing northwest).

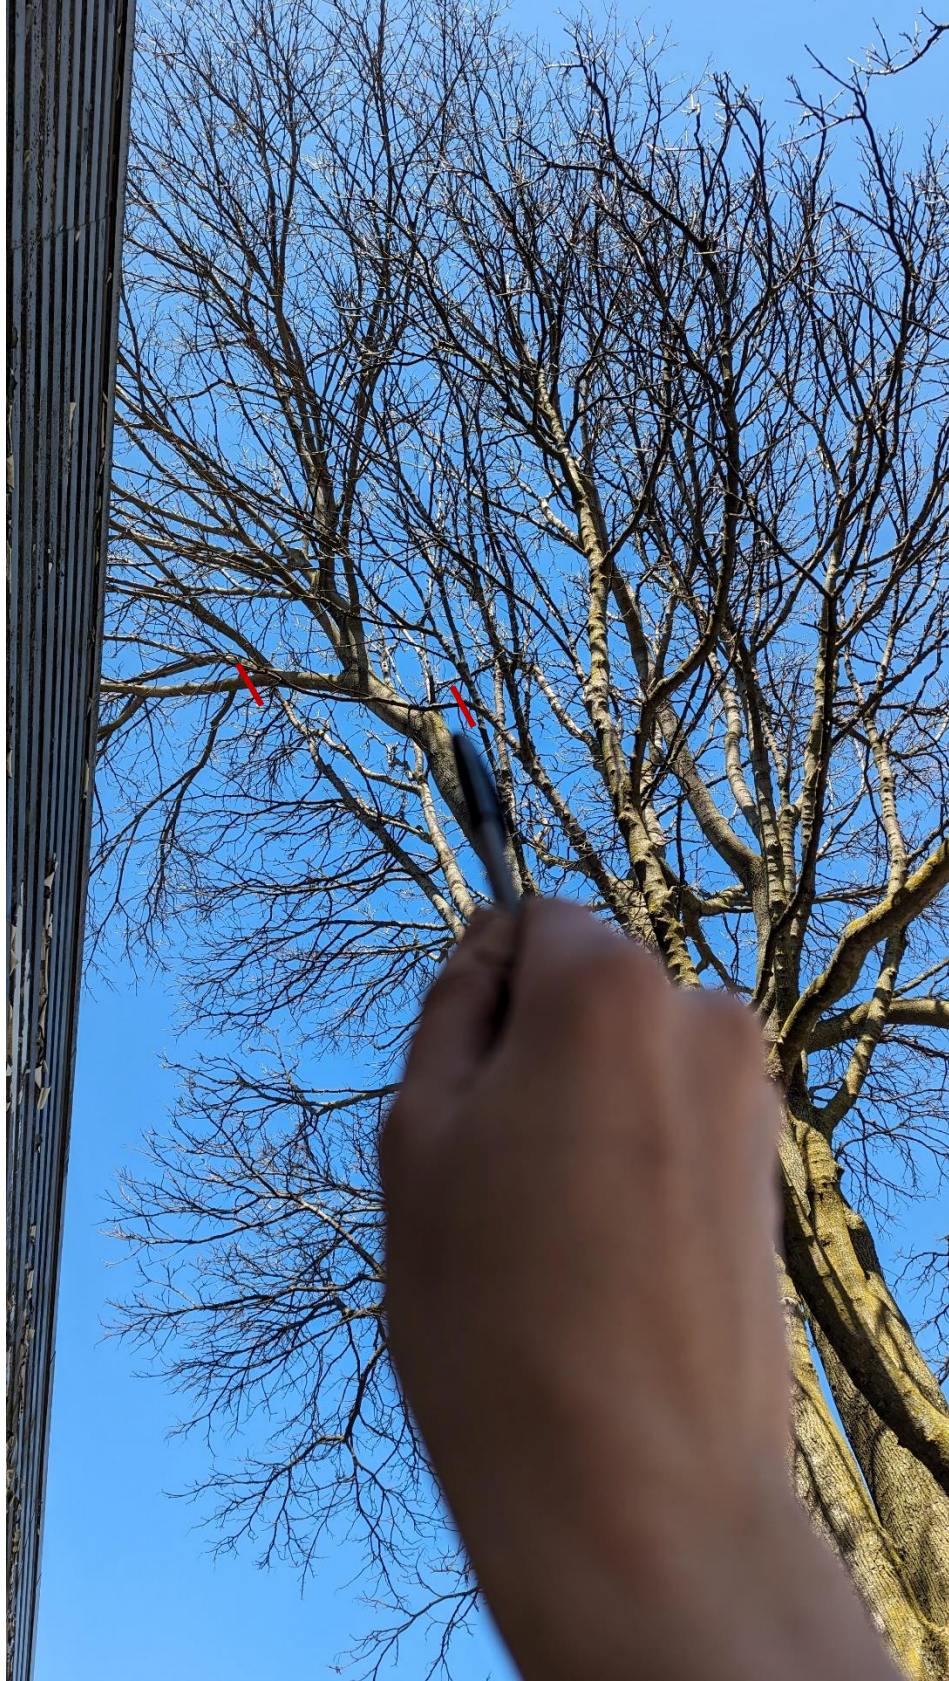
**Figure 14.** Red lines indicate which branches should be pruned back from the building (facing north).

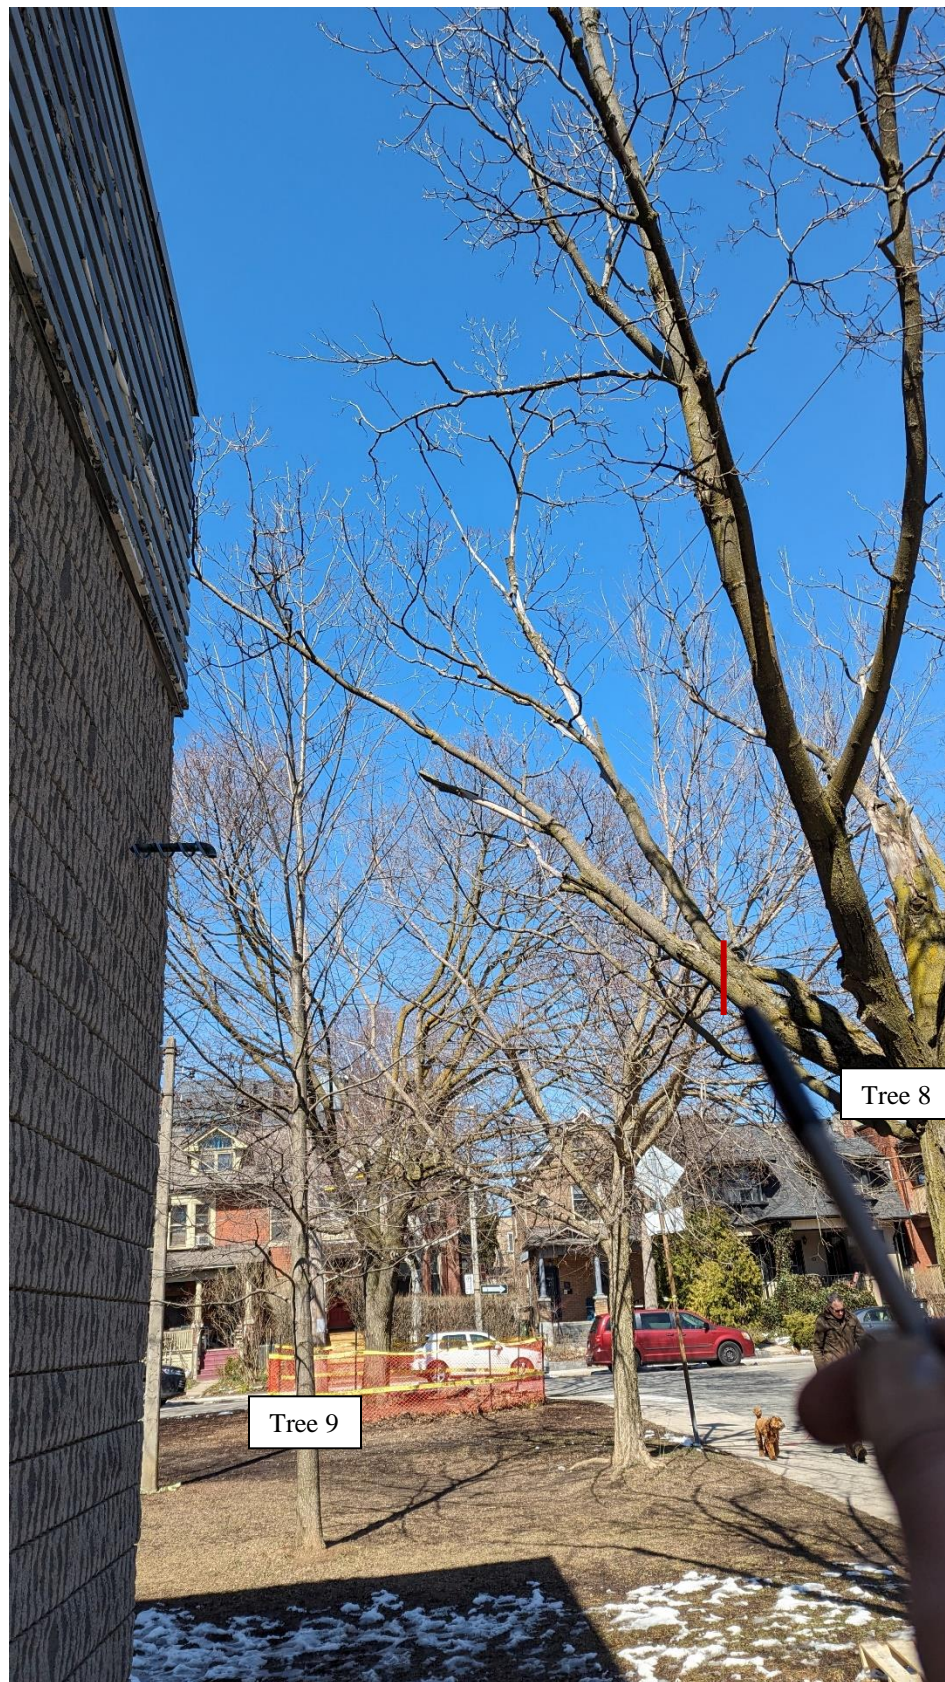
**Figure 16.** Red lines indicate which branches should be pruned back from the building (facing north).

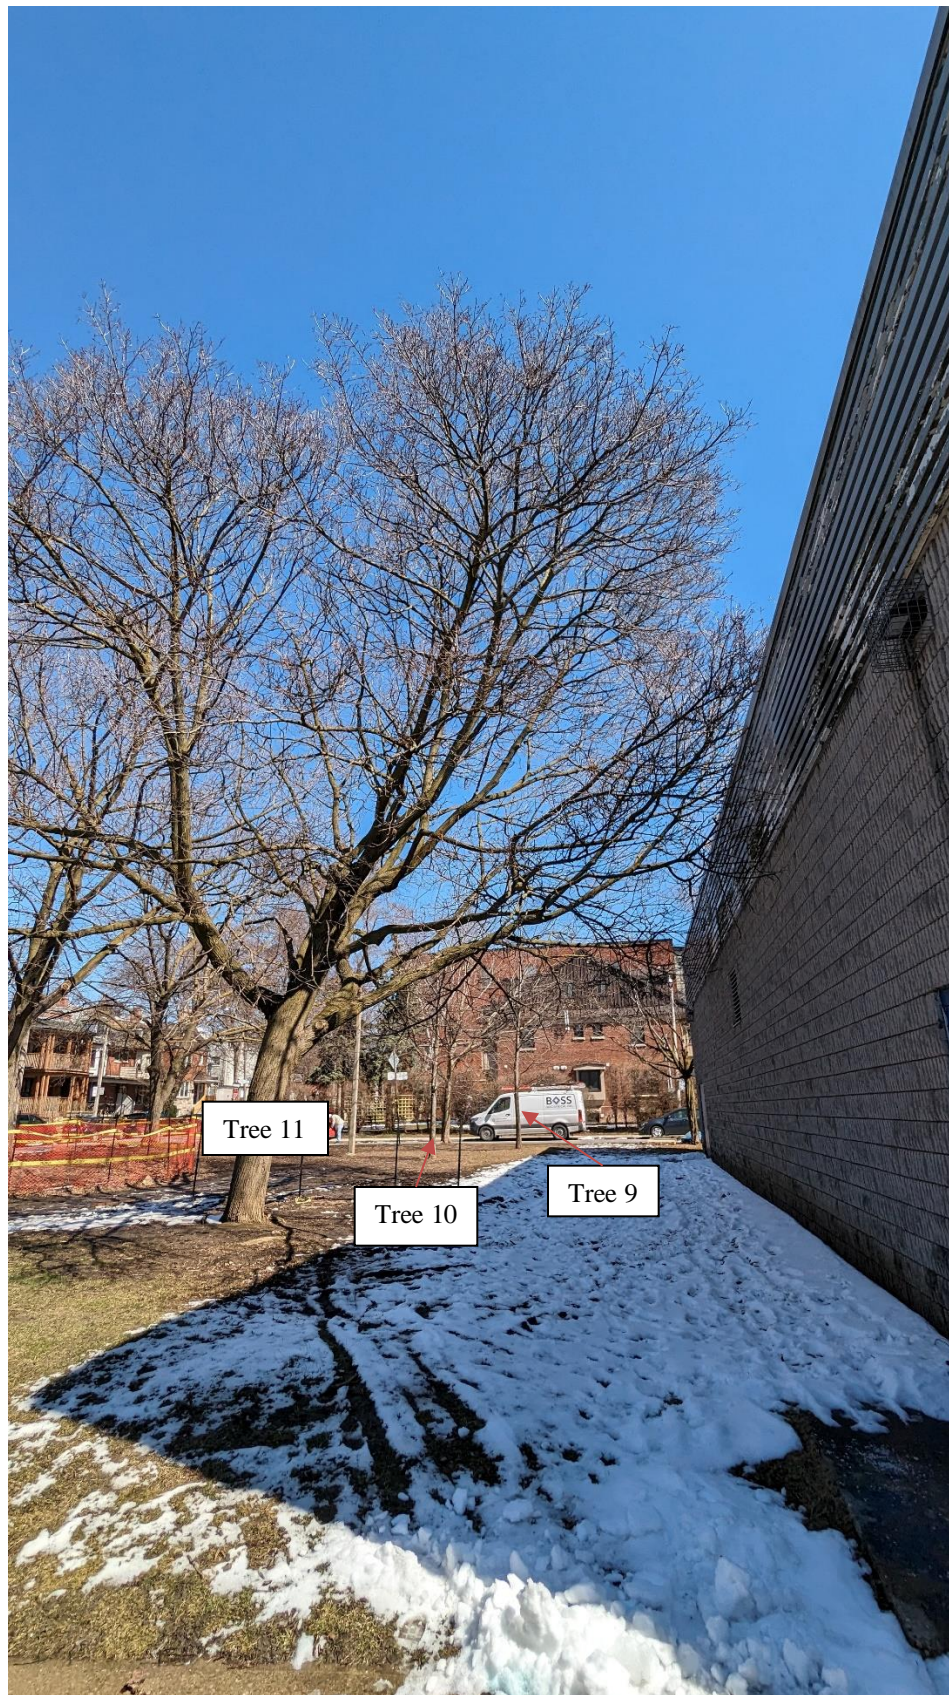
**Figure 17.** Northside of the building with Tree 11's canopy touching the building (facing east).

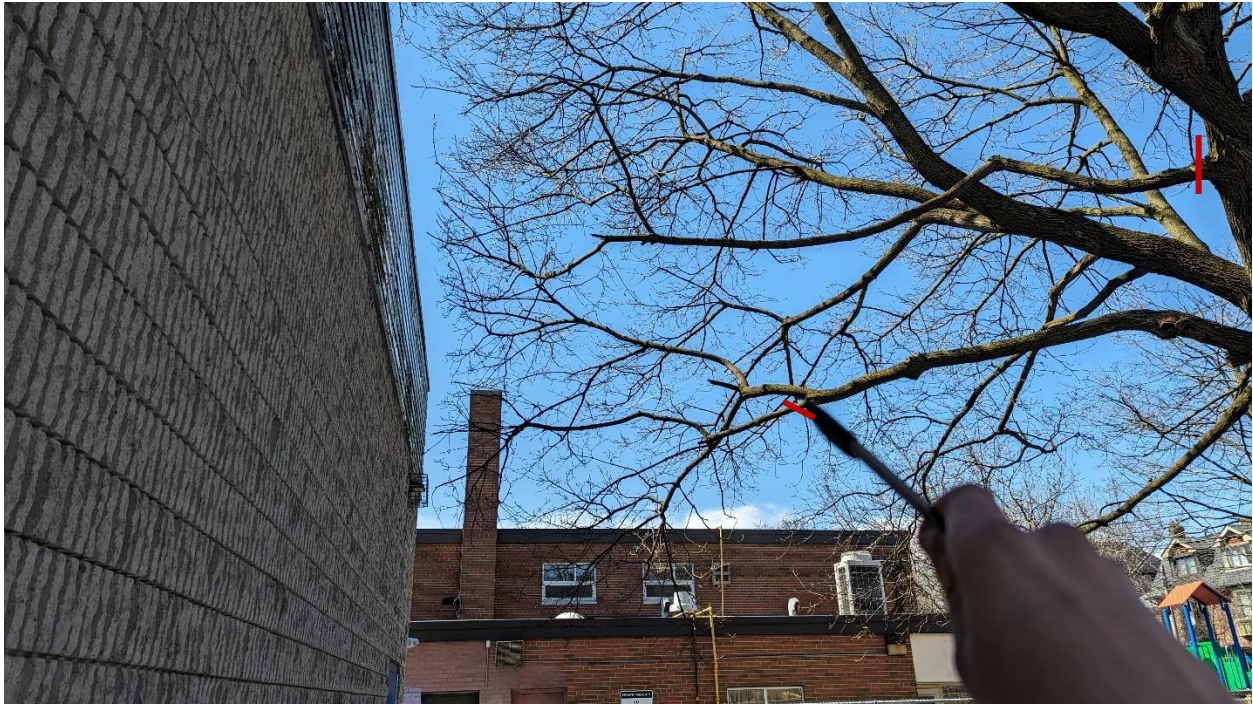
**Figure 18.** Red lines indicate which branches should be pruned back from the building (facing west).

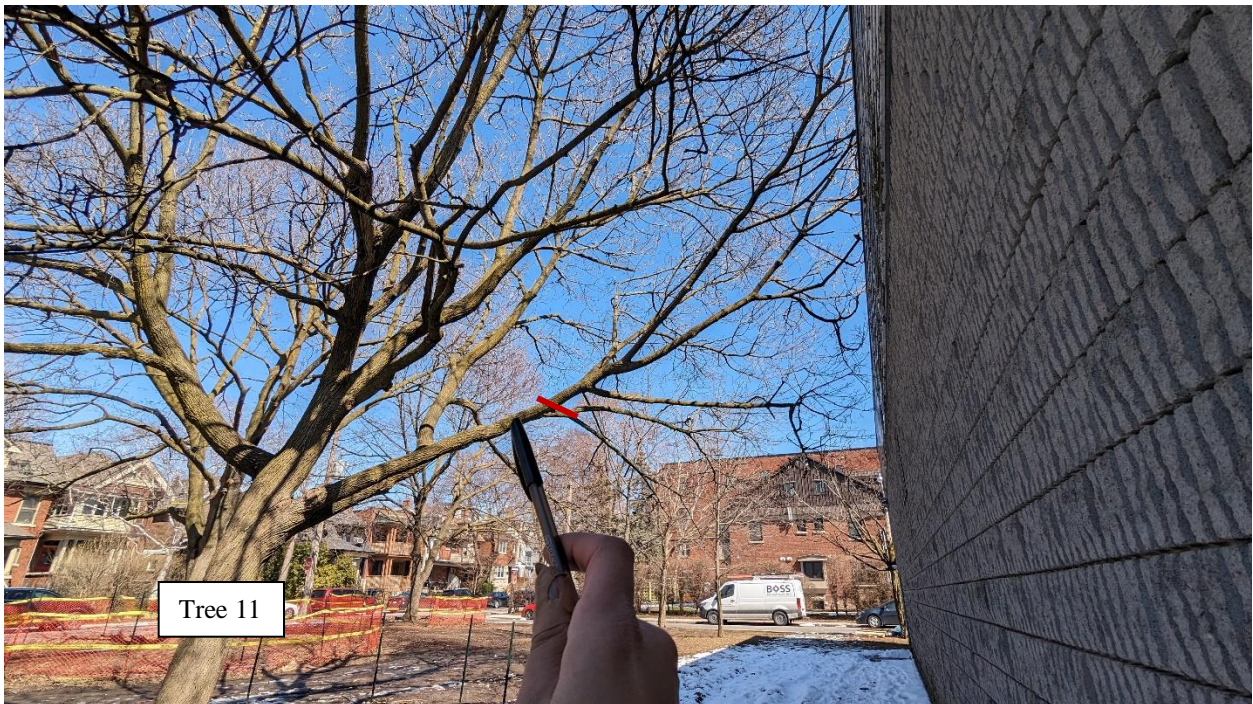
**Figure 19.** Red lines indicate which branches should be pruned back from the building (facing east).
