**Re: 40 Rossmore Road – William Bolton Arena (Ward 11)**

## Arborist Report

Central Tree Care Ltd. has been retained by the City of Toronto. to provide a professional arborist report for the proposed work at 40 Rossmore Road at the William Bolton Arena.

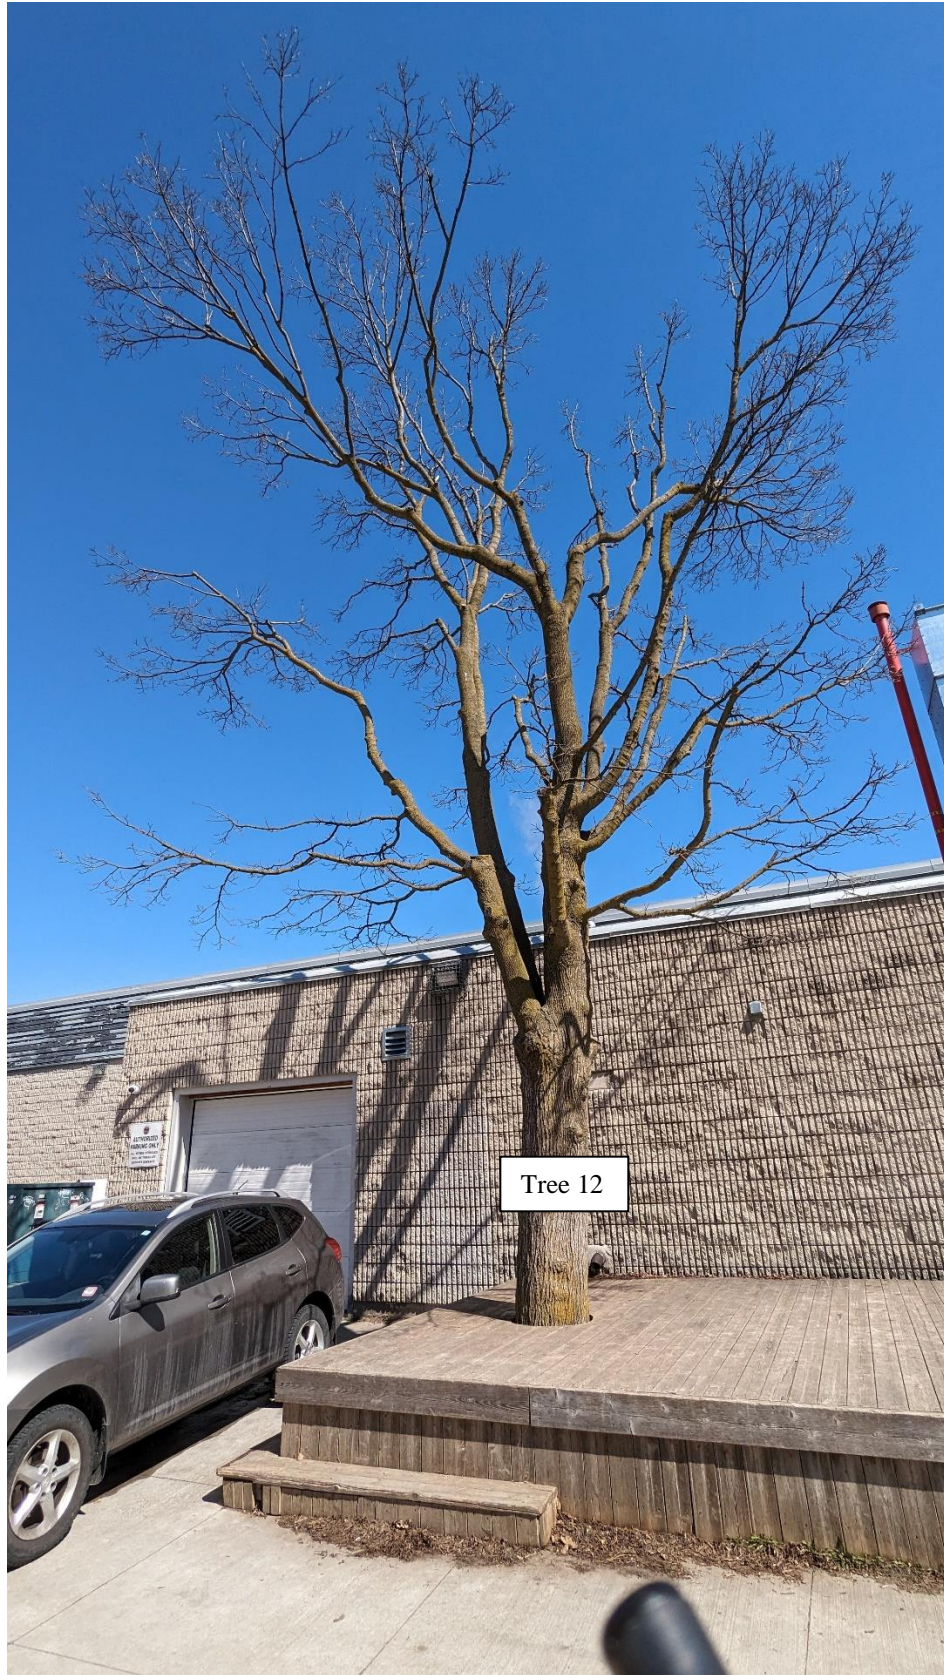
**Figure 20.** Tree 12 (facing east).

*12	Norway maple	<i>Acer platanoides</i>	59.5	3.6	Fair	Fair	Co-dominant stem. Wooden elevated deck built around the tree. Epicormic growth. Stem and limb reduction cuts on the tree.	Requires pruning	3
*13	English oak	<i>Quercus robur</i>	23	1.8	Good	Good fair	Small deadwood in canopy of tree.	Requires pruning	3
*14	Norway maple	<i>Acer platanoides</i>	50	3	Fair	Fair	Girdling roots around the base of the tree. Large deadwood. Deadwood in upper canopy of the tree. Co-dominant stem at ~3m. Epicormic growth. Decay shadow on one of the stems. Machine damage on surface roots.	Requires pruning	3
*15	Norway maple	<i>Acer platanoides</i>	42	3	Good fair	Fair	Flat root flare. Co-dominant stem at ~4m. Tree has been lifted ~4-5m. Large deadwood in canopy of tree.	Requires pruning	3

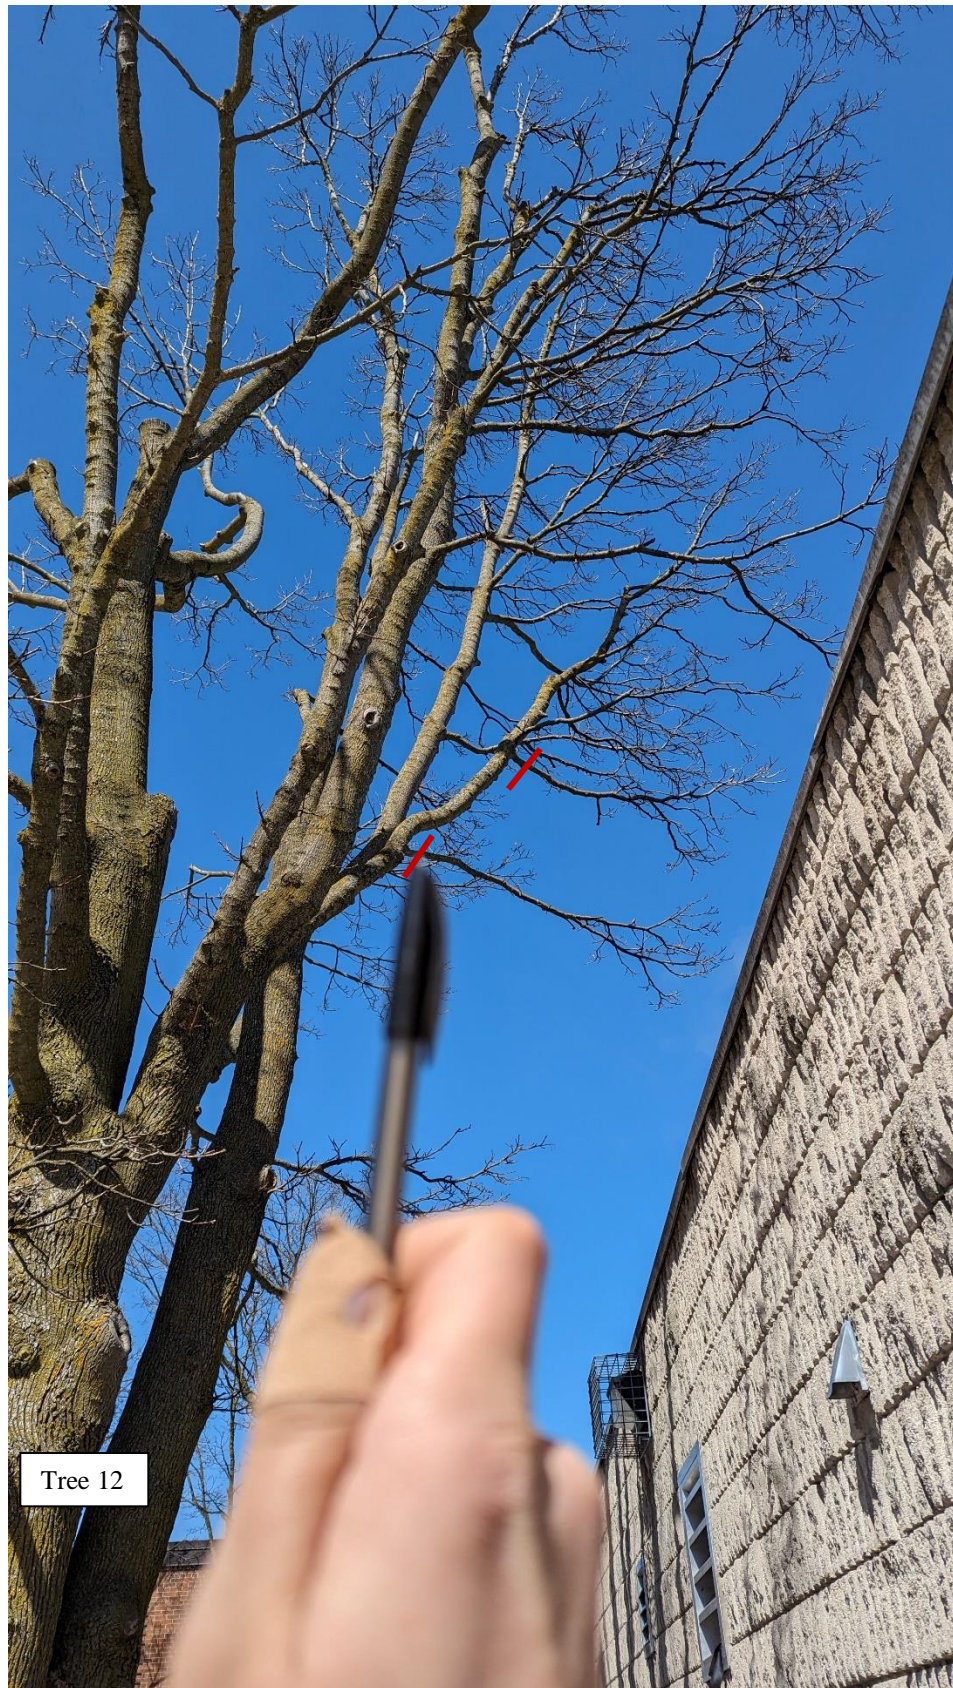
**Figure 21.** Red lines indicate which branches should be pruned back from the building (facing north).

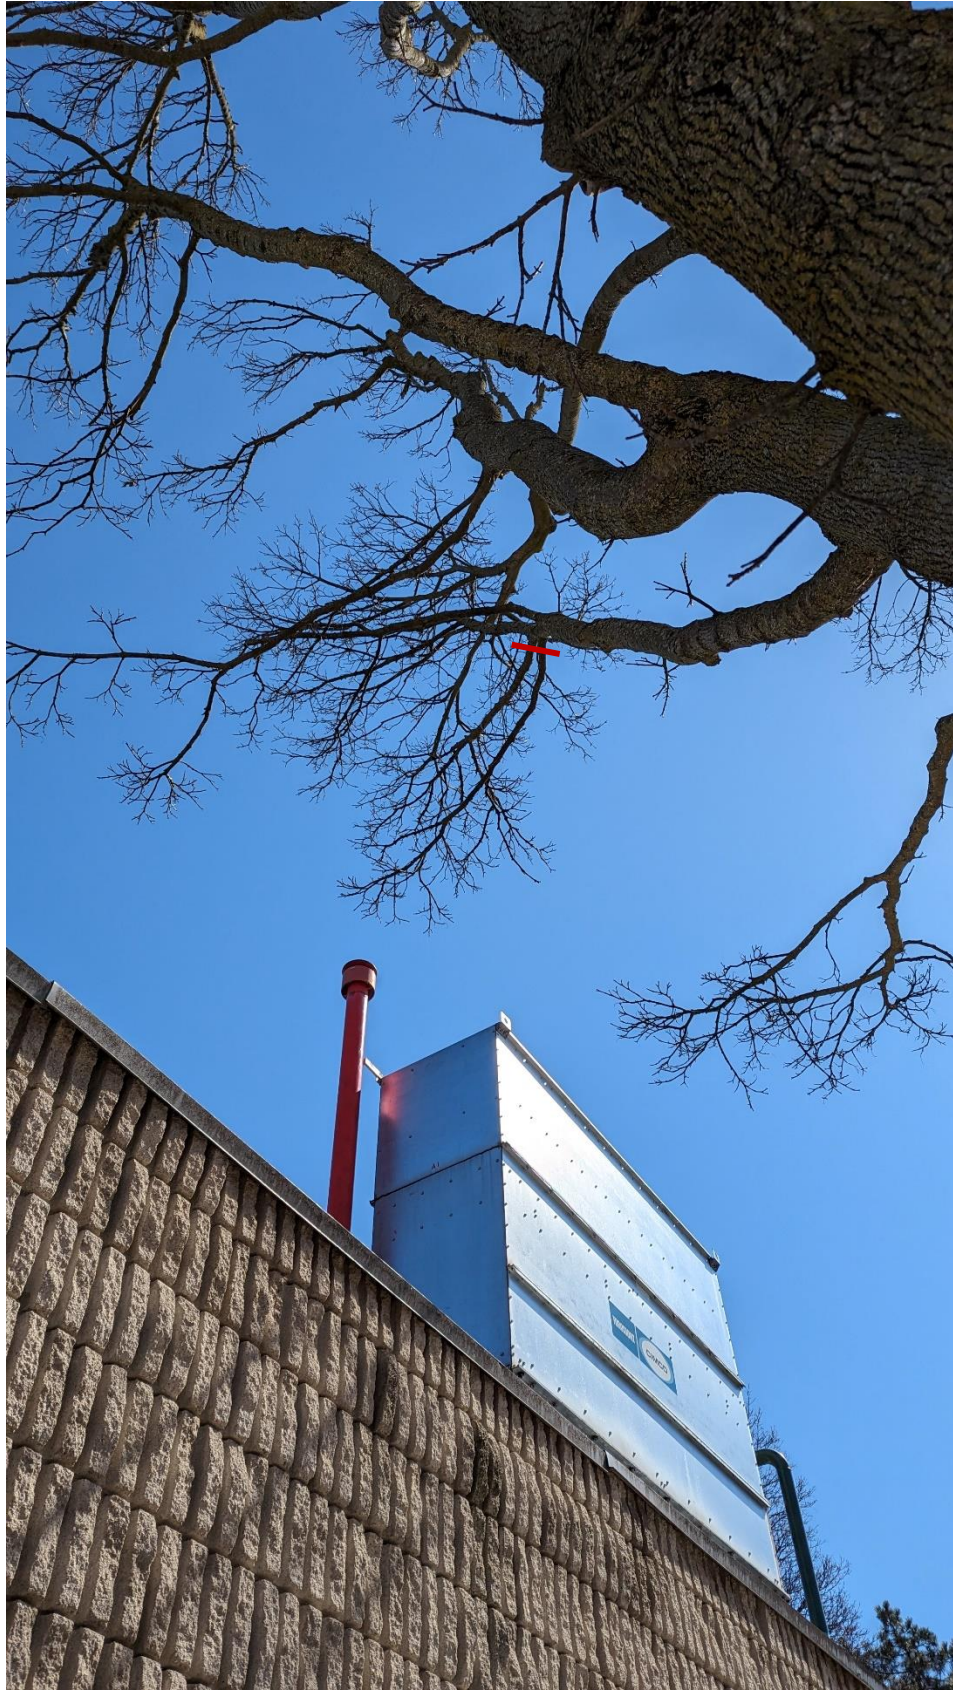
**Figure 22.** Red lines indicate which branches should be pruned back from the building (facing southeast).

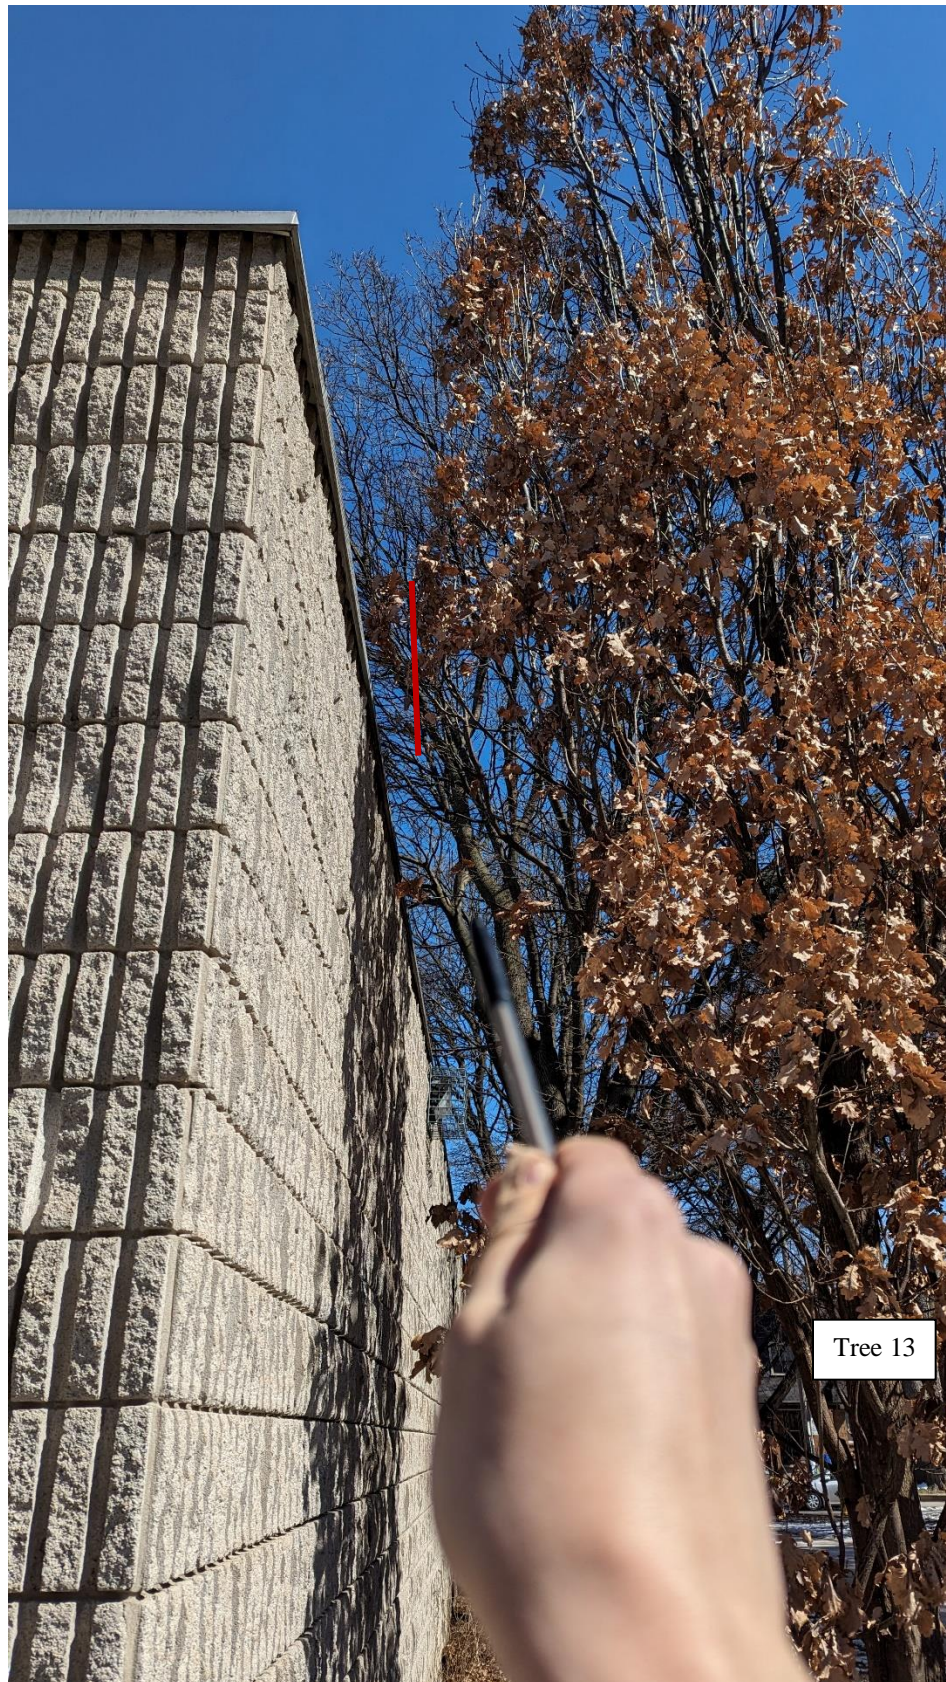
Tree 13

**Figure 24.** Red lines indicate which branches should be pruned back from the building (facing east).

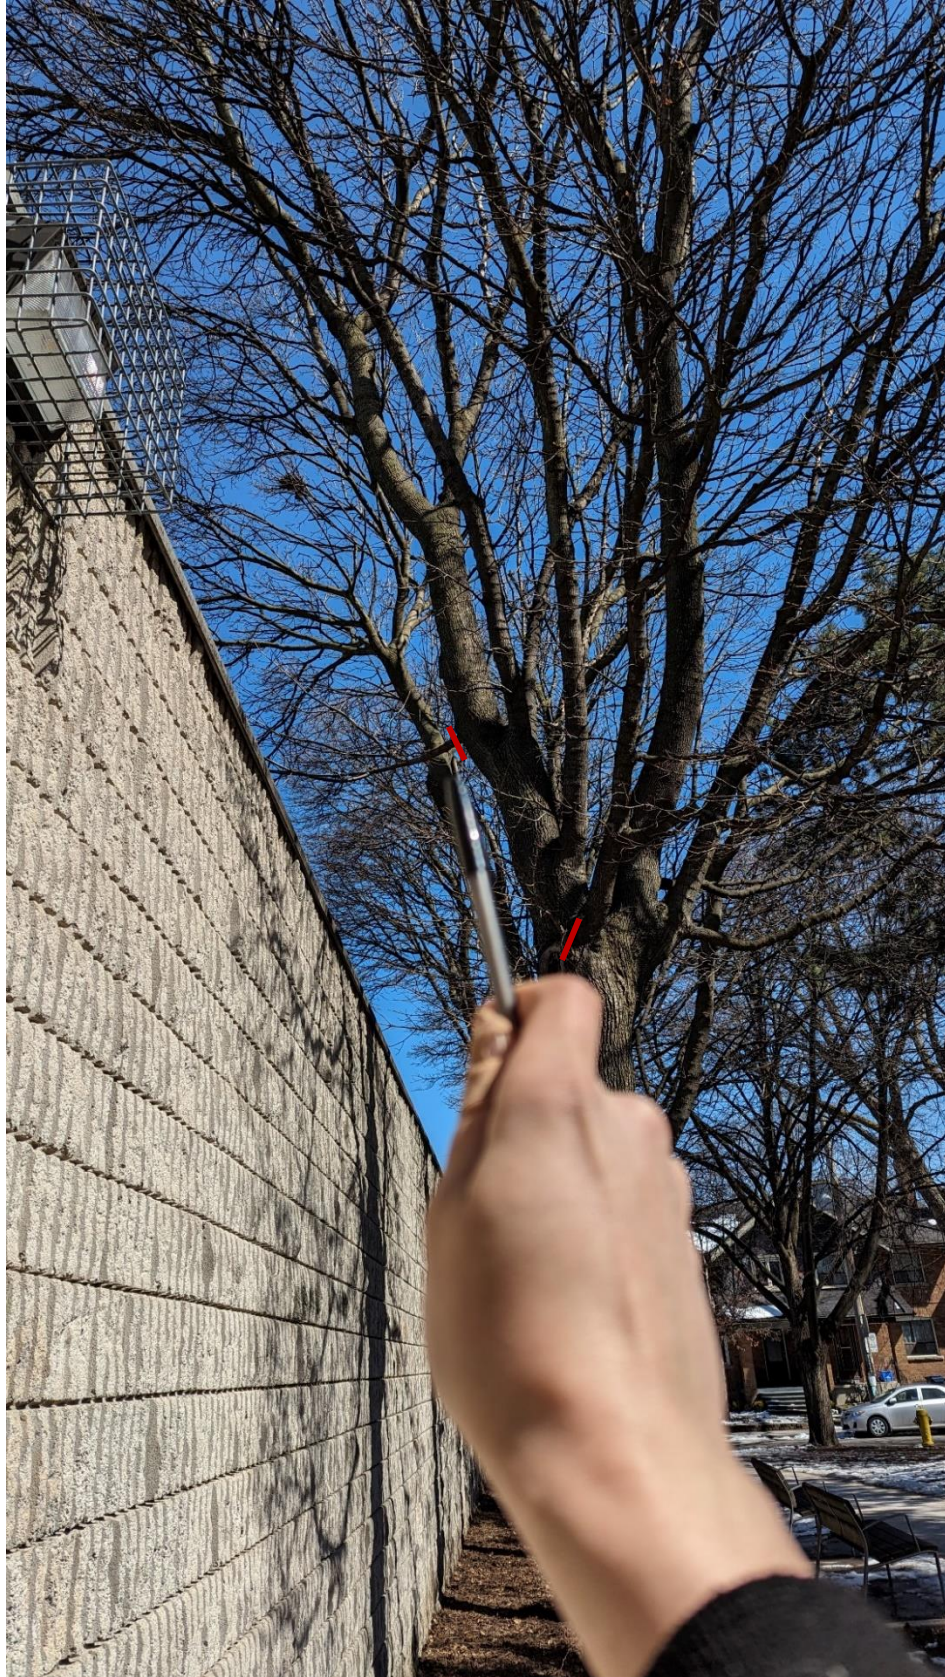
**Figure 26.** Red lines indicate which branches should be pruned back from the building (facing east).

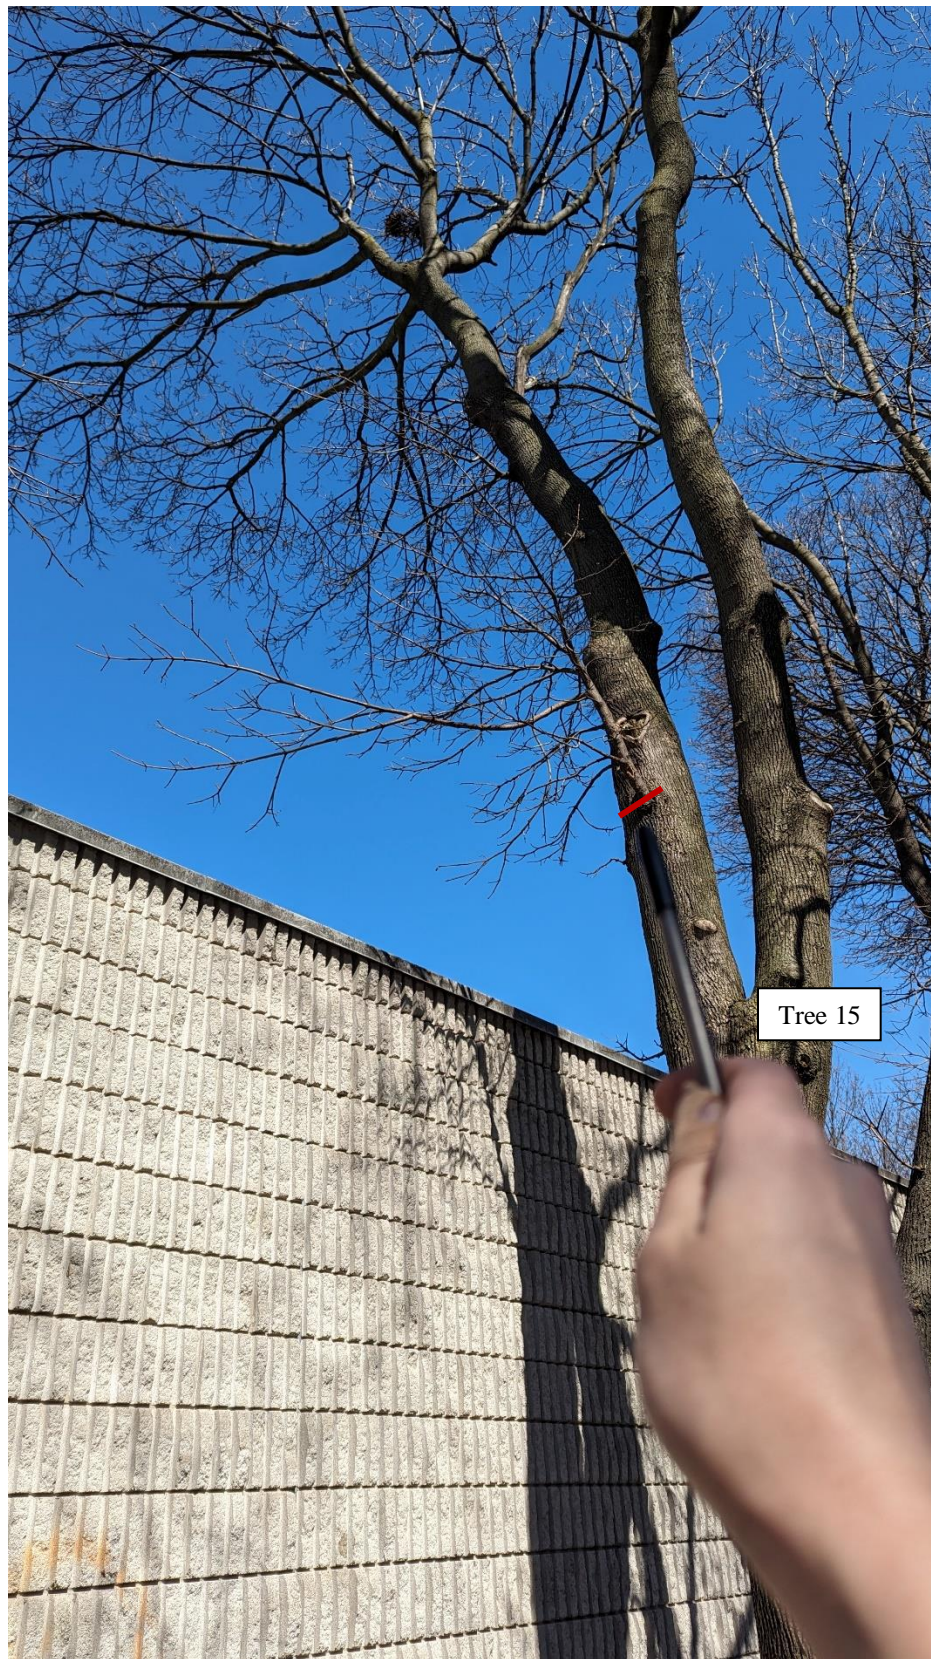
**Figure 27.** Red lines indicate which branches should be pruned back from the building (facing northeast).

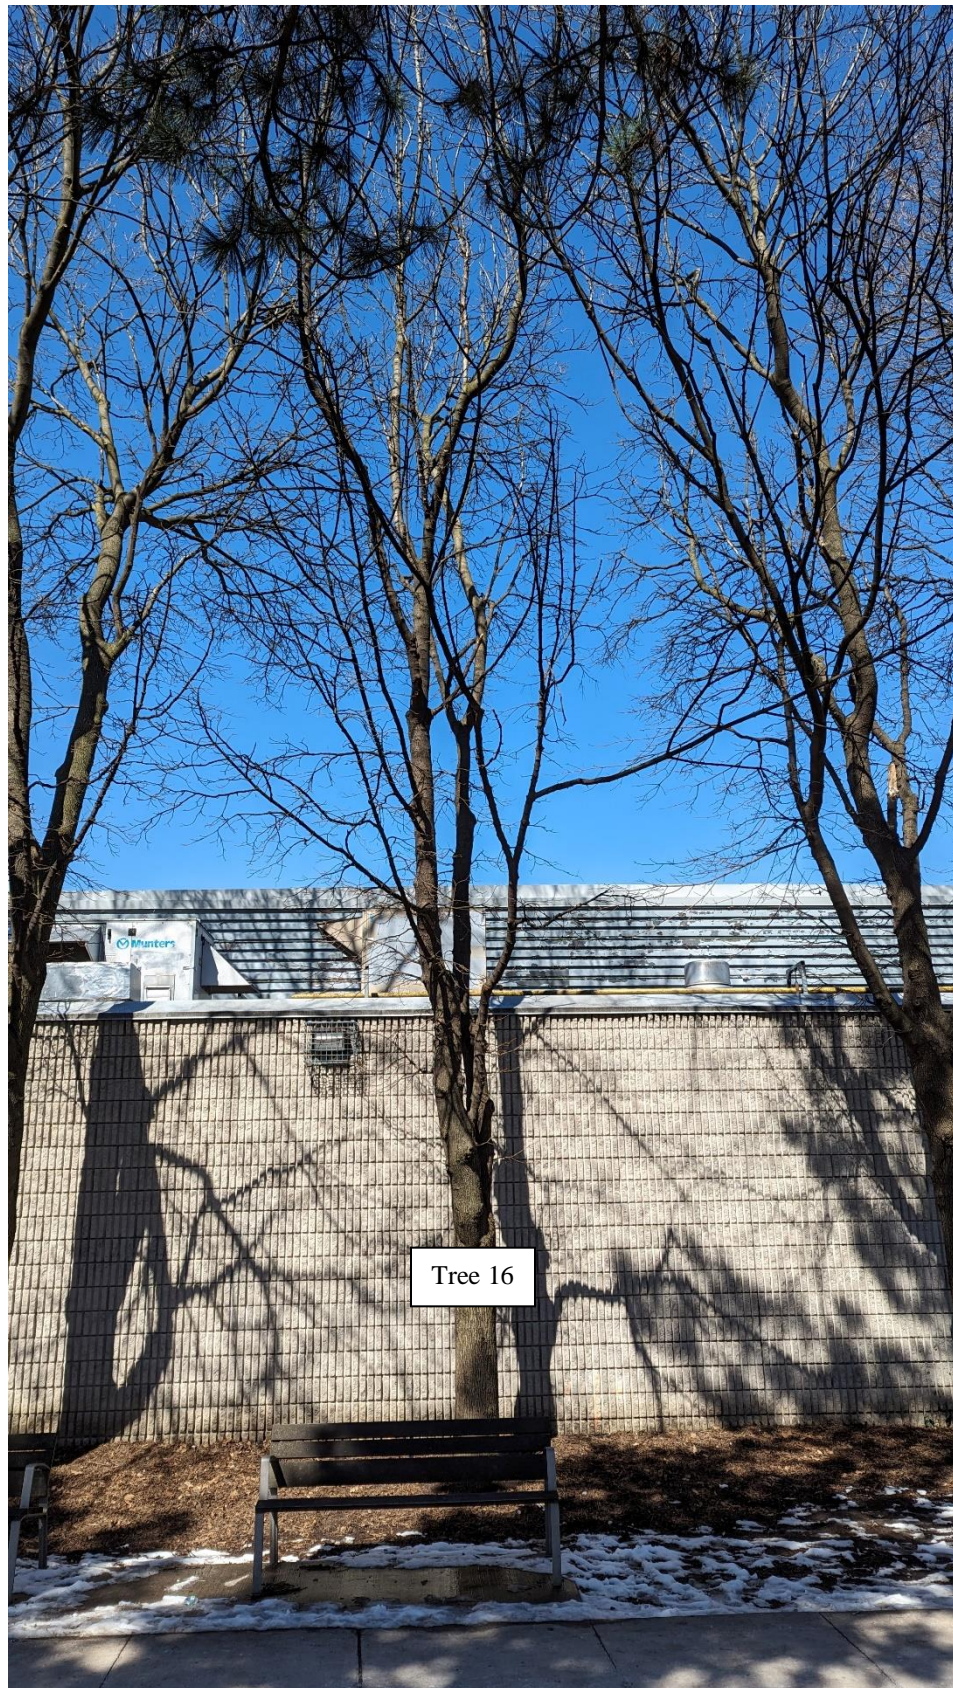
**Figure 28.** Tree 16 (facing north).

*16	Norway maple	<i>Acer platanoides</i>	34.5	2.4	Fair poor	Fair	Co-dominant stem. Decay shadow on both stems. Epicormic growth. Deadwood in canopy of tree. Flat root flare. Tree appears to be suppressed on its east and west side.	Requires pruning	3
*17	Norway maple	<i>Acer platanoides</i>	35	2.4	Fair	Good fair	Deadwood, some lateral branches are dead. Flat root flare. Epicormic growth.	Requires pruning	3
*18	Norway maple	<i>Acer platanoides</i>	46	3	Good fair	Fair	Co-dominant stem on ~3m. Suspected soil cavity in main union. Frost crack on main stem, running vertically up the stem to the main union, crack has reaction wood on it. Epicormic growth. Small deadwood in canopy of tree.	No pruning required	3

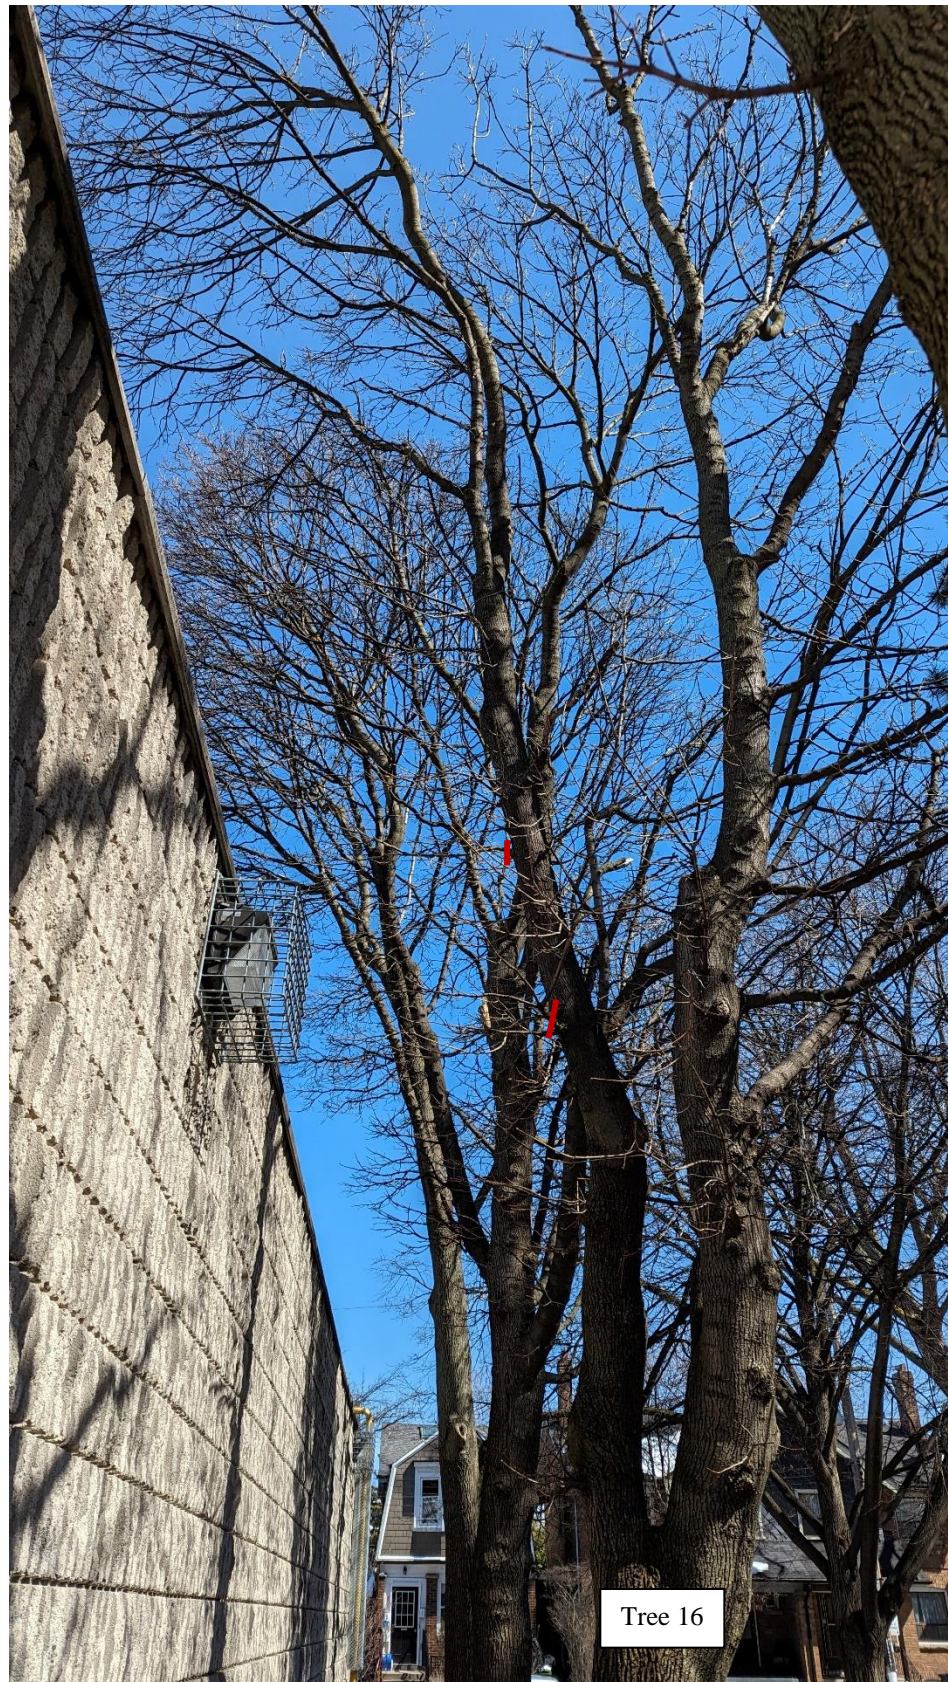
**Figure 29.** Red lines indicate which branches should be pruned back from the building (facing east).

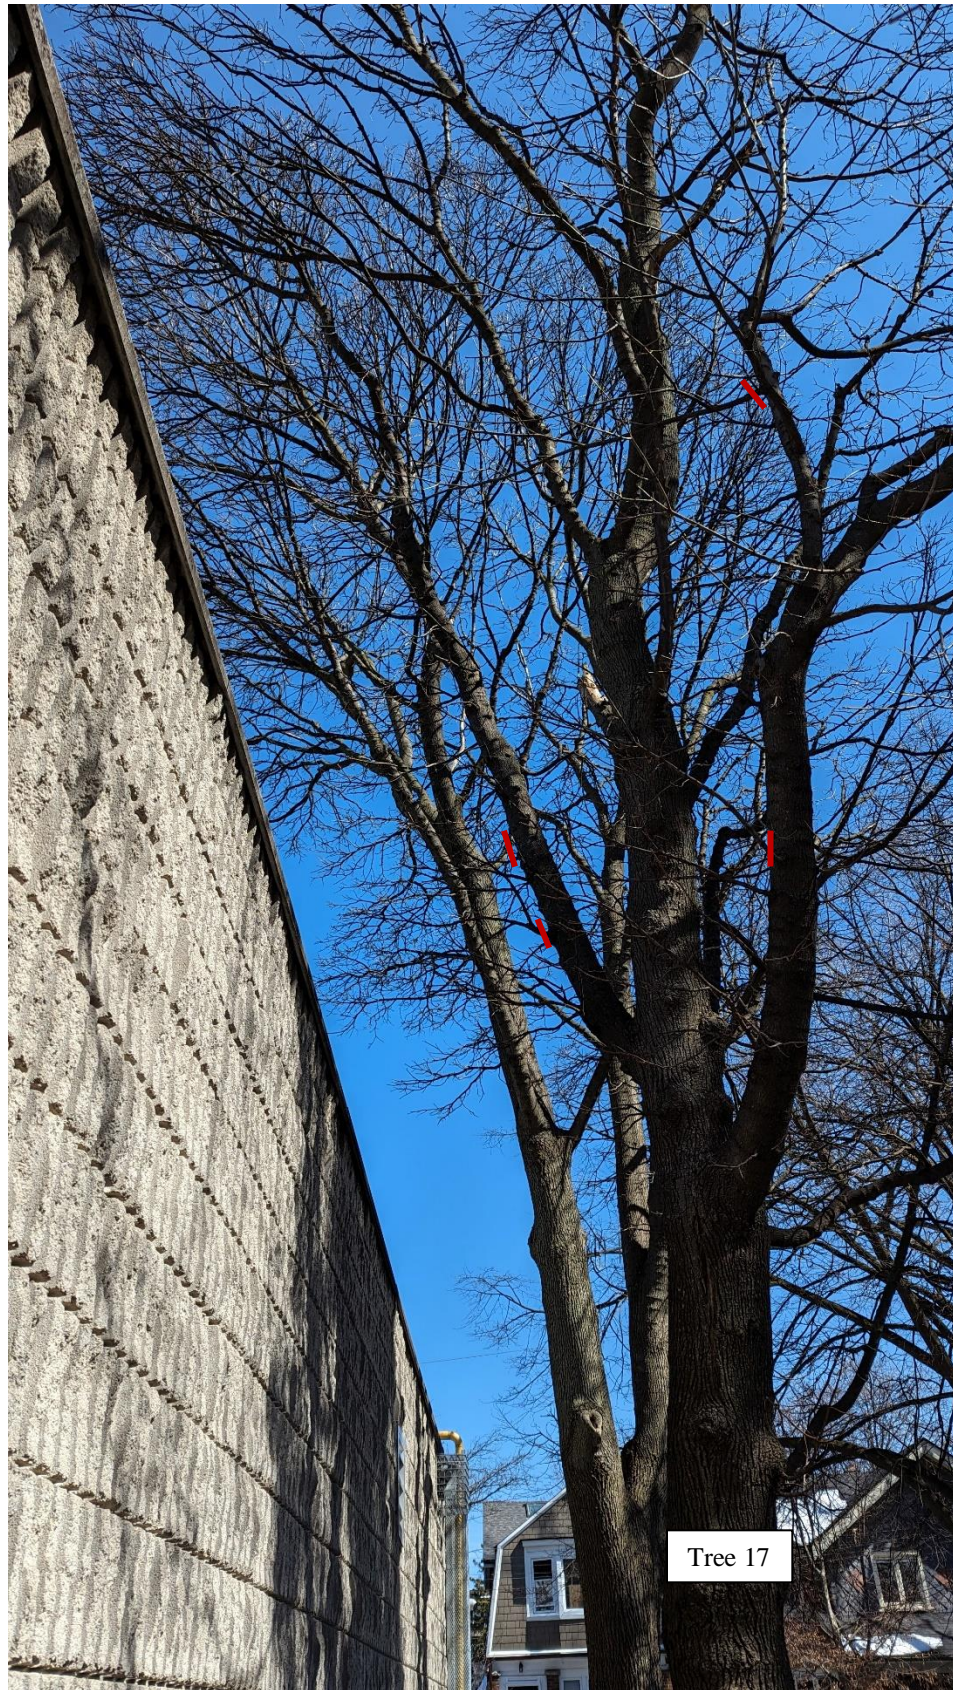
**Figure 31.** Red lines indicate which branches should be pruned back from the building (facing east).
