June 21, 2024

Premier Project Number: 624024.CE OILC / Colliers Project Number: 1105014-274159 Sent via e-mail: Assad.Kazeely@Colliersprojectleaders.com

RE: 1105014-274159 – DESIGNATED SUBSTANCE SURVEY CAYUGA DETECHMENT PARKING LOT PAVING 72 HIGHWAY 54, CAYUGA, ONTARIO

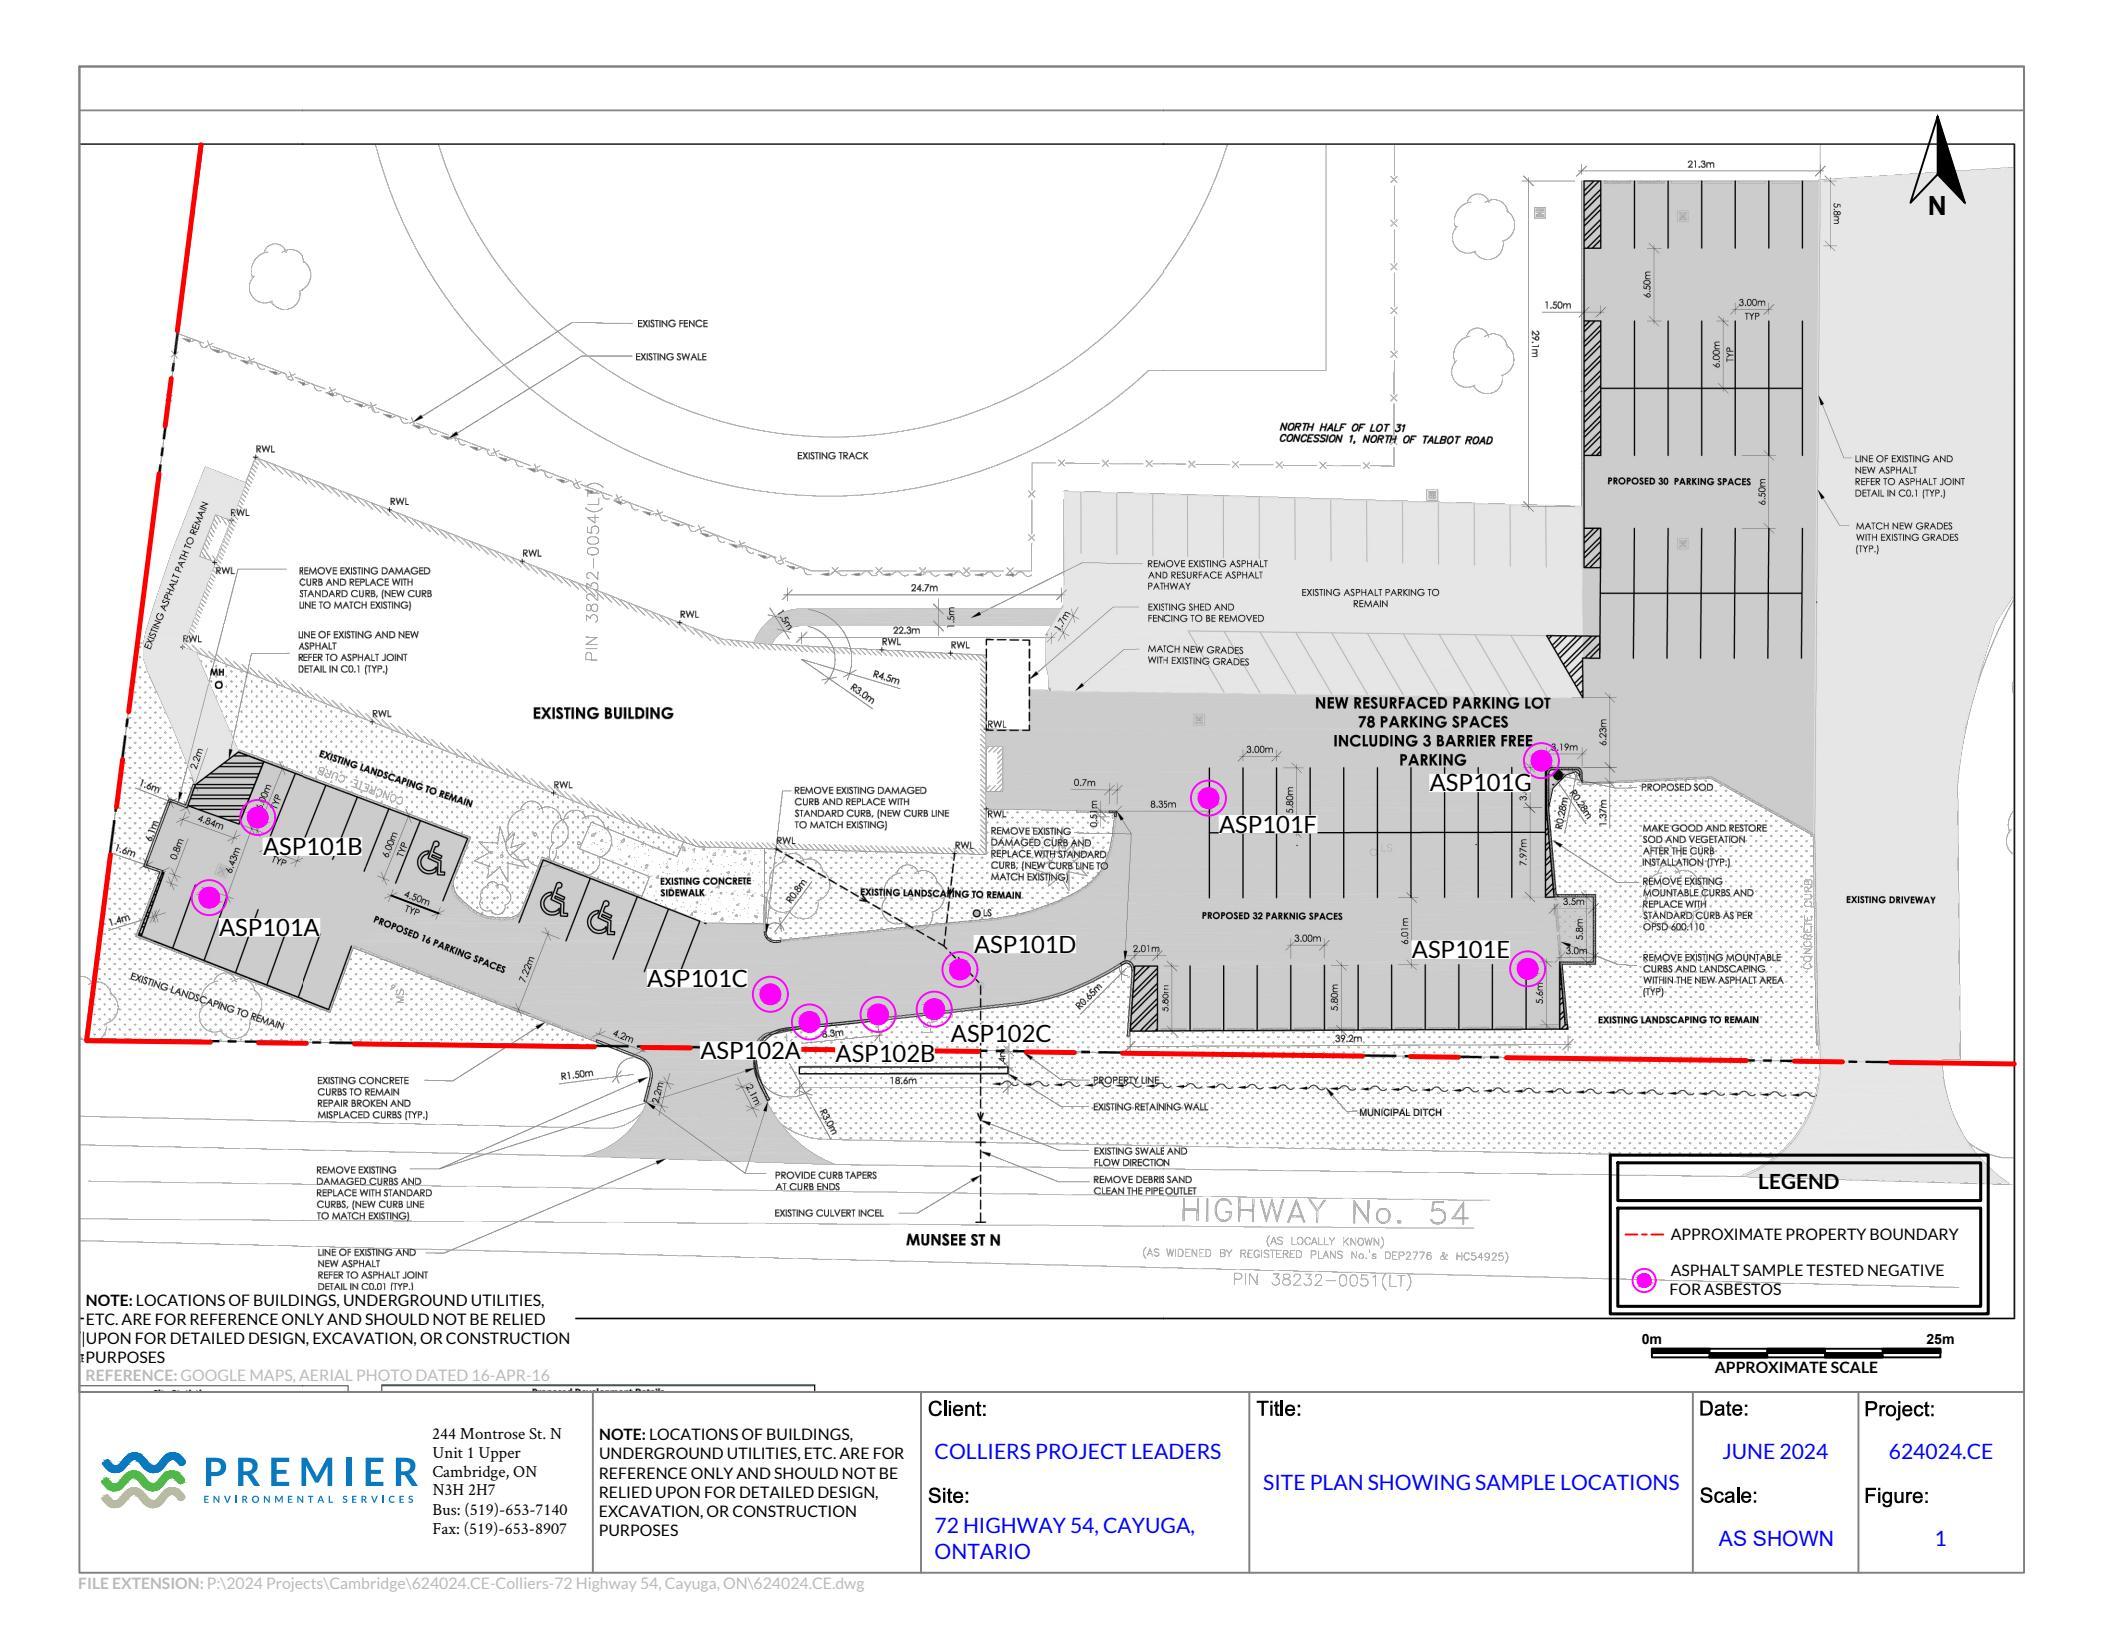
A Site plan showing the bulk sampling locations are presented as Figure 1 in Attachment A.

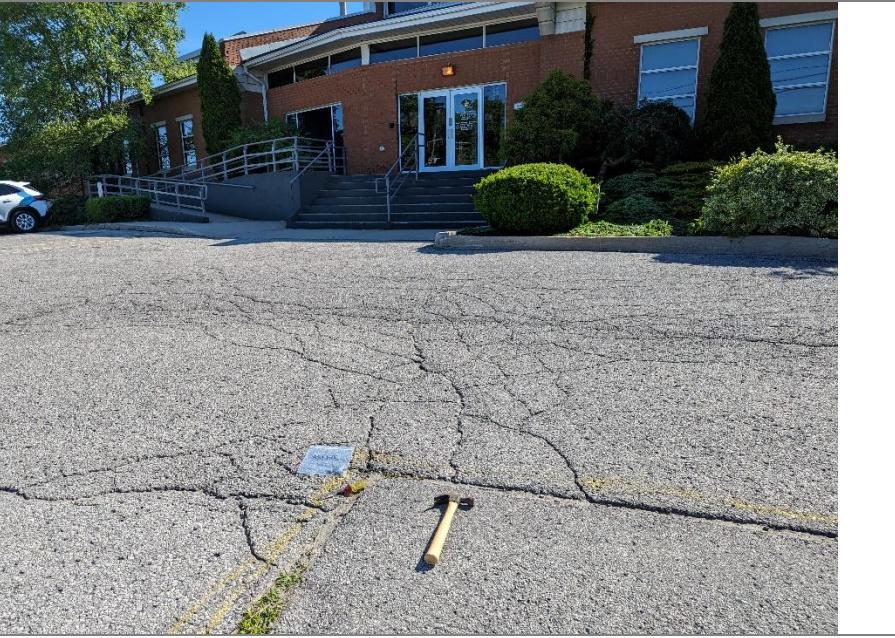
Photo No.	Date:	
1	31-June-24	-
Direction Ph		
Northeast	2	
Description:		
A view of the building, lane sample locati	1

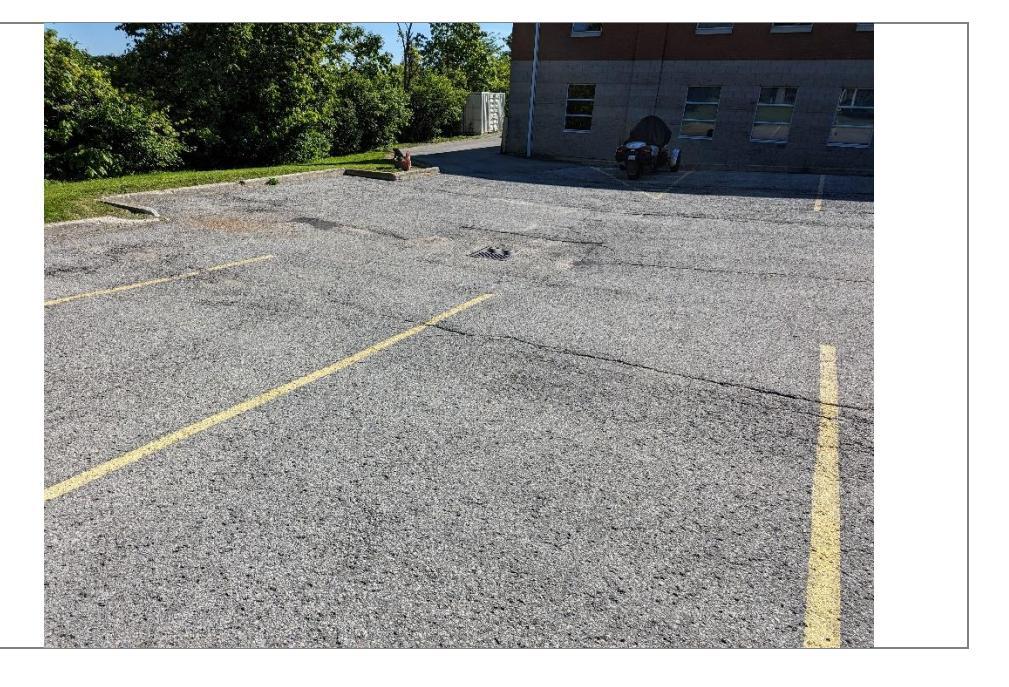
Photo No.	Date: 31-June-24	
Direction Ph	oto Taken:	
Description: A view of the north		
parking lot

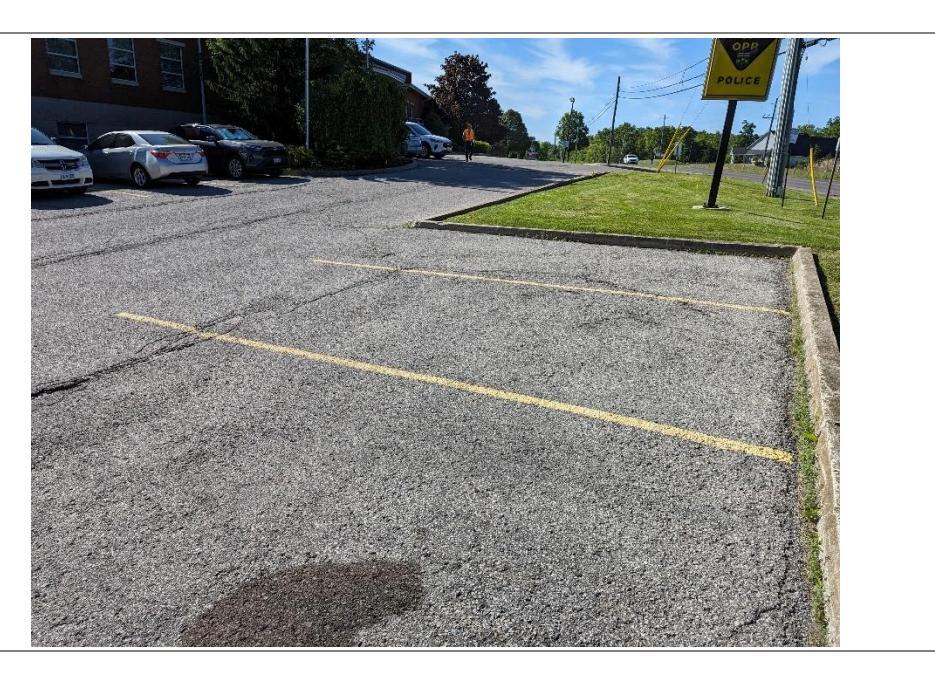
Photo No.	Date:	
3	31-June-24	
Direction Photo Taken:		
Southeast		
Description:		
A view of the north parking lot and laneway.

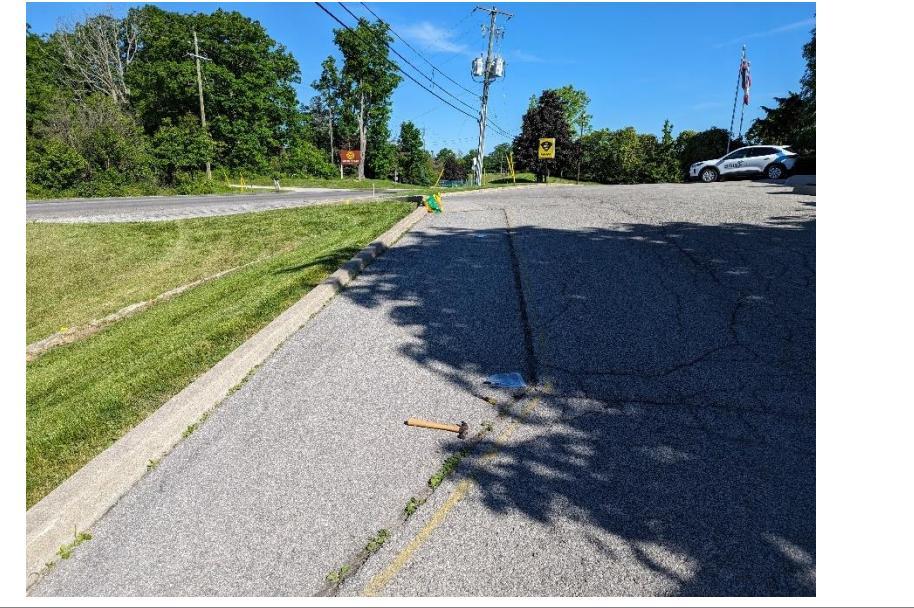
Client Name		Site Location	Project No.
Colliers Project Leaders		72 Highway 54, Cayuga, ON	624024.CE
Photo No. 5	Date: 31-June-24		and the second
Direction Ph North	oto Taken:		
Description:			
A view of the parking lot.	south
