# Hazardous Building Materials Assessment (Pre-construction)

P01970 Dust Collector Replacement Project Orchard Park Secondary School 200 Dewitt Road, Stoney Creek, Ontario

# Hamilton-Wentworth District School Board

February 19, 2025

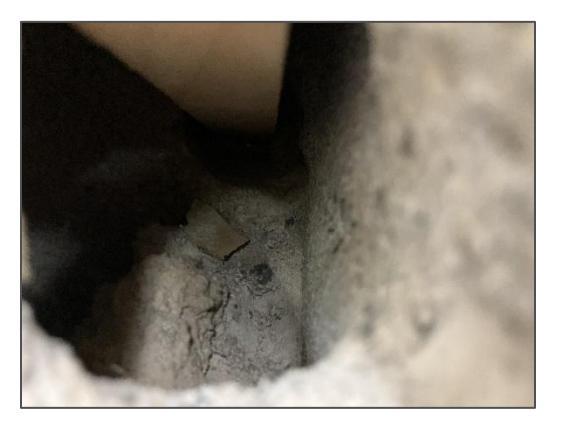
Photo 1

Loose fill vermiculite was not observed within open cavities of block walls (photo 1).

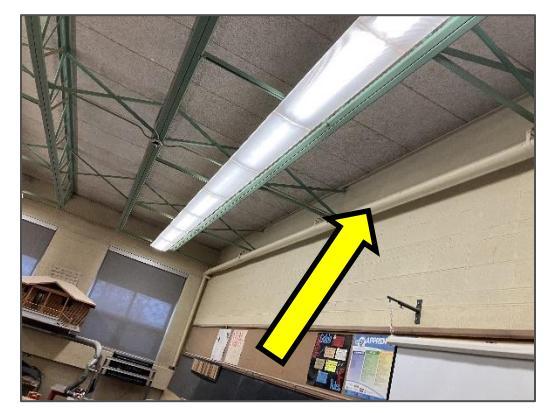
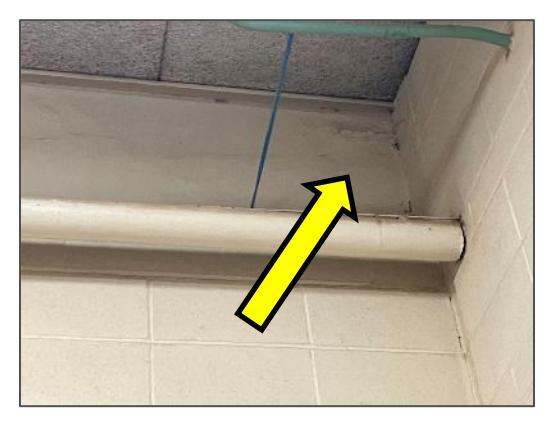
Rough plaster, containing asbestos, is present on a steel beam along the south wall of the Wood Shop (previously sampled, photos 1 and 2).

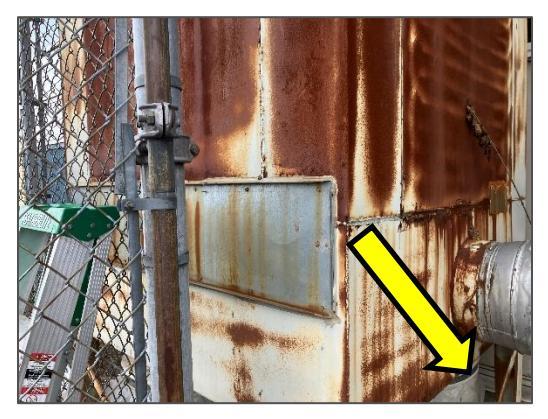
Photo 1

Textile vibration dampers, present as duct connectors on the exterior dust collector, do not contain asbestos (samples S0009A-C, photo 1).

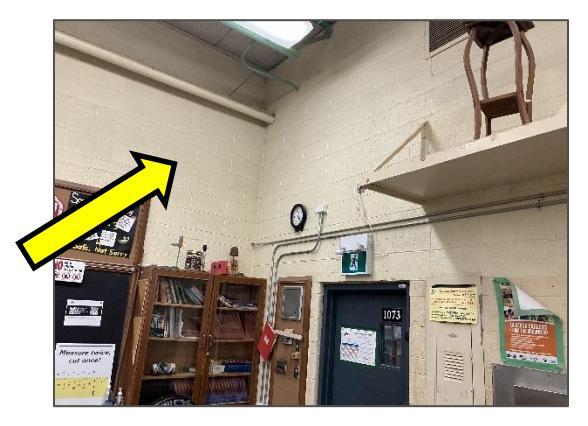
Photo 1

Beige paint present on concrete block throughout the assessed area does not contain asbestos (samples S0008A-C, photo 1).

Items painted with paints containing elevated levels of lead may be a hazardous waste. Test lead-painted materials for leachable lead and other metals prior to disposal. Metallic components coated with lead paint do not require leachate testing and can be disposed of as non-hazardous construction and demolition (C&D) waste.

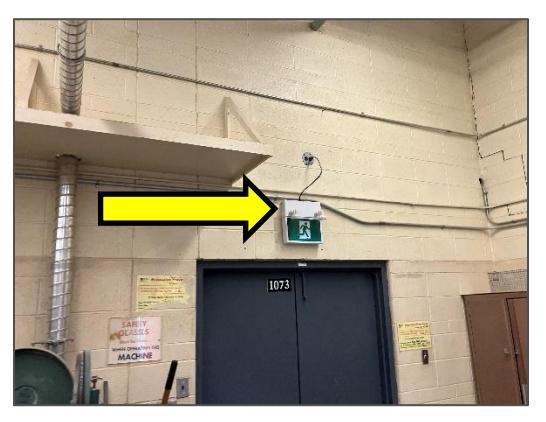
Photo 1

Lead-containing batteries are present in emergency lighting (photo 1).

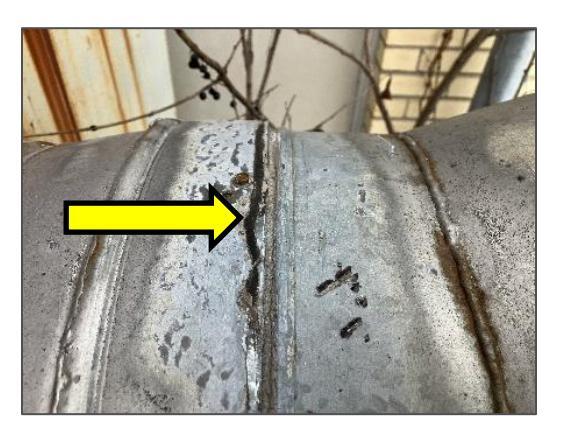
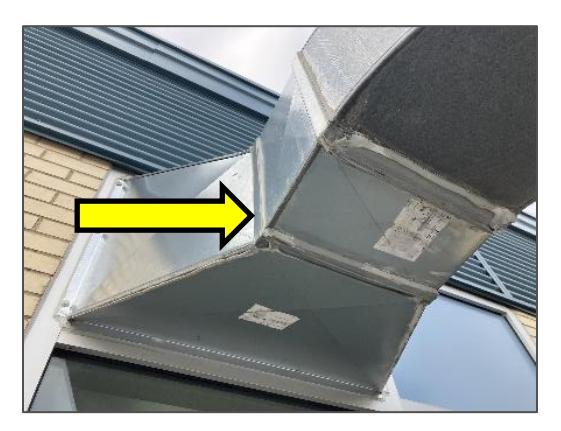
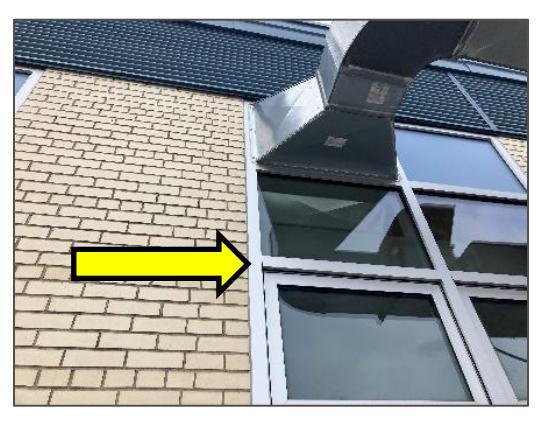
Caulking is present at exterior window frames and on exterior ductwork (samples P0001, photos 1-3). The material is a non-PCB solid based on the threshold (50 mg/kg).
