DESIGNATED SUBSTANCES SURVEY

PICKERING FIRE STATION #2

553 KINGSTON ROAD

SITE ASSESSMENT DATE: JANUARY 9, 2018

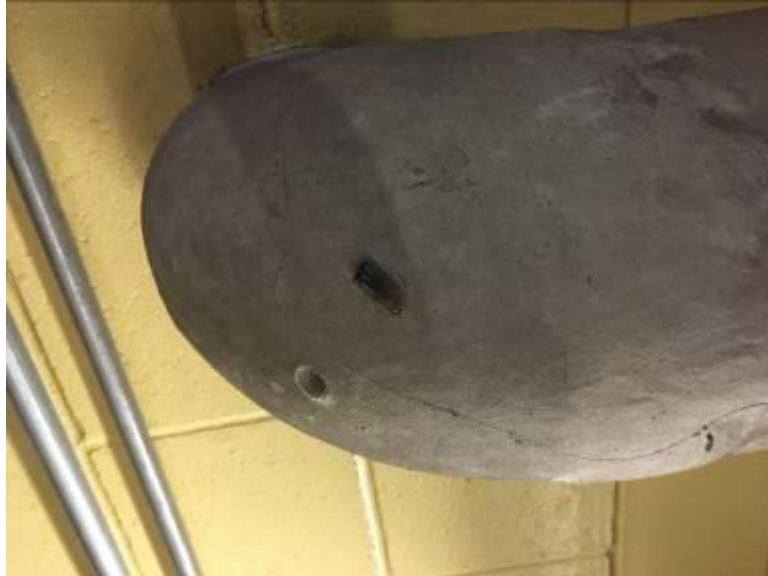
Apparatus Bay - Piping Elbows and Piping T Joints
Canvas Wrapped Applied White, Cementitious Insulations
Not Asbestos Containing

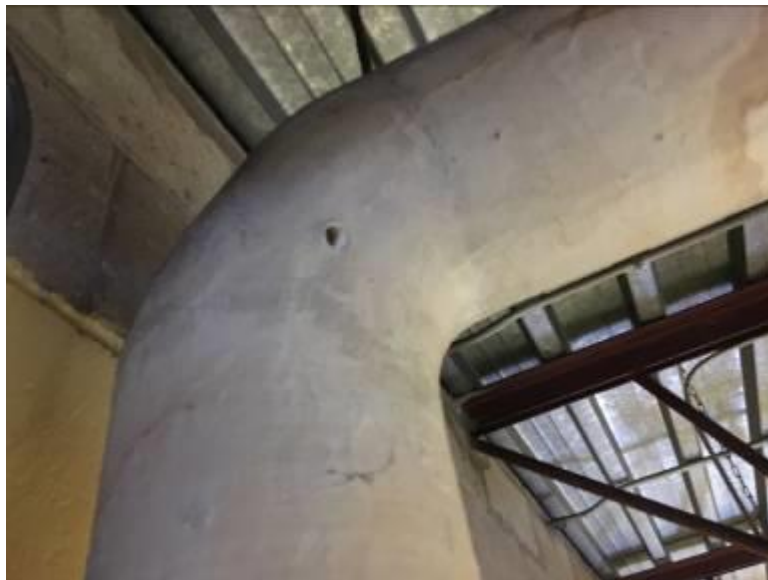
Apparatus Bay - Piping Elbows and Piping T Joints
Canvas Wrapped Applied White, Cementitious Insulations
Not Asbestos Containing

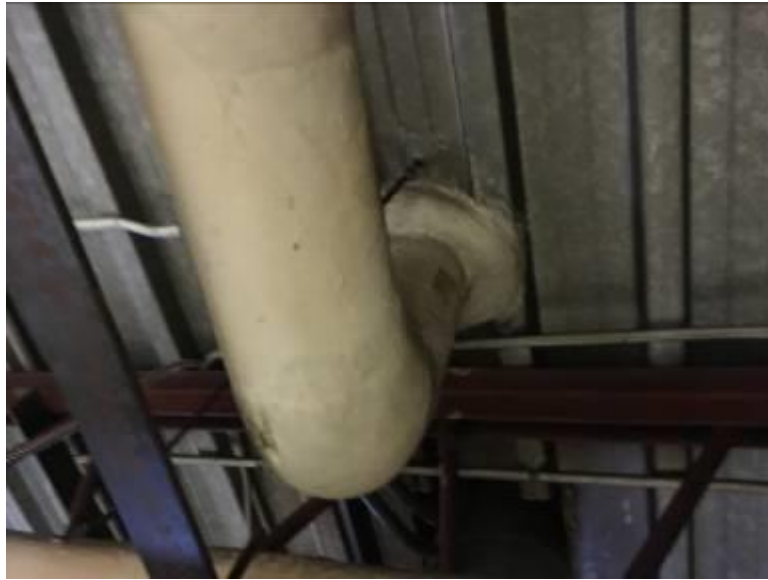
Apparatus Bay - Piping Elbows and Piping T Joints
Canvas Wrapped Applied White, Cementitious Insulations
Not Asbestos Containing

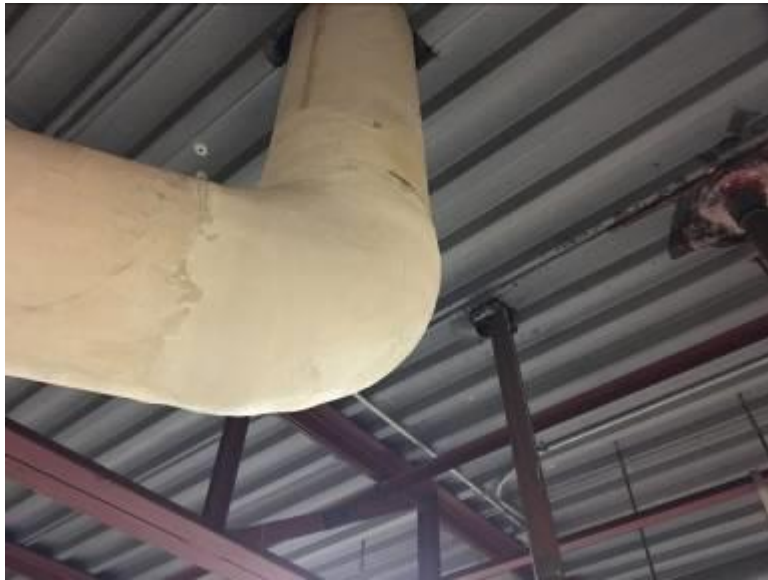
Apparatus Bay - Piping Elbows and Piping T Joints
Canvas Wrapped Applied White, Cementitious Insulations
Not Asbestos Containing

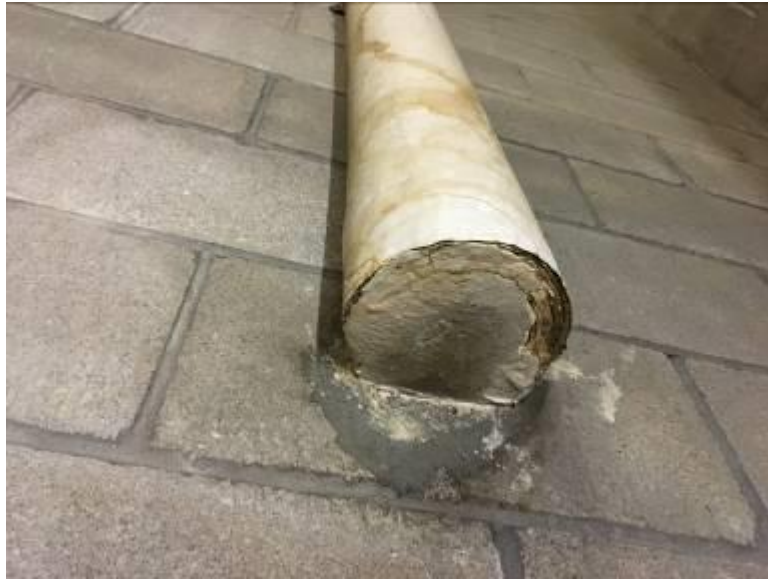
Hose Room - Piping Elbows and Piping T & End Joints
Canvas Wrapped Applied White, Cementitious Insulations
Not Asbestos Containing

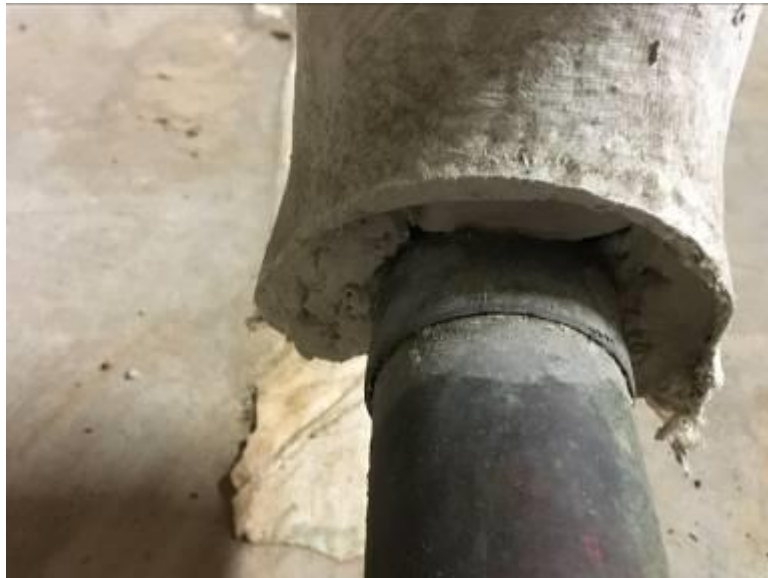
Hose Room - Piping Elbows and Piping T Joints
Canvas Wrapped Applied White, Cementitious Insulations
Not Asbestos Containing

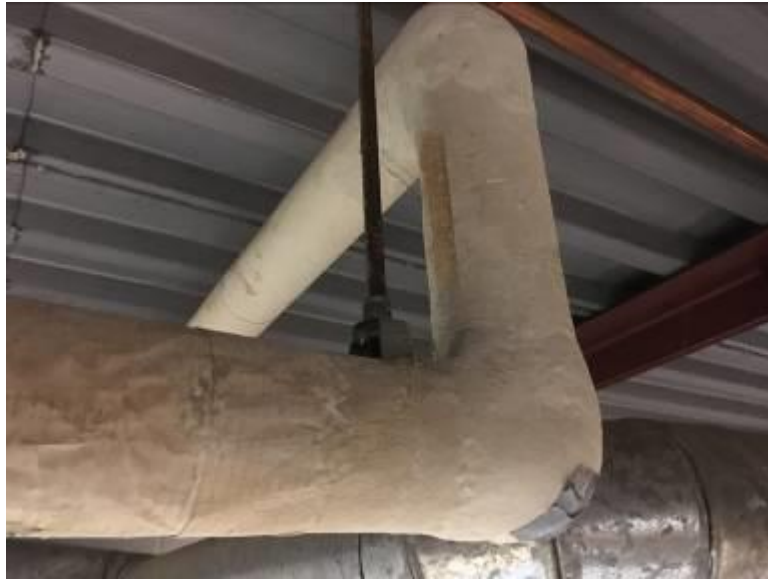
Basement - Piping Elbows and Piping T Joints
Canvas Wrapped Applied White, Cementitious Insulations
Not Asbestos Containing

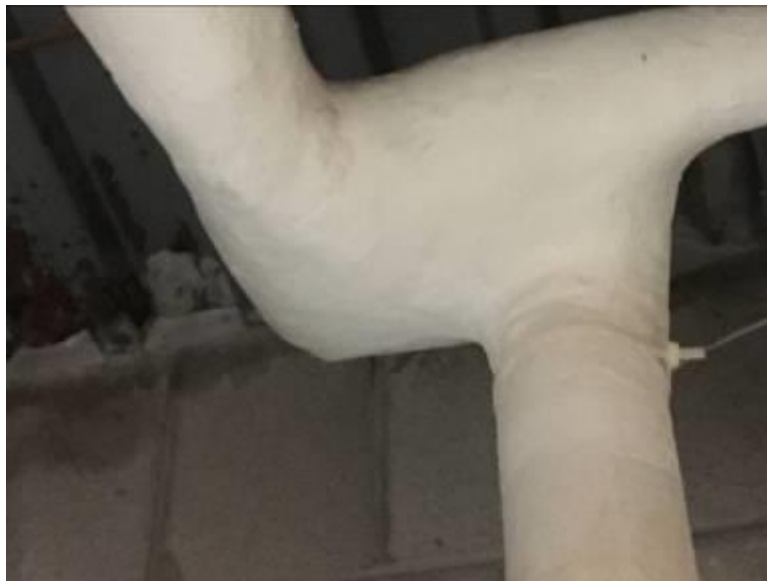
Basement Piping Elbows and Piping T Joints
Canvas Wrapped Applied White, Cementitious Insulations
Not Asbestos Containing

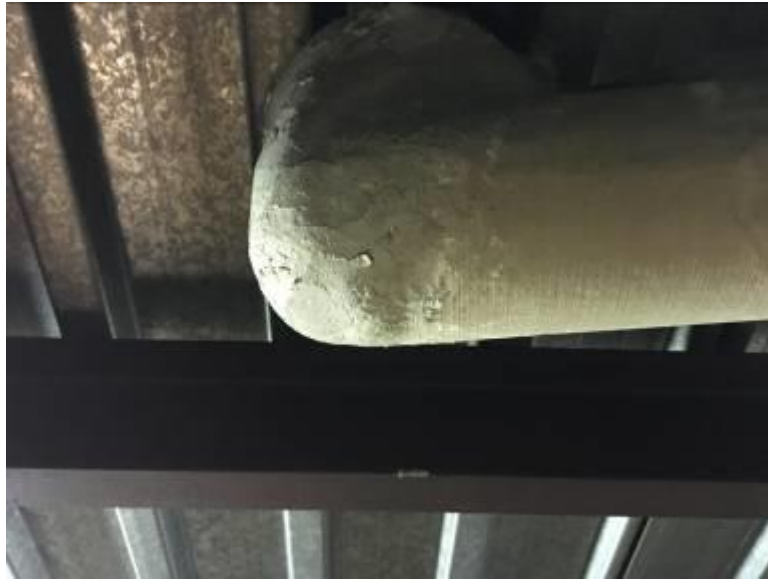
Basement Piping Elbows and Piping T Joints
Canvas Wrapped Applied White, Cementitious Insulations
Not Asbestos Containing

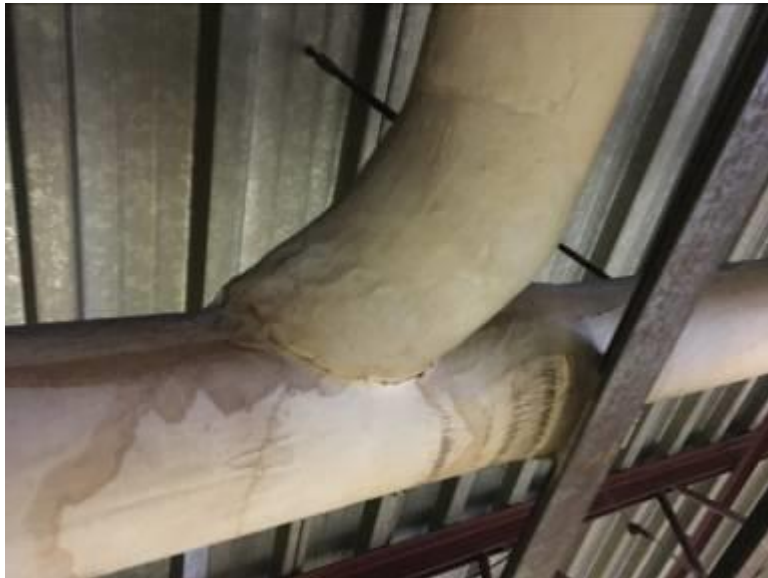
Basement Piping Elbows and Piping T Joints
Canvas Wrapped Applied White, Cementitious Insulations
Not Asbestos Containing

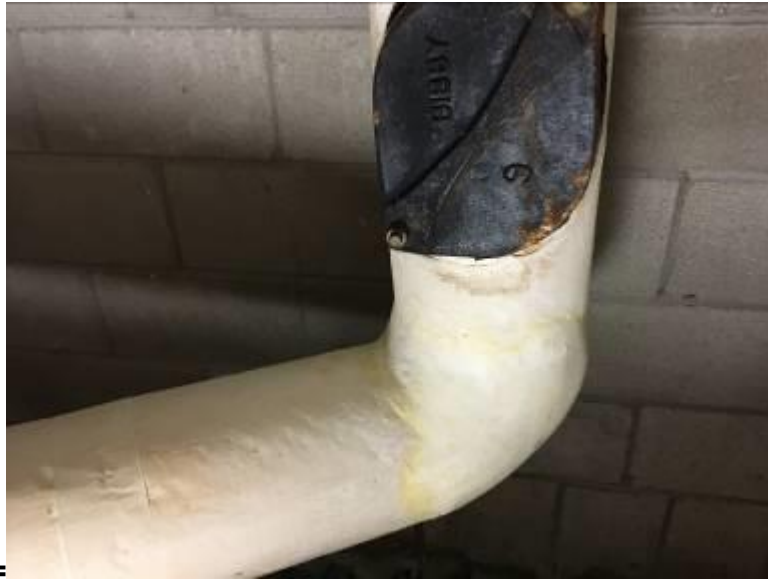
Basement Piping Elbows and Piping T Joints
Canvas Wrapped Applied White, Cementitious Insulations
Not Asbestos Containing

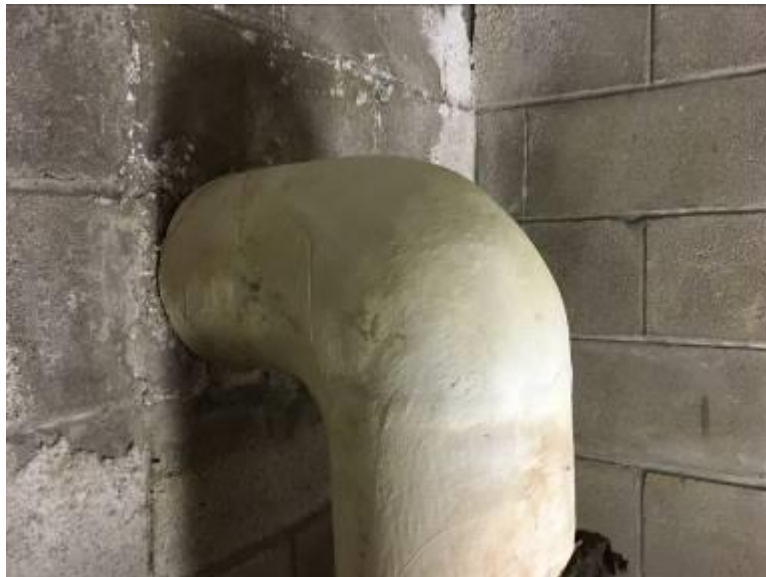
Basement Piping Elbows and Piping T Joints
Canvas Wrapped Applied White, Cementitious Insulations
Not Asbestos Containing

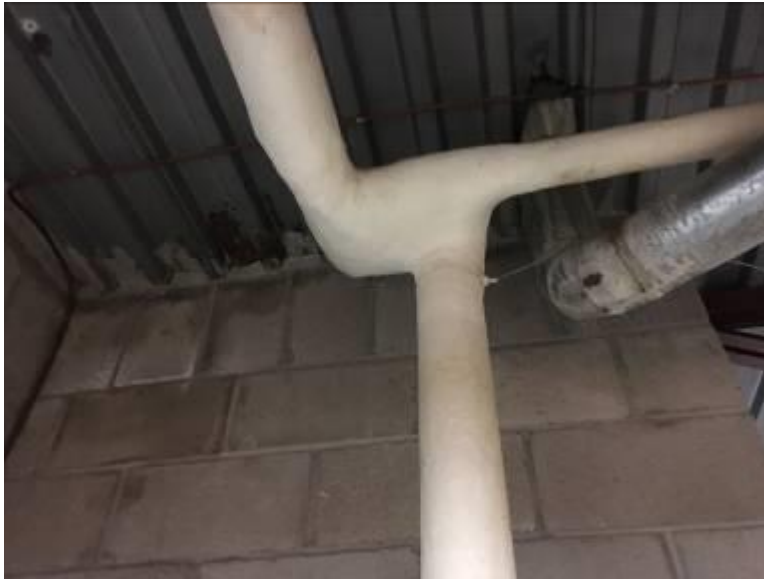
Basement Piping Elbows and Piping T Joints
Canvas Wrapped Applied White, Cementitious Insulations
Not Asbestos Containing

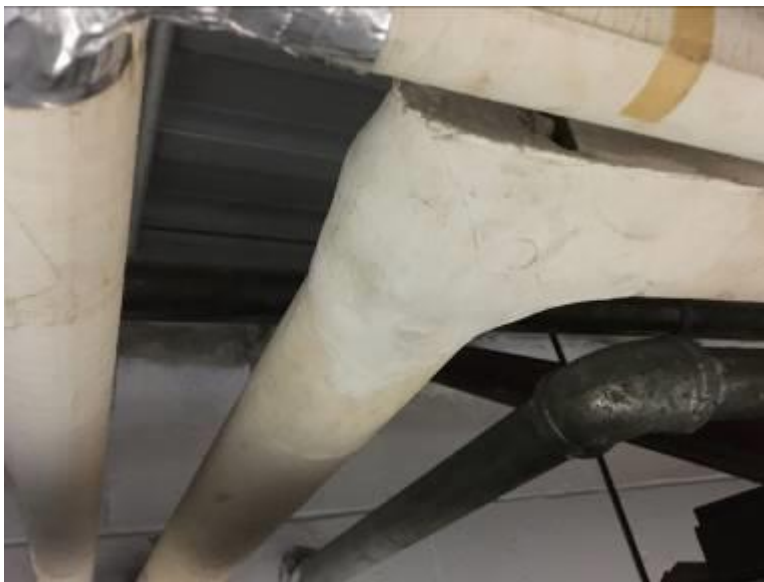
Basement Piping Elbows and Piping T Joints
Canvas Wrapped Applied White, Cementitious Insulations
Not Asbestos Containing

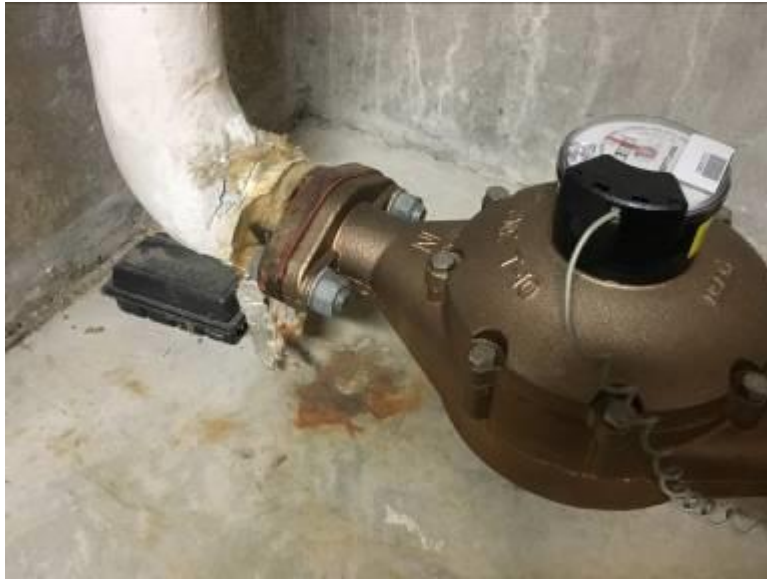
Basement Water Meter Piping Elbows and Piping T Joints
Canvas Wrapped Applied White, Cementitious Insulations
Not Asbestos Containing

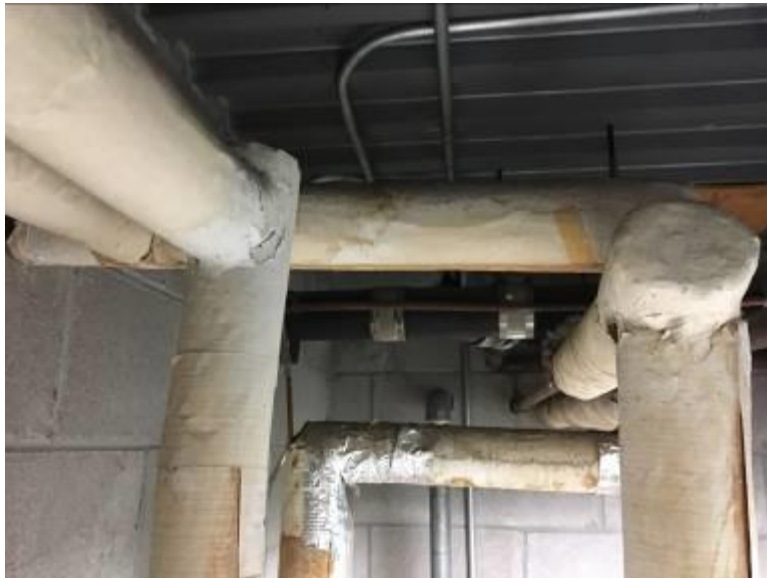
Basement Mechanical Room Piping Elbows and Piping T Joints
Canvas Wrapped Applied White, Cementitious Insulations
Not Asbestos Containing

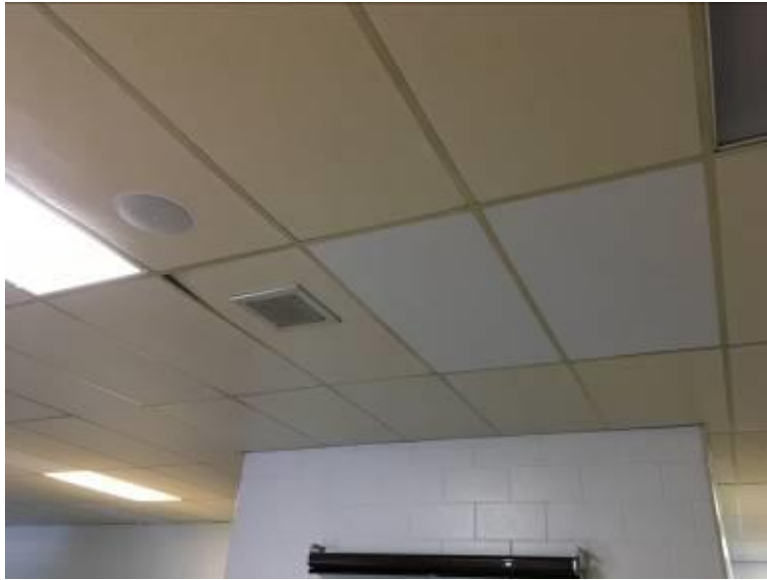
Main Floor Kitchen/Lounge/Sleeping Areas - T-Bar 2'X3' Ceiling Tiles
White with Fibrous Glass Material
Not Asbestos Containing

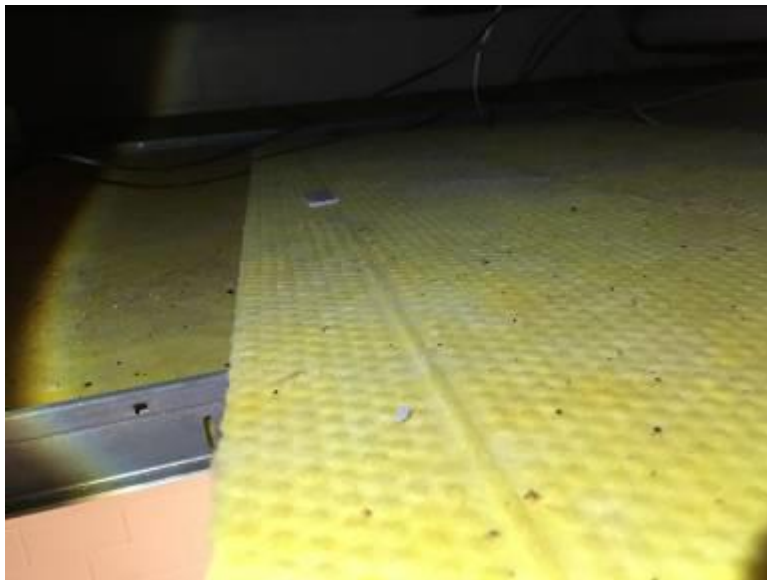
Main Floor Kitchen/Lounge/Sleeping Areas - T-Bar 2'X3' Ceiling Tiles
White with Fibrous Glass Material
Not Asbestos Containing

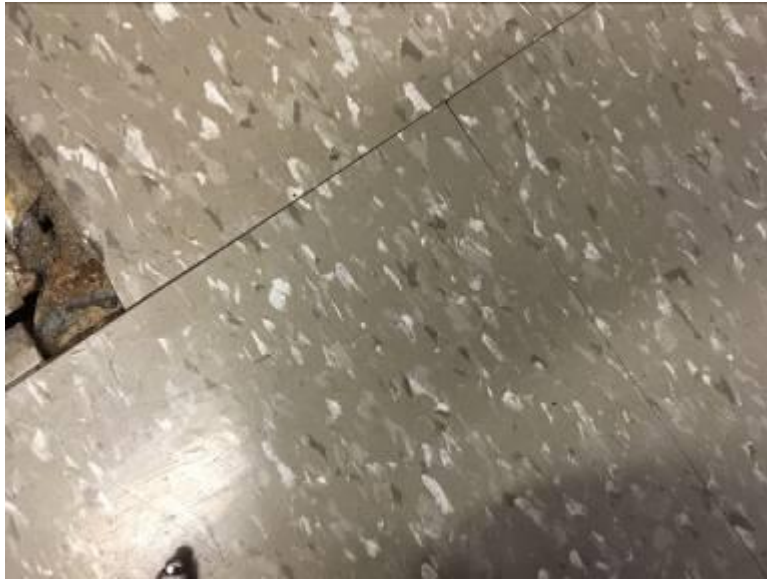
Main Floor Kitchen/Lounge/Sleeping Areas – 12” x 12” Vinyl Floor Tiles
Beige White Flecked and Black Mastic Material
Not Asbestos Containing

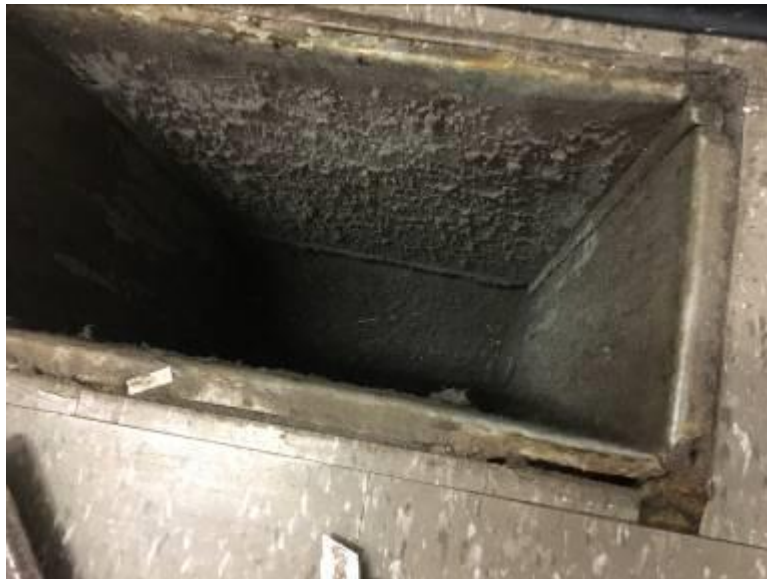
Main Floor Kitchen/Lounge/Sleeping Areas – 12” x 12” Vinyl Floor Tiles
Beige White Flecked and Black Mastic Material
Not Asbestos Containing

(Note; HVAC Duct Dust Accumulation)

There were no indications of significant historical observable water ingress, stains, pronounced odours or associated mould growths in the Pickering Fire Station #2 building room areas located at 553 Kingston Road. Although beyond the scope of this assessment, the main floor HVAC duct was noted to be very dusty and is recommended to be cleaned. (See HVAC - Duct Photo)

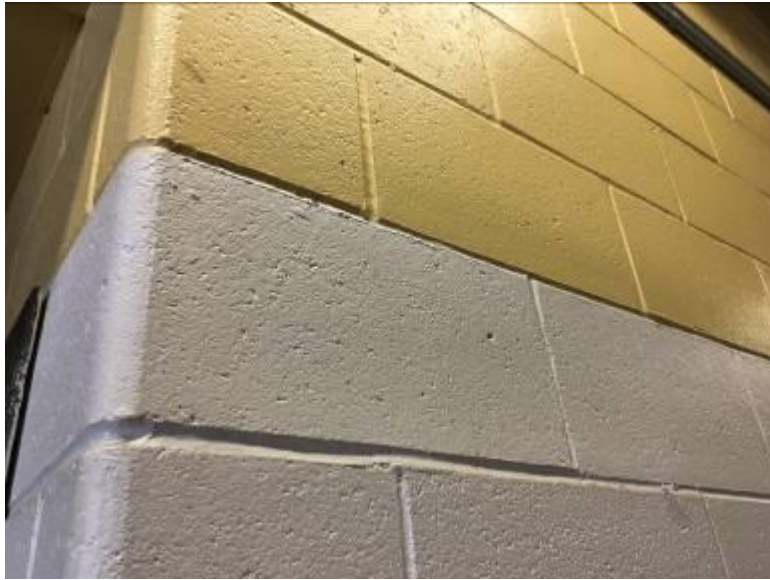
The facility applied accessible surface paints were generally in good repair with no significant loss of adhesion, peeling, flaking or crazing or deteriorations noted.

Main Floor – Painted Block Wall – White and Yellow

8 ug/g to 260 ug/g Lead

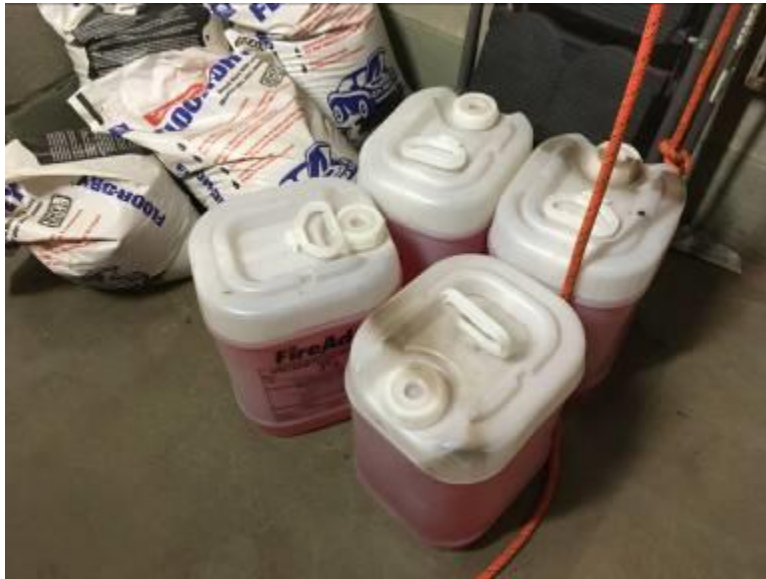
There were several 5 gallon containers of liquid fire retardant materials stored at the site. (Photo Above) These liquid fire retardant materials are used for support of the on-site fire fighting equipment and were noted to be in labelled secure designed storage containers. The 5 gallon containers are portable and are staged in a storage room area that was noted to be free of any spills and surface stains.
