Arborist Report
2524 Cawthra Road, Mississauga ON

**Arborist Report
2524 Cawthra Road, Mississauga ON**

**July 2024
300058445.0000**

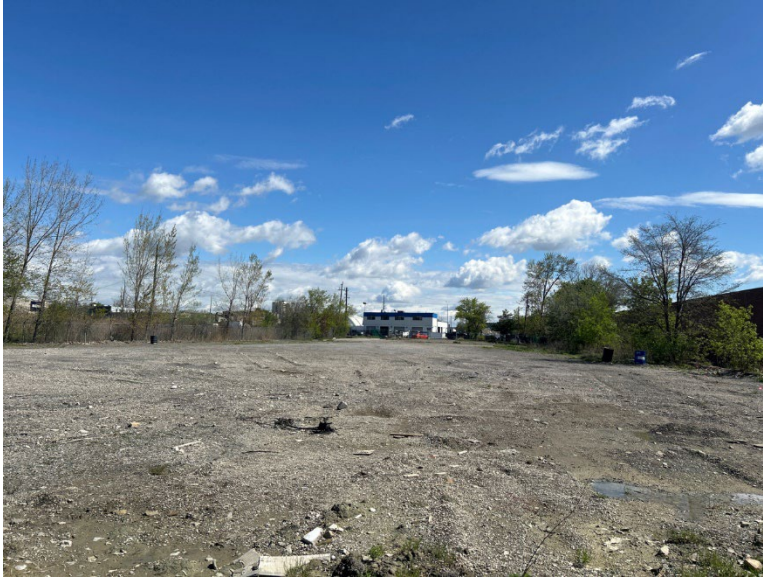
Photo 1: Existing site conditions, looking east

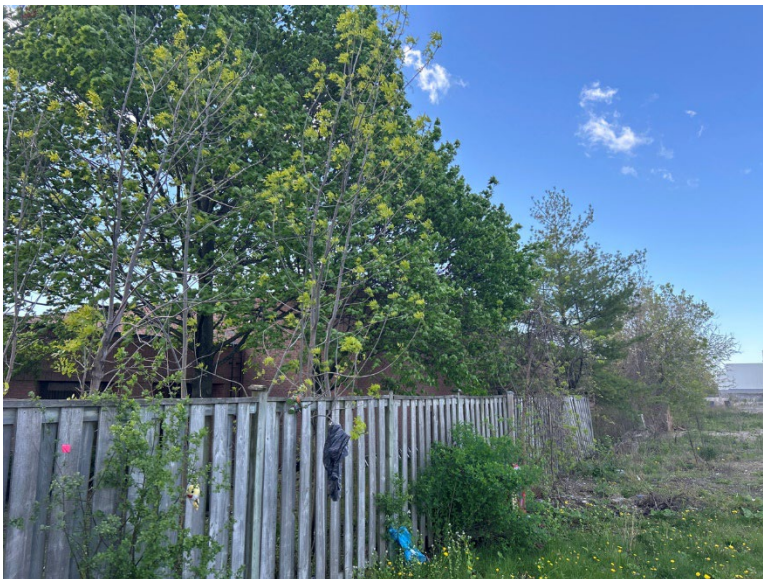
Photo 2: Off-site trees along south property boundary, looking west

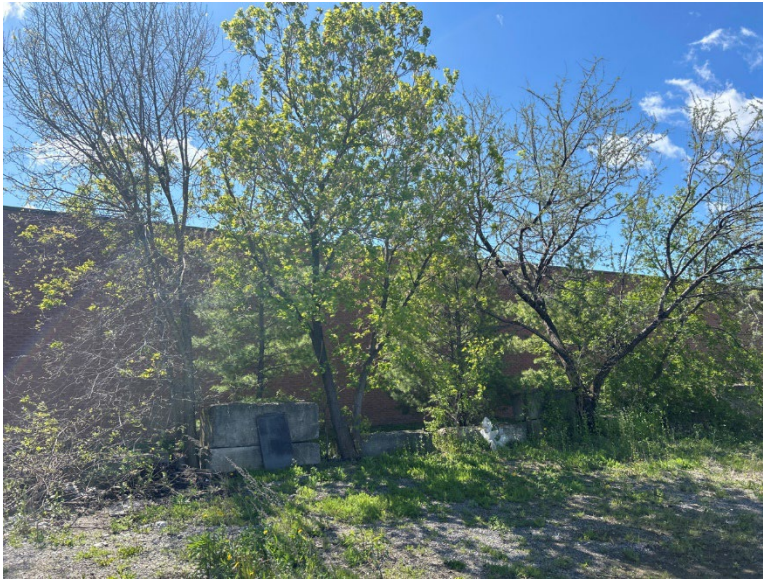
Photo 3: Tree nos. T52 to T57 on-site along south property boundary, looking south

- A total of 12 of the 14 trees proposed for removal are located on-site including tree nos. T47 to T58.
- Tree nos. T59 and T60 are located off-site, immediately adjacent to the south property boundary where a retaining wall is proposed. These trees will conflict with the elements of development over time. Permission and an agreement from the adjacent landowner will be required to remove these two trees.
- The remaining two trees recommended for removal (T43 and T66) are based on poor condition, with no construction impacts anticipated. These trees have been assigned an asterisk within the data set for distinguishment. Tree no. T66 is located off-site, and its removal is at the final discretion of the adjacent landowner.

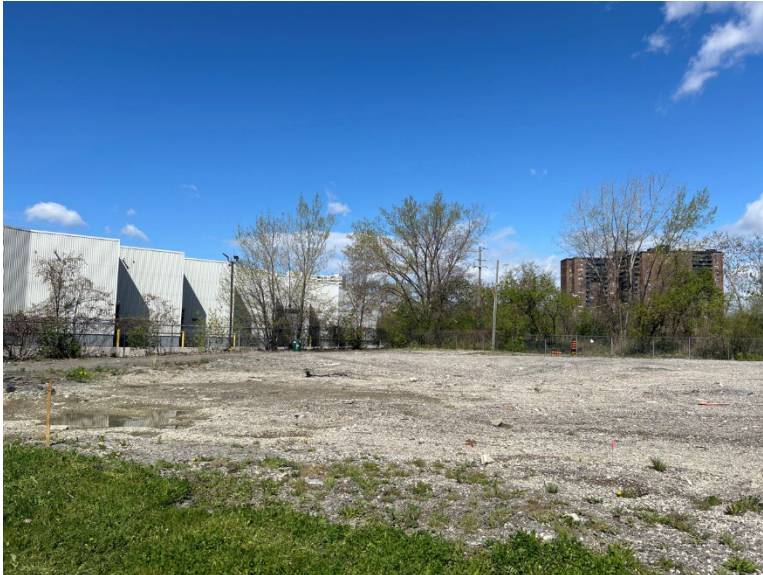
Photo 4: Trees off-site along northeast property boundary, looking north

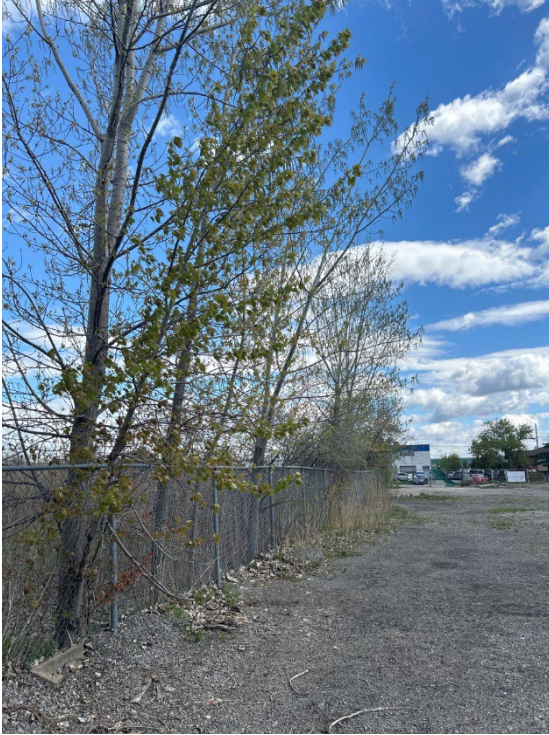
Photo 5: Trees off-site along north property boundary, looking east

Existing trees located off-site along the north property boundary are adequately setback from construction or have minor MTPZs encroachments. The 1.2 m side yard

(north) setback is proposed for landscaping which will enhance the existing site conditions. Existing trees located off-site along the west property boundary are subject to a 7.5 m rear yard setback and will be undisturbed.

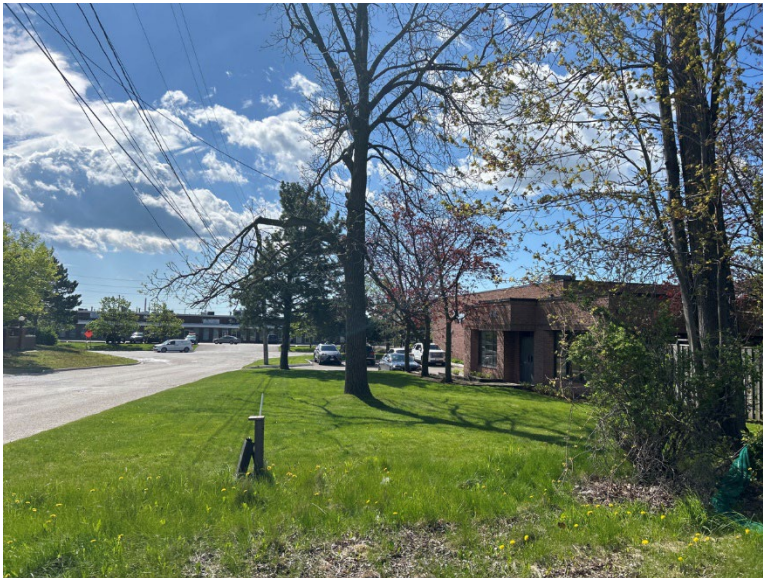
Photo 6: Trees off-site southeast of property, looking south

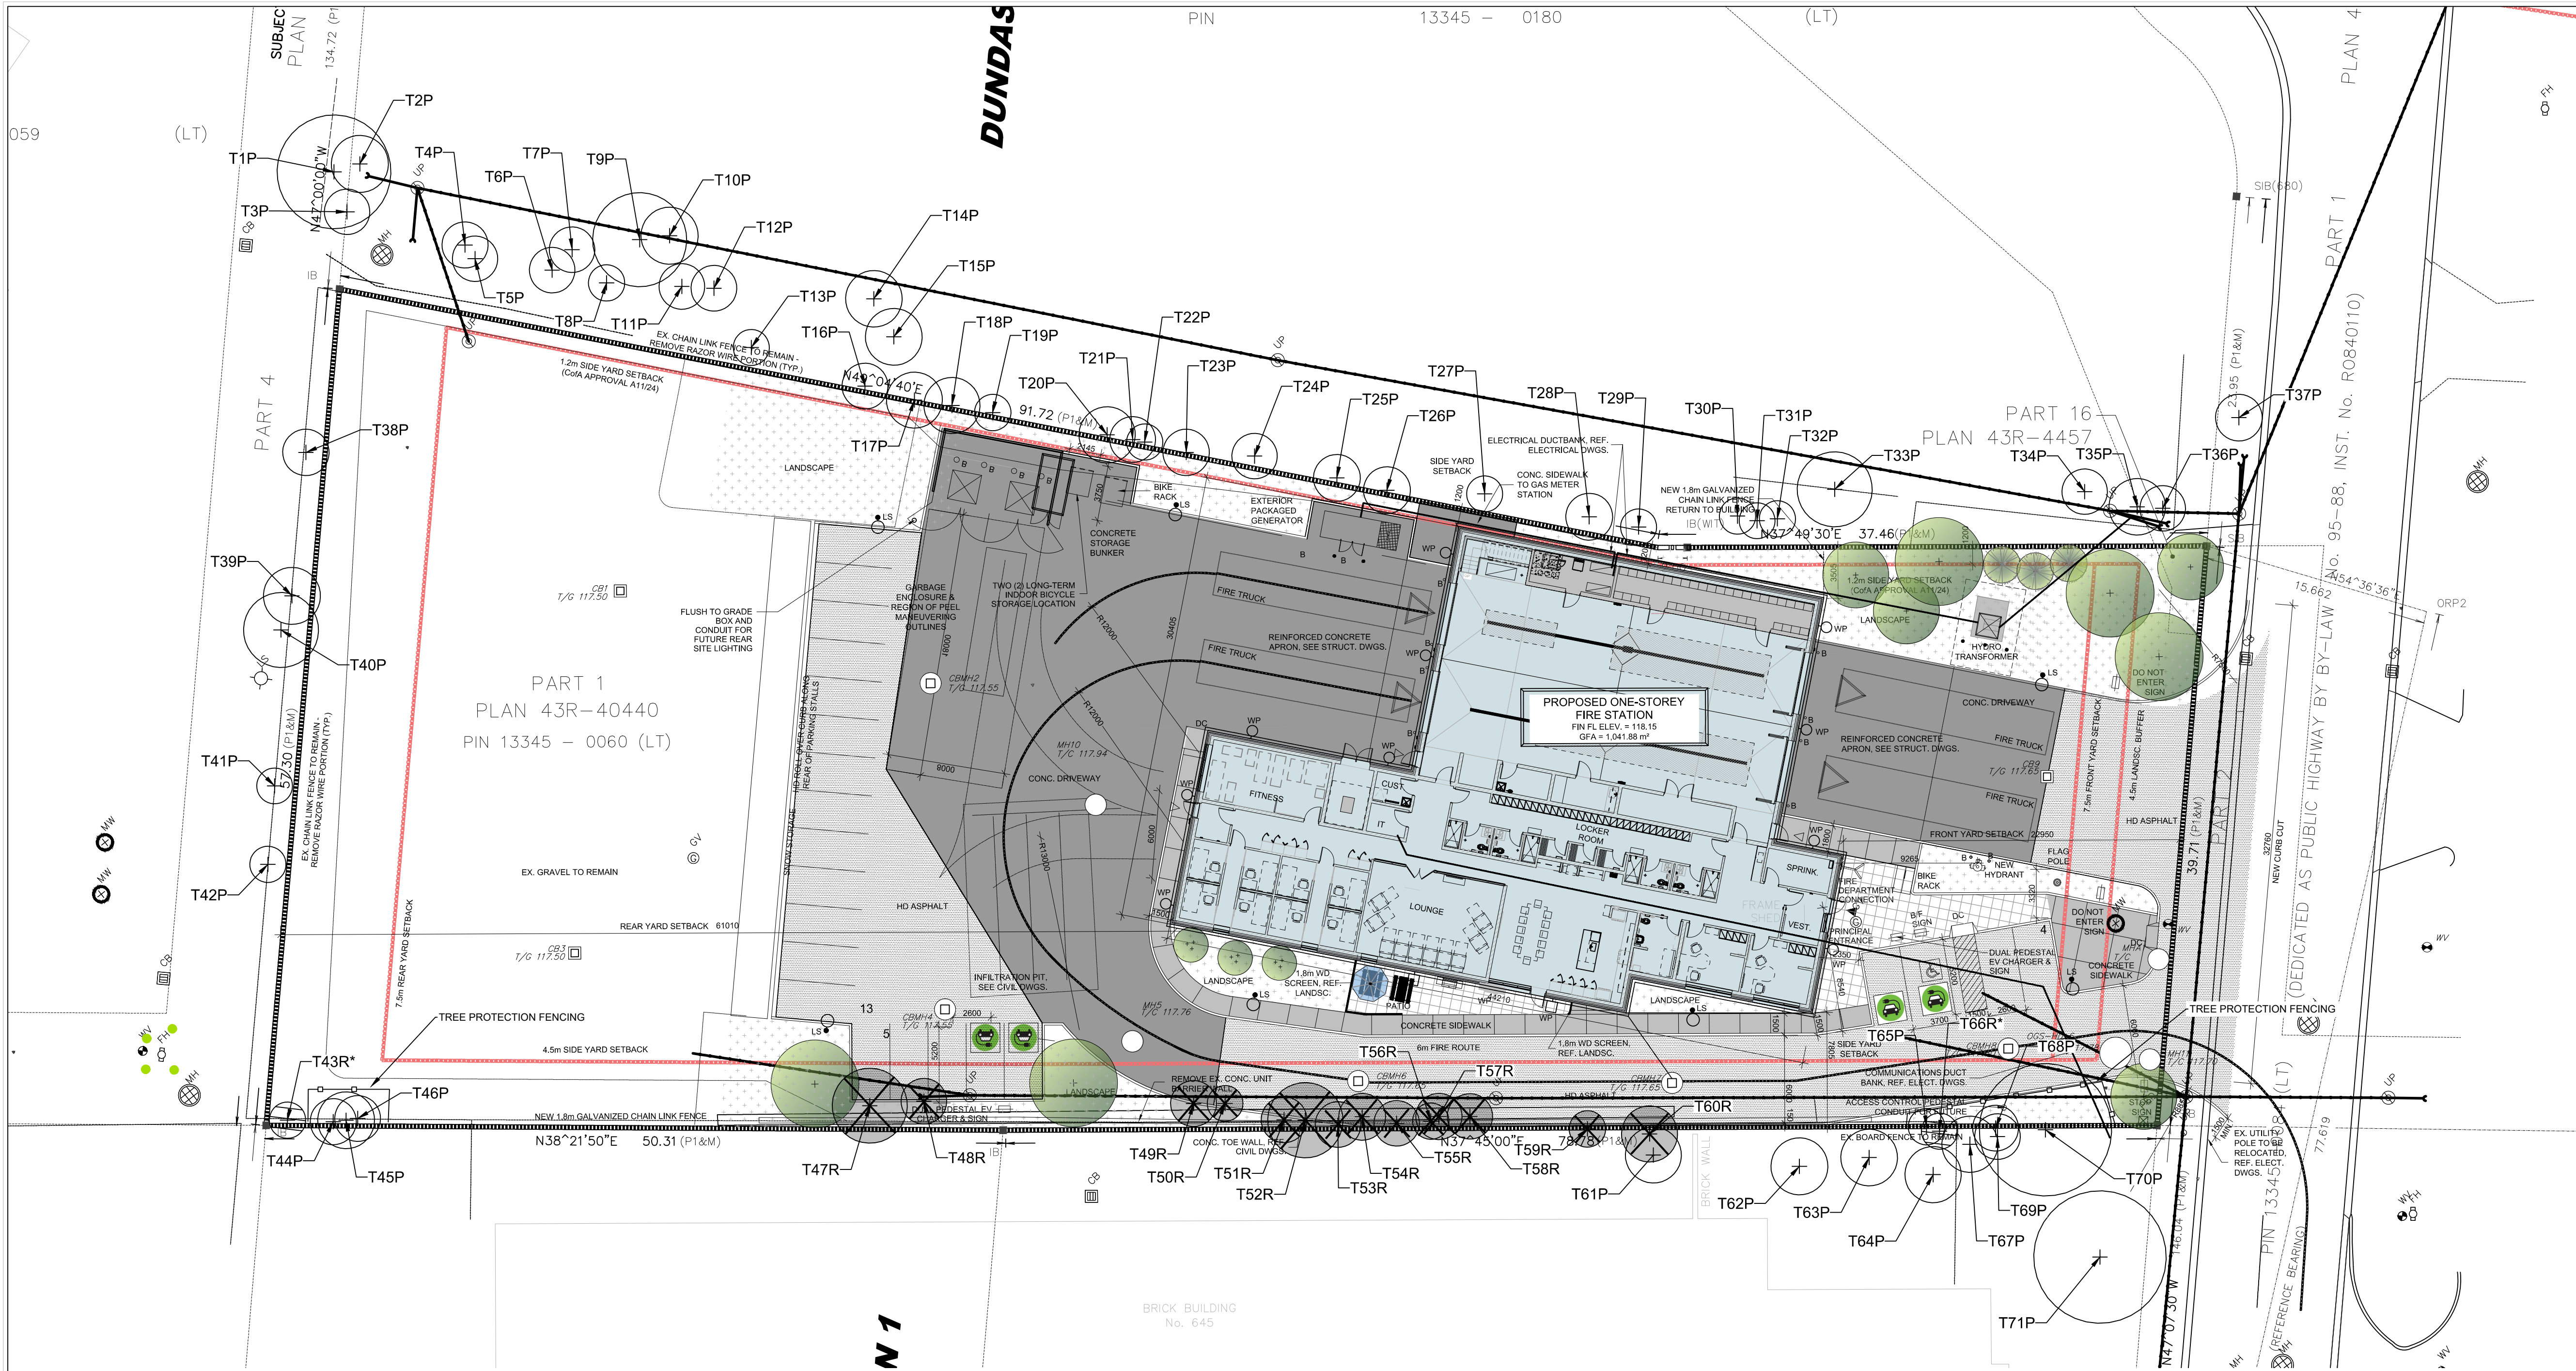
T1

- T8P EXISTING TREE, RECOMMENDED FOR PRESERVATION. CIRCLE REPRESENTS MINIMUM TREE PROTECTION ZONE OF TREE.
- T15R EXISTING TREE, RECOMMENDED FOR REMOVAL. CIRCLE REPRESENTS MINIMUM TREE PROTECTION ZONE OF TREE.
- T40R* EXISTING TREE, RECOMMENDED FOR REMOVAL BASED ON CONDITION. CIRCLE REPRESENTS MINIMUM TREE PROTECTION ZONE OF TREE.
- TREE PROTECTION FENCING PER DETAIL 02830-6

- Tree nos. T65 to T70 are located off-site, immediately adjacent to the south property boundary. TPF should be installed to protect a significant portion of these trees MTPZs.
- Tree nos. T44 to T46 are located on-site along the south property boundary. TPF should be installed at the limits of the trees MTPZs for protection.

The associated TPP identifies the locations of trees to be removed.

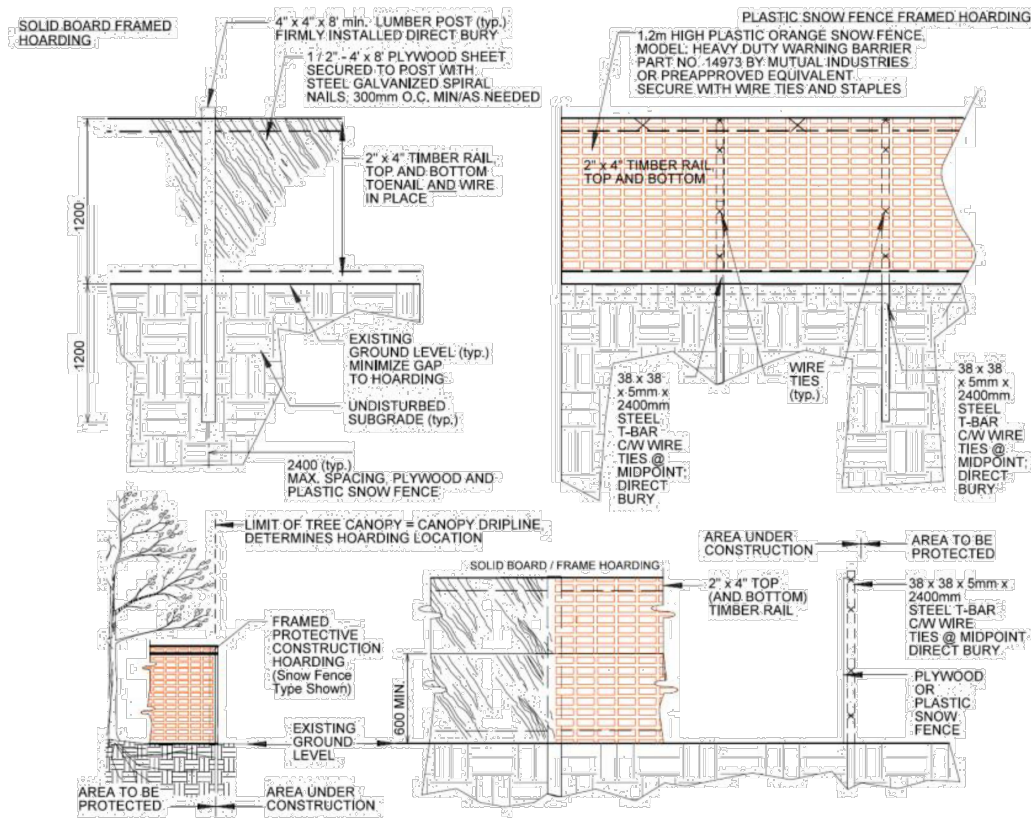
Detail: 02830-6

Hoarding
Framed Protective Construction Hoarding
Solid Board- Plastic Snow Fence

- MAIN INSTALLING DIRECT BURY TIMBER POSTS AND GABLE TIES TO AVOID VISIBLE AND ACCURATELY ANCHOR TREE ROOTS.
 - PLACE HOARDING AT LIMIT OF TREE CANOPY OR LINE OR BEYOND (E.G. FURTHER AWAY FROM TRUNK OF TREE).

- HOARDING OFF AREA TO REMAIN UNDISTURBED. NO STOCKPILING, STAGING OR MOVEMENT OF VEHICLES TO OCCUR WITHIN PROTECTED AREA.
 - FOR PROTECTION OF TREES AND ROOT SYSTEMS, CONTRACTOR MAY BE REQUIRED TO PROVIDE WATERING, MULCHING, FERTILIZING, PRUNING OR OTHER ACTIVITIES TO ENSURE THE HEALTH OF THE TREES.

Tree protection fencing details as per the City's (Detail: 02830-6) Framed Protective Construction Hoarding Solid Board – Plastic Snow Fence, and Tree Protection Zone Signage are provided in the Tree Preservation Plan Details section of the Figures.
