**TORONTO PARAMEDIC SERVICES
D6 RENOVATION**

610 BAY STREET TORONTO ONTARIO

VOLUME 3 · REPORTS

**PRE-RENO
DESIGNATED SUBSTANCE SURVEY**
Toronto Coach Terminal
610 Bay Street, Toronto, ON

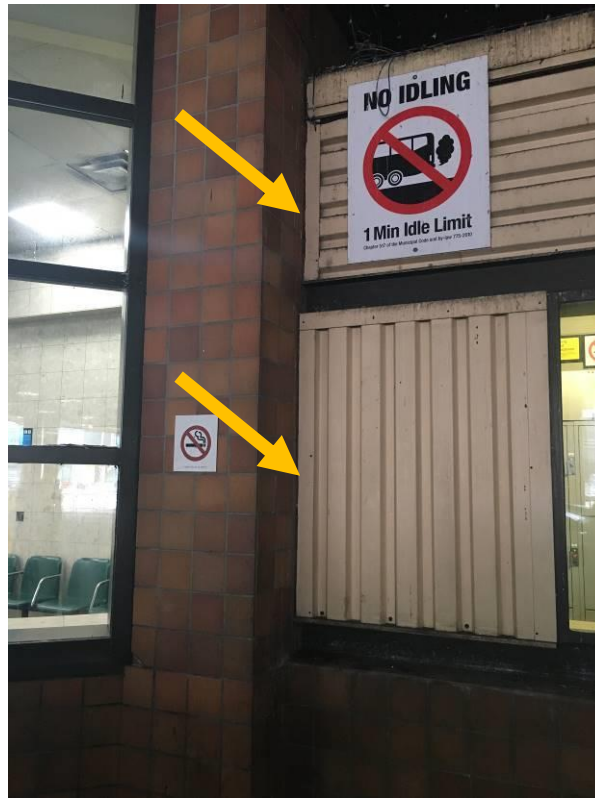
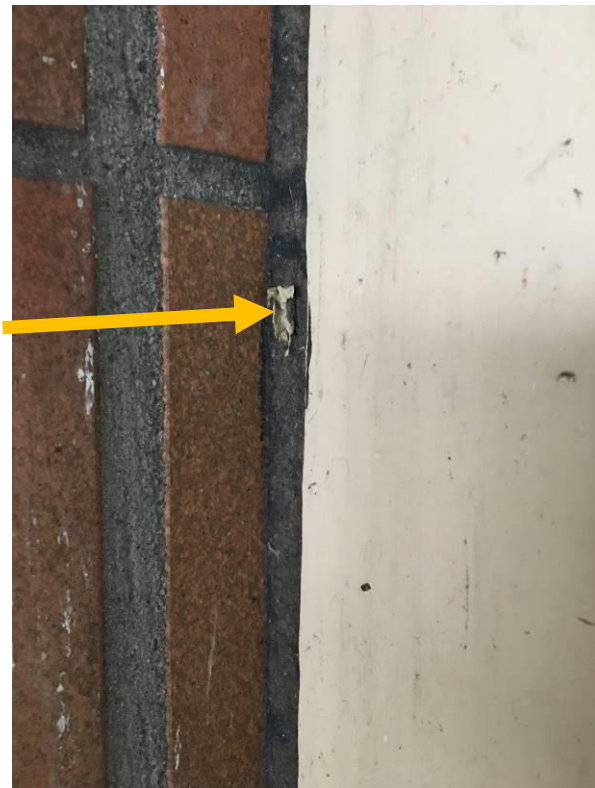
- Asbestos was found in cream caulking (approximately 6 LF) in the bus bay between wall and metal siding in South-East corner of the bus bay.

Based on the laboratory analysis by the PLM method, cream caulking on the wall near the southeast corner of the Bus Bay was found to contain 0.5-5% Chrysotile asbestos.

Photos 1, 2 – View of the **asbestos-containing** cream caulking on the wall in the Bus Bay.

- ✓ The removal of asbestos-containing cream caulking will require Type 1 asbestos abatement procedures, as outlined in O. Reg. 278/05.

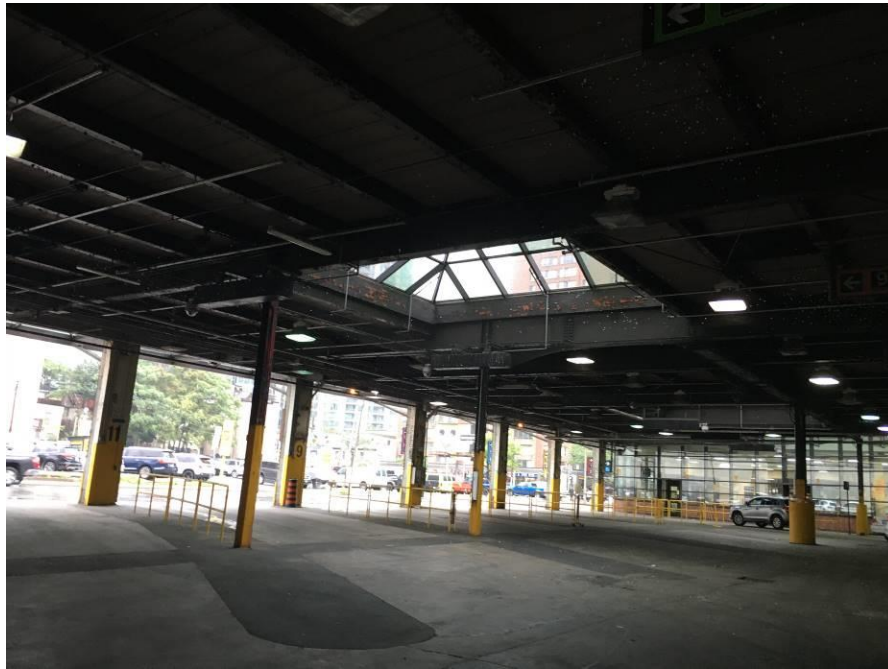
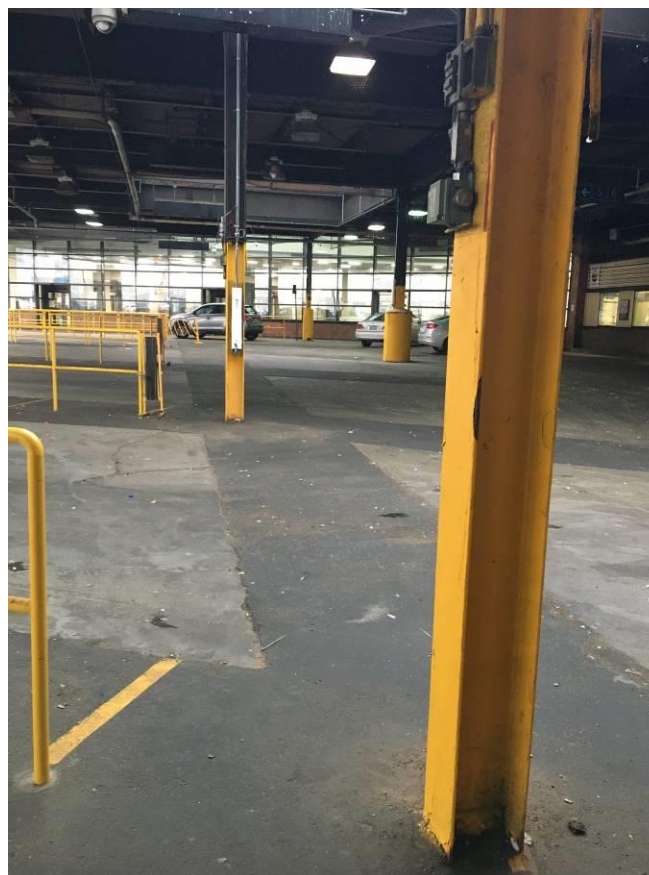
Elevated concentrations of lead (greater than 0.1% lead) were detected in the yellow paint sample, observed on the metal columns in the Bus Bay.

Photos 3, 4 – View of lead-containing yellow paint on metal columns.

- ✓ Removal of any lead-containing materials shall be carried out in accordance with the following regulations and guidelines:
 - Guideline: Lead on Construction Projects (issued by Ontario MOL);
 - Designated Substances Regulation, O. Reg. 490/09; and
 - Regulation for Construction Projects, O. Reg. 213/91.

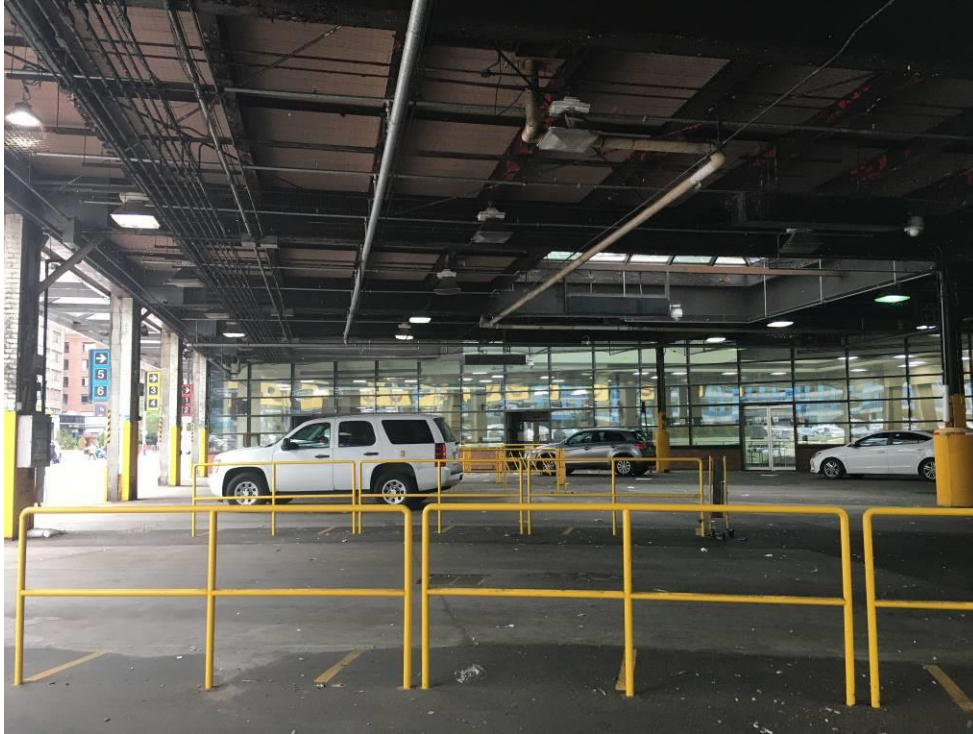
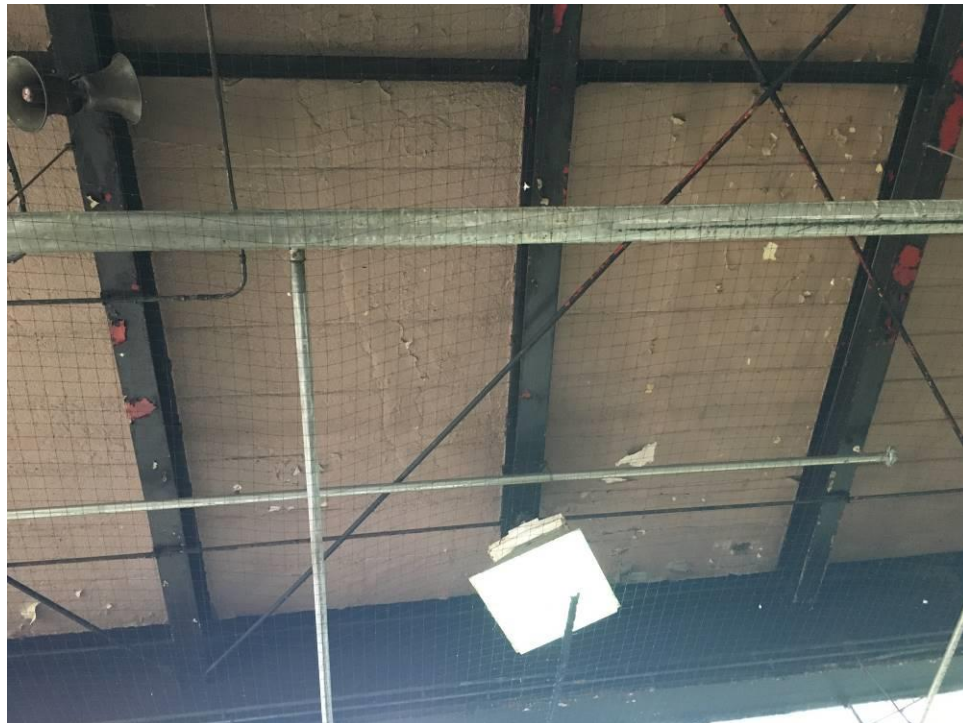
Photos 5, 6 – View of the ceiling in the Bus Bay with no lead containing paint.

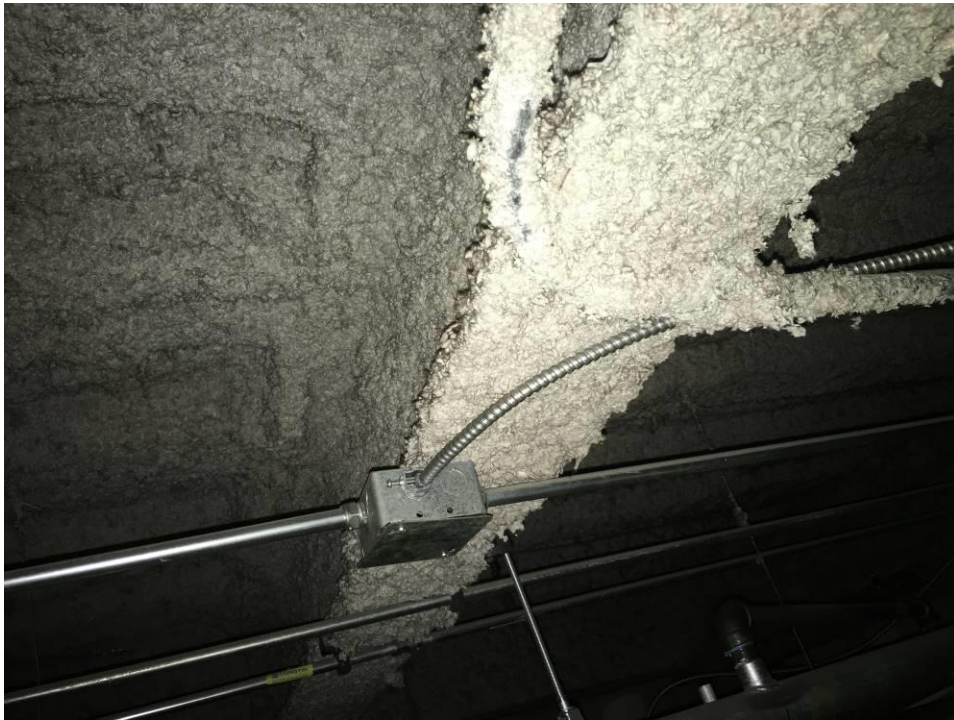
Photo 7 – View of the **non-asbestos** sprayed fire proofing observed in the ceiling space above Ceiling Tiles on the lower level.

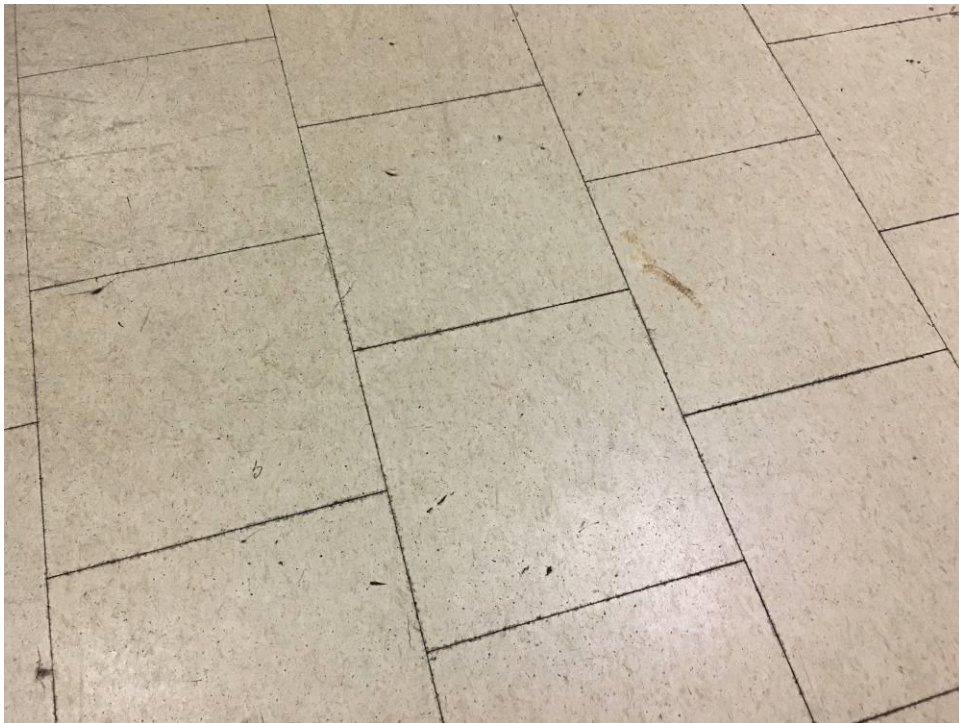
Photo 8 – View of the **non-asbestos** floor tiles observed on lower and upper level.
