Lincoln Alexander Elementary School

Exterior Window and Door Replacement

Designated Substance Audit Report

50 Ravenbury Drive, Hamilton, ON

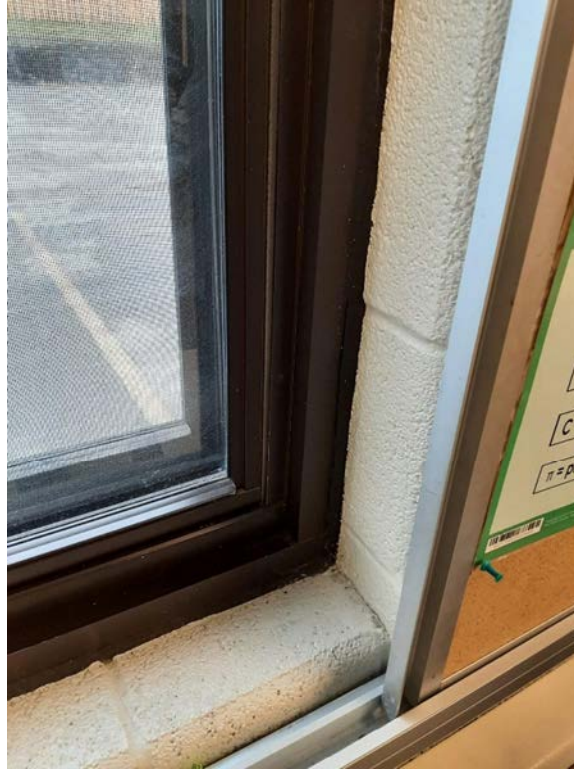
Photograph No. 1 – Black window sealant was observed around the perimeter of windows throughout the interior of the building. The sealant was sampled (S02A,B,C) and found to be asbestos-containing. The sealant was also sampled for PCBs (PCB1) and is non-PCB.

ACMs were identified during the assessment. If these materials, including those deemed or suspected, will be disturbed, or will likely be disturbed, during building maintenance, renovations, construction, or demolition activities, they must be handled and disposed of in accordance with the procedures prescribed by O. Reg. 278/05.

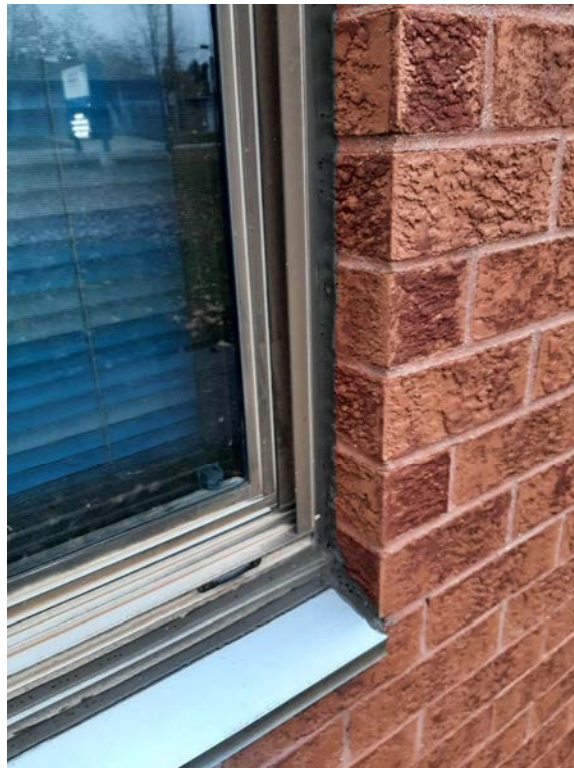
Photograph No. 2 – Black window sealant was observed around the perimeter of windows throughout the exterior of the building. The sealant was sampled (S05A,B,C) and found to be asbestos-containing. The sealant was also sampled for PCBs (PCB4) and is non-PCB.

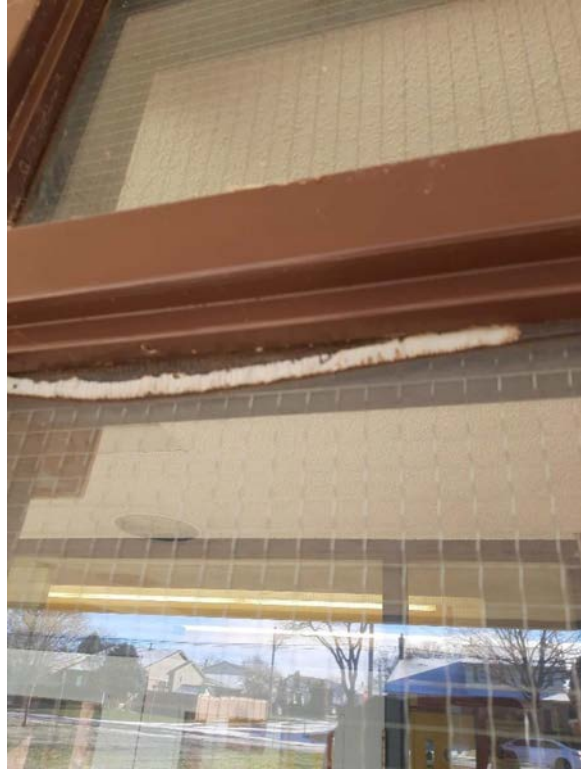
Photograph No. 3 – Glazing was observed between the glass and the frame/casing on the main entrance window. The glazing was sampled (S04A,B,C) and found to be asbestos-containing. The glazing was also sampled for PCBs (PCB3) and is non-PCB.

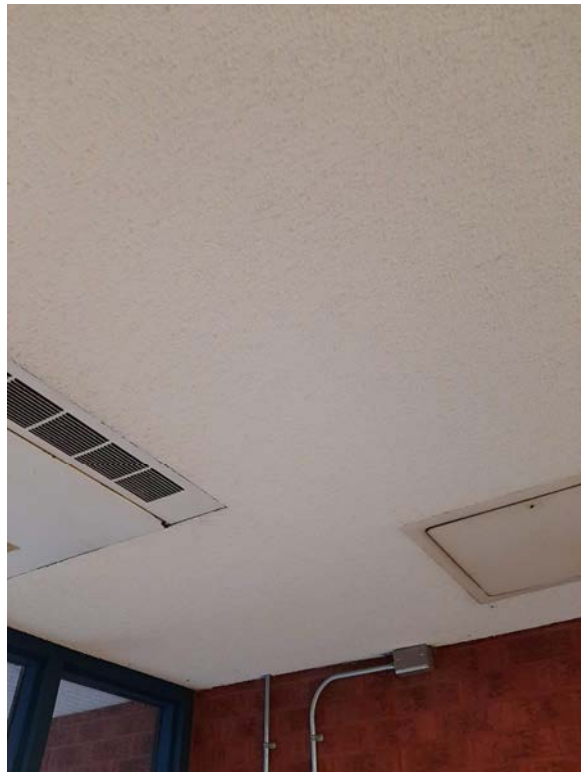
Photograph No. 4 – Texture coat ceilings were observed within the lobby and main entrance vestibule. The texture coat was sampled (S03A,B,C) and found to be non-asbestos.

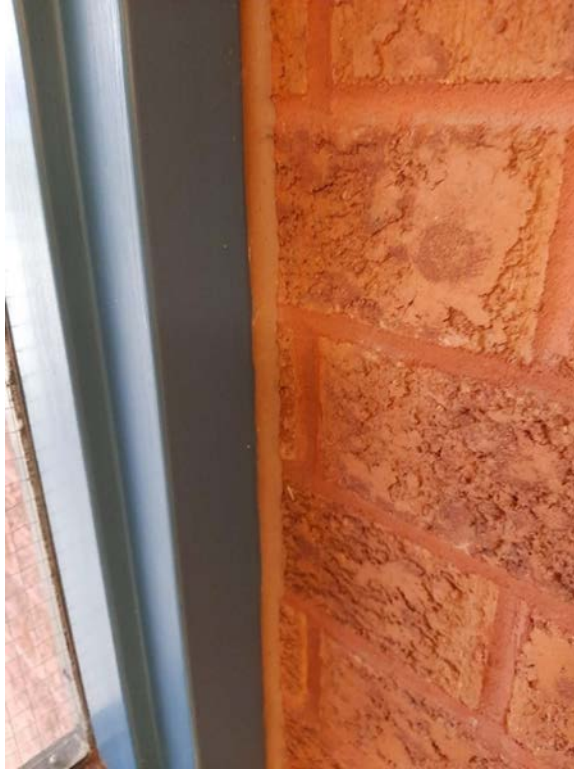
Photograph No. 5 – Brown sealant was observed around the perimeter of exterior doors. The sealant was sampled (S01A,B,C) and found to be non-asbestos. The sealant was also sampled for PCBs (PCB2) and is non-PCB.
