DESIGNATED SUBSTANCES AND HAZARDOUS BUILDING MATERIALS ASSESSMENT REPORT

**Renovation Project
Ground, 7th, 9th, 10th and 11th Floors
Centre for Addiction and Mental Health (CAMH)
250 College Street
Toronto, Ontario
M5T 1R8**

Safetech Project Number: 3220708

**Date of Site Work: October 14, 2022
Date of Issue: October 27, 2022**

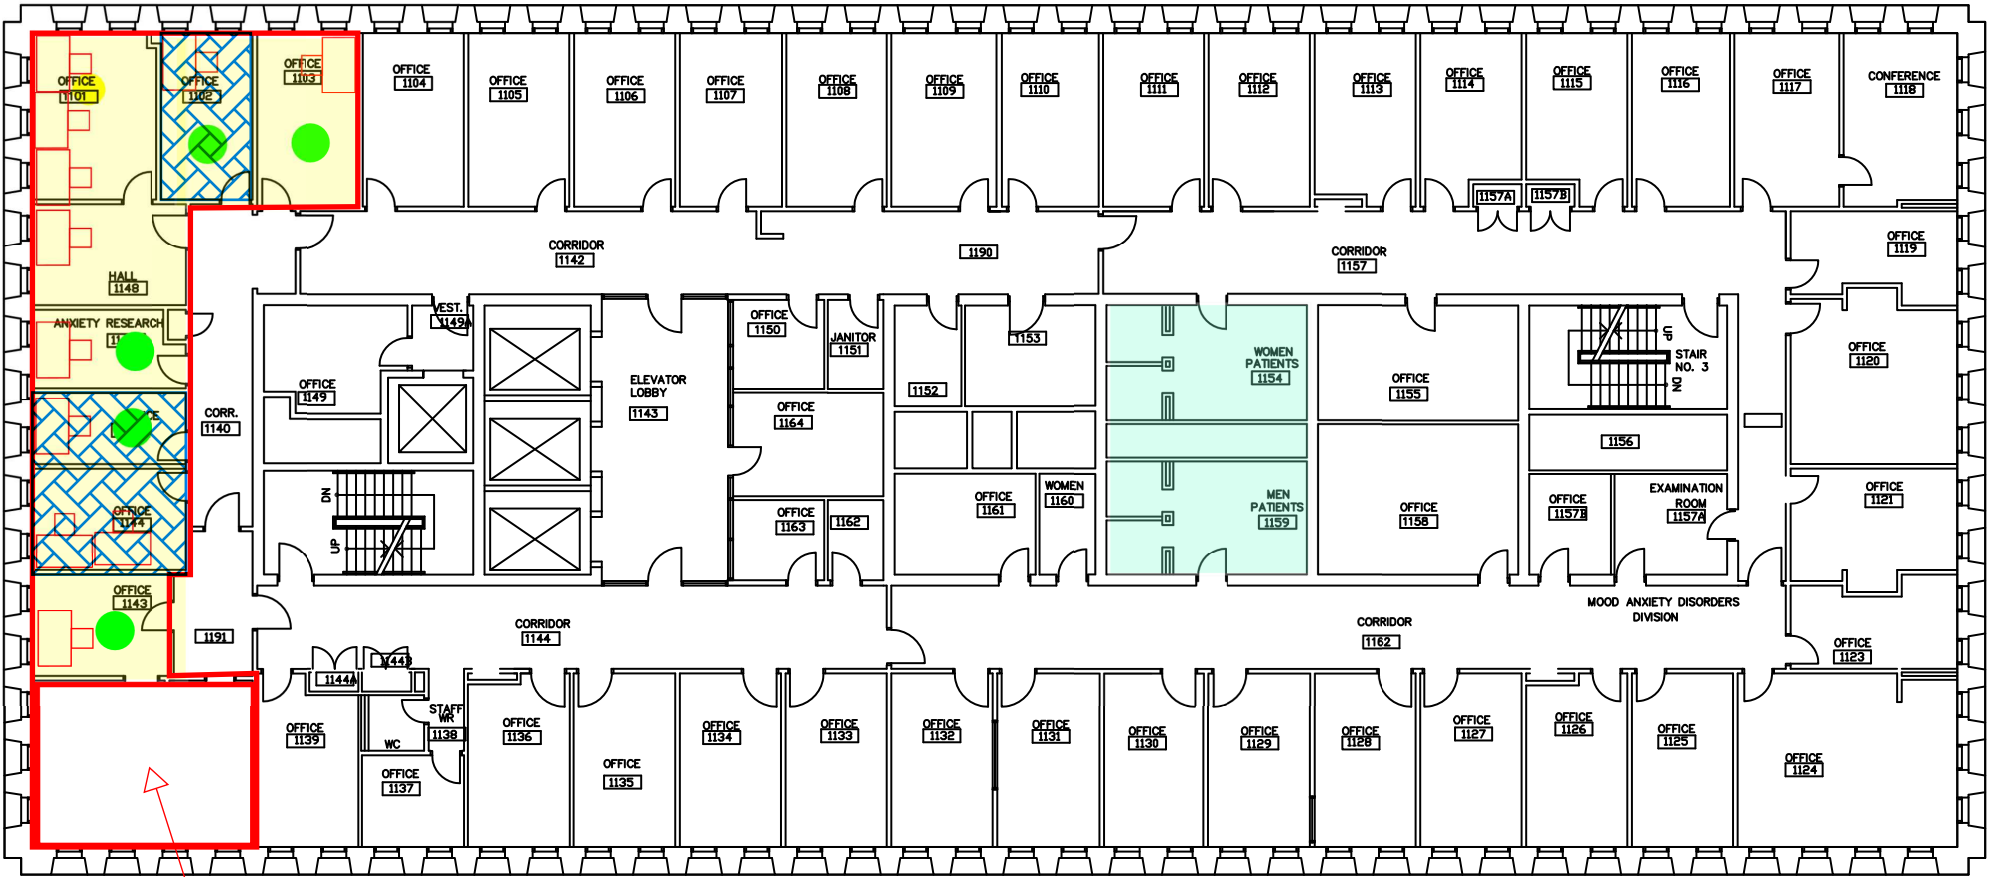
PLASTER FINISHES THROUGHOUT ARE ASBESTOS-CONTAINING

DRYWALL JOINT COMPOUND ASSOCIATED WITH DRYWALL FINISHES THROUGHOUT ARE ASBESTOS-CONTAINING
