**C13-31-23 - General Contractor Required for Victoria Park Field House Renovations**

**ADDENDUM 2**

## **Hazardous Building Materials Assessment (Pre-construction)**

Victoria Park  
500 King Street West, Hamilton,  
Ontario

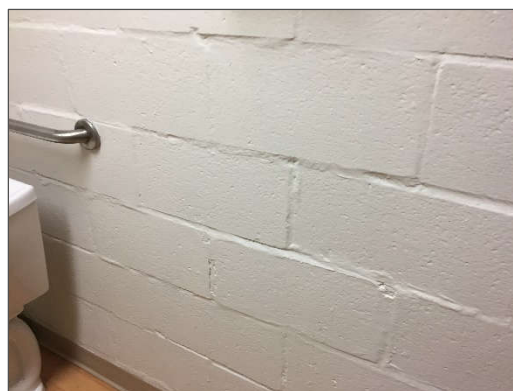
Photo 2

| Sample Number and Photo # | Colour, Substrate Description | Sample Location | Lead (%) |
|---|---|---|---|
| L0002, photo 2 | White on masonry wall | Washroom (Location 5) | 6.2 |

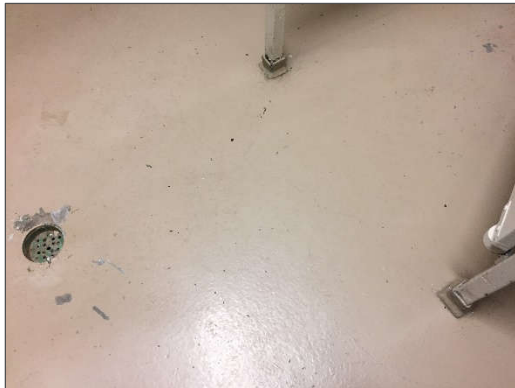
Photo 3

| Sample Number and Photo # | Colour, Substrate Description | Sample Location | Lead (%) |
|---|---|---|---|
| L0003, photo 3 | Beige on concrete floor | Woman's Washroom (Location 7) | <0.0069 |

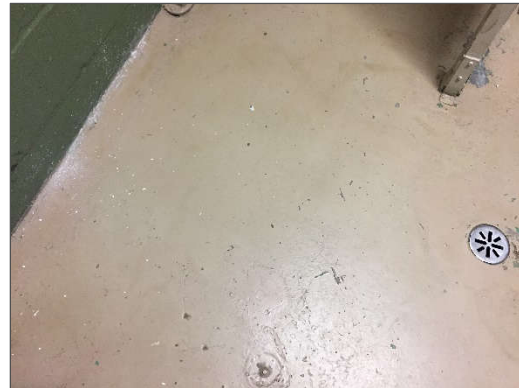
Photo 4

| Sample Number and Photo # | Colour, Substrate Description | Sample Location | Lead (%) |
|---|---|---|---|
| L0004, photo 4 | Beige on concrete floor | Men's Washroom (Location 6) | 0.14 |

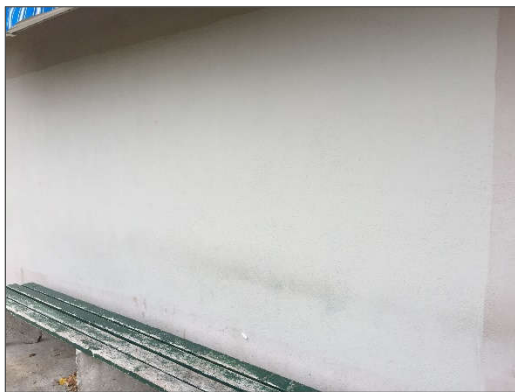
Photo 5

| Sample Number and Photo # | Colour, Substrate Description | Sample Location | Lead (%) |
|---|---|---|---|
| L0005, photo 5 | Beige on concrete wall | Exterior (Location 8) | <0.0055 |
