**REVISED**  
**Hazardous Building  
Materials Assessment**

4267 Bridge Street, Niagara  
Falls, Ontario

**The Regional Municipality of  
Niagara**

December 20, 2018

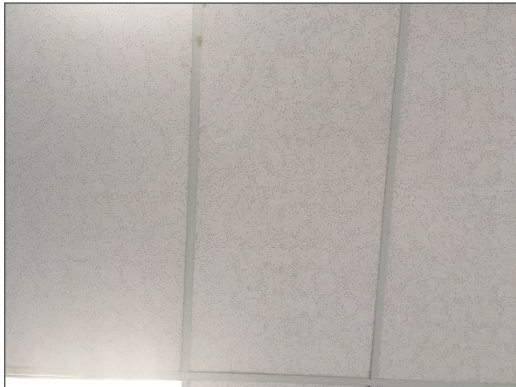
| <b>Size, Type, Pattern, Photo #</b> | <b>Locations</b> | <b>Sample Number or Date Code</b> | <b>Asbestos Type</b> |
|--|--|---|---|
| 24"x48", lay-in, pinhole, Photo 1 | Waiting Room, Location 1 | 0010A-C | None Detected |

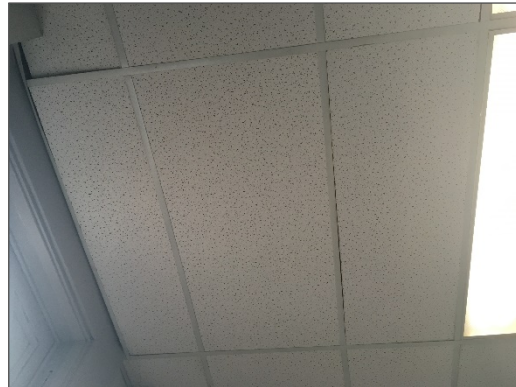
| <b>Size, Type, Pattern, Photo #</b> | <b>Locations</b> | <b>Sample Number or Date Code</b> | <b>Asbestos Type</b> |
|--|--|---|---|
| 24"x48", lay-in, large fleck, Photo 2 | Women's Washroom, Location 3<br>Men's Washroom, Location 8 | 03/22/2006 | None-asbestos |

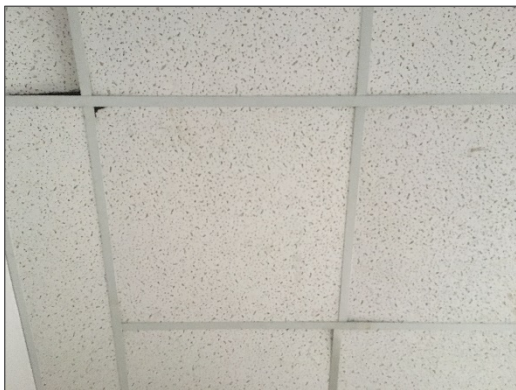
| <b>Size, Type, Pattern, Photo #</b> | <b>Locations</b> | <b>Sample Number or Date Code</b> | <b>Asbestos Type</b> |
|--|--|---|---|
| 24"x48", lay-in, dense fleck and pinhole, Photo 3 | Ticket Office, Location 2 | 10/29/2002 | None-asbestos |

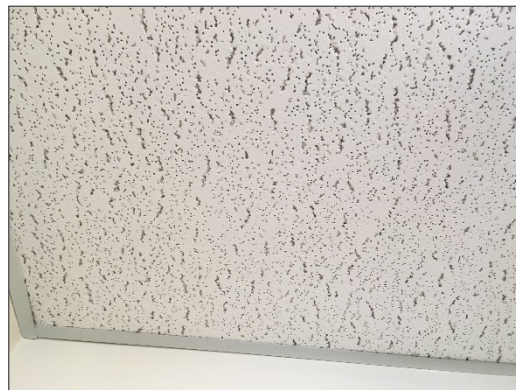
| <b>Size, Type, Pattern, Photo #</b> | <b>Locations</b> | <b>Sample Number or Date Code</b> | <b>Asbestos Type</b> |
|--|--|---|---|
| 24"x48", lay-in, width-wise fissure and pinhole, Photo 4 | Baggage Room, Location 4<br>East Stairs, Location 7<br>Washroom, Location 9<br>West Stairs, Location 13<br>Open Area, Location 14<br>Corridor, Location 16<br>Lounge, Location 18<br>Lunch Room, Location 19<br>Washroom, Location 20<br>Washroom, Location 21<br>Janitor, Location 22 | 0011A-C | None Detected |

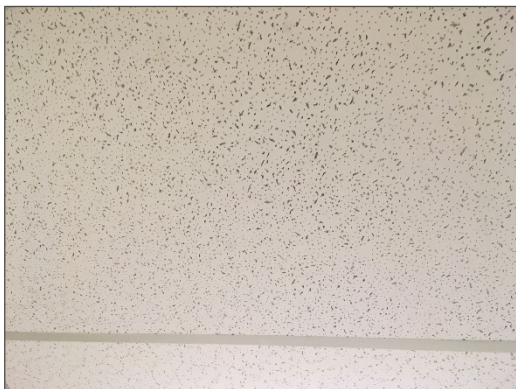
| <b>Size, Type, Pattern, Photo #</b> | <b>Locations</b> | <b>Sample Number or Date Code</b> | <b>Asbestos Type</b> |
|--|--|---|---|
| 24"x48", lay-in, fleck, Photo 5 | VIA OTS, Location 10<br>VIA Train Operations, Location 11<br>VIA Office, Location 12 | 03/28/2010 | None Detected |

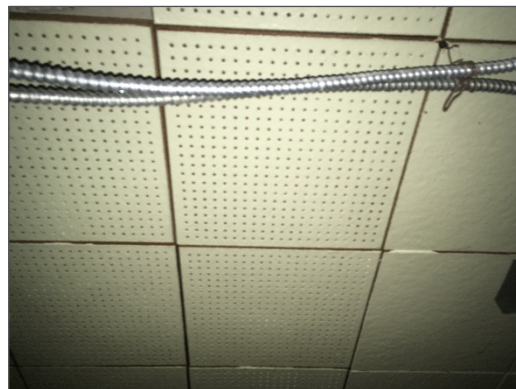
| <b>Size, Type, Pattern, Photo #</b> | <b>Locations</b> | <b>Sample Number or Date Code</b> | <b>Asbestos Type</b> |
|--|--|---|---|
| 12"x12", glued-on, ordered pinhole, Photo 6 | VIA OTS, Location 10 | Tile - Wood fibre<br>Mastic - 0005A-C | Non-asbestos<br>None Detected |

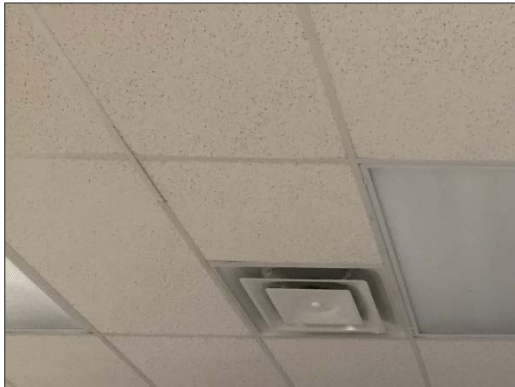
| <b>Size, Type, Pattern, Photo #</b> | <b>Locations</b> | <b>Sample Number or Date Code</b> | <b>Asbestos Type</b> |
|--|--|---|---|
| 24"x48", lay-in, small fleck with pinhole, Photo 7 | Customs Area, Location 24 | 05/15/2018 | None-asbestos |

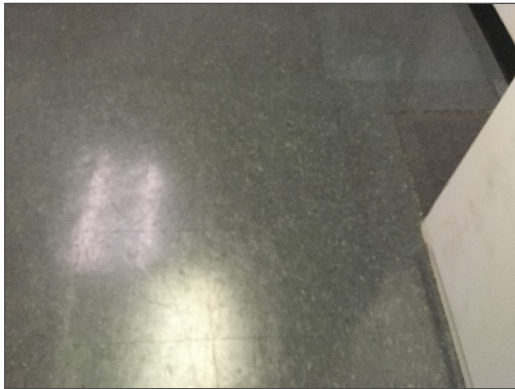
| Size, Pattern, Colour and Photo # | Locations | Sample Number | Asbestos Type (tile) | Asbestos Type (mastic) |
|--|---|---|---|---|
| 12"x12", dark grey flakes, Photo 1 | Ticket Office, Location 2<br>Corridor, Location 16 | 0006A-C | None Detected | None Detected |

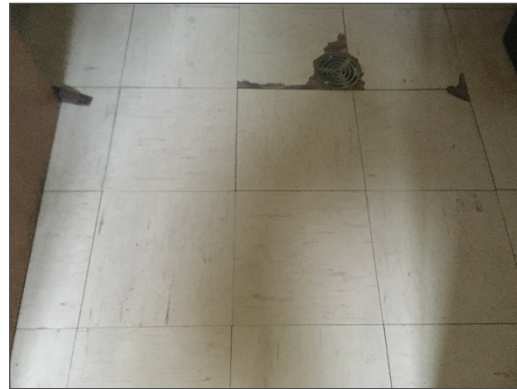
| Size, Pattern, Colour and Photo # | Locations | Sample Number | Asbestos Type (tile) | Asbestos Type (mastic) |
|--|---|---|---|---|
| 12"x12", white with brown lines, Photo 2 | East Stairs, Location 7<br>Washroom, Location 9<br>West Stairs, Location 13<br>Washroom, Location 20<br>Washroom, Location 21<br>Janitor, Location 22 | 0007A-C | None Detected | None Detected |

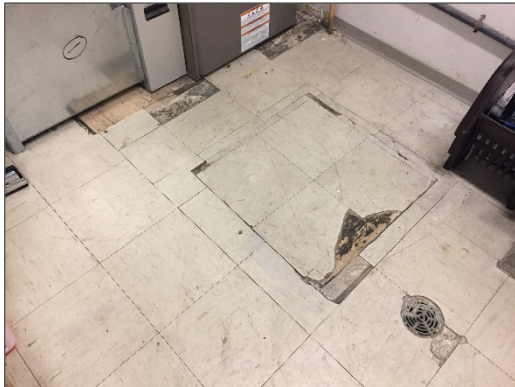
| Size, Pattern, Colour and Photo # | Locations | Sample Number | Asbestos Type (tile) | Asbestos Type (mastic) |
|--|---|---|---|---|
| 12"x12", cream with brown streak, Photo 5 | Furnace Room, Location 25 | 0018A-C | None Detected | None Detected |

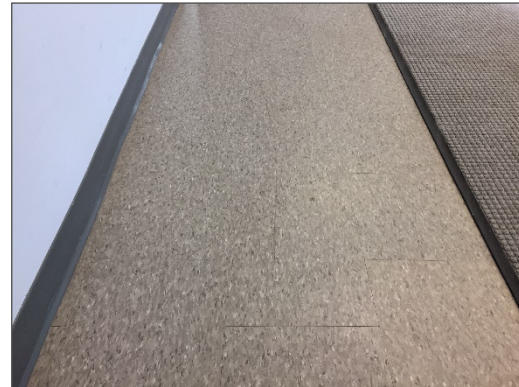
| Size, Pattern, Colour and Photo # | Locations | Sample Number | Asbestos Type (tile) | Asbestos Type (mastic) |
|--|---|---|---|---|
| 12"x12", grey with light grey fleck, Photo 6 | Customs Area, Location 24<br>Washroom, Location 26<br>Telephone Room, Location 27 | 0019A-C | None Detected | None Detected |

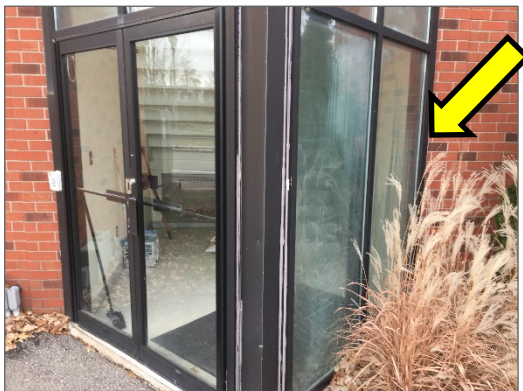
| Colour, Type, Photo # | Locations (Quantity) | Sample Number | Asbestos Type |
|---|---|---|---|
| Brown, caulking, Photo 3 | Located between the brick and metal window frames within the East Stairs, Location 7 and 17 | 0016A-C | None Detected |
