**VIA RAIL CANADA**

**Asbestos Management Program**

Niagara Falls Train Station

**Re-Inspection Report (2008)**

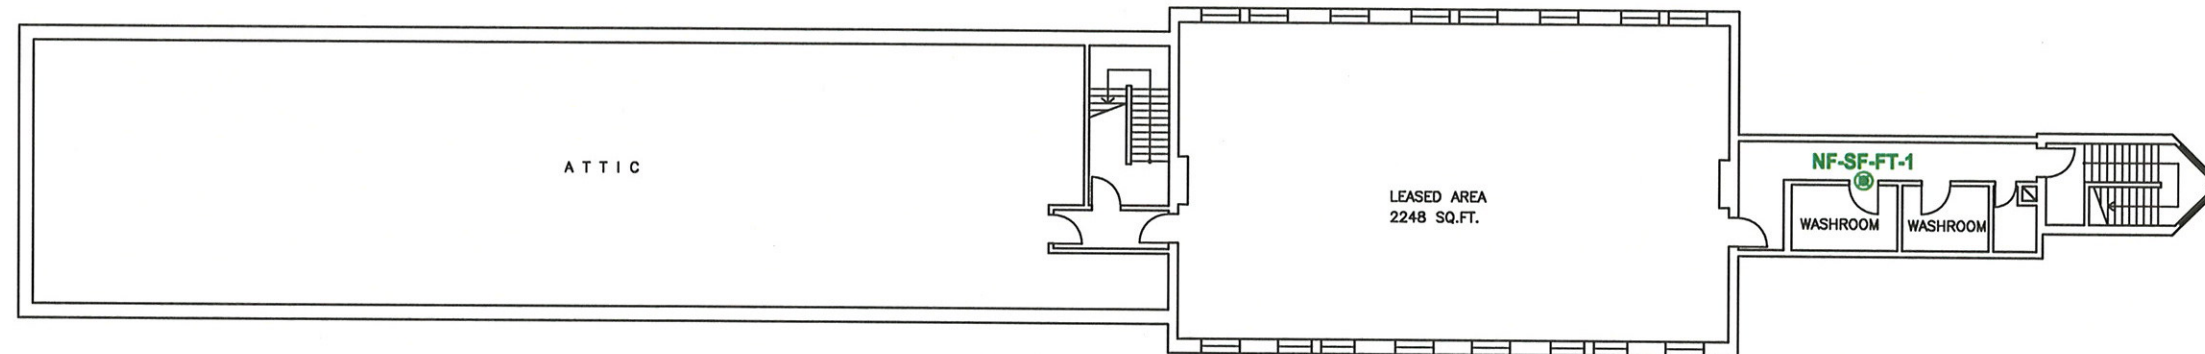
**SECOND FLOOR PLAN**

**NF-FF-CI-1** LOCKER ROOM CEILING PLASTER AND CEMENT

**NF-FF-CG-1** LOCKER ROOM CEILING TILES ADHESIVES NO ASBESTOS
