CCTV INVESTIGATION REPORT

Project #51842 Niagara Falls VIA

CCTV Report for – VIA rail station 4267 Bridge St,

Niagara Falls, ON

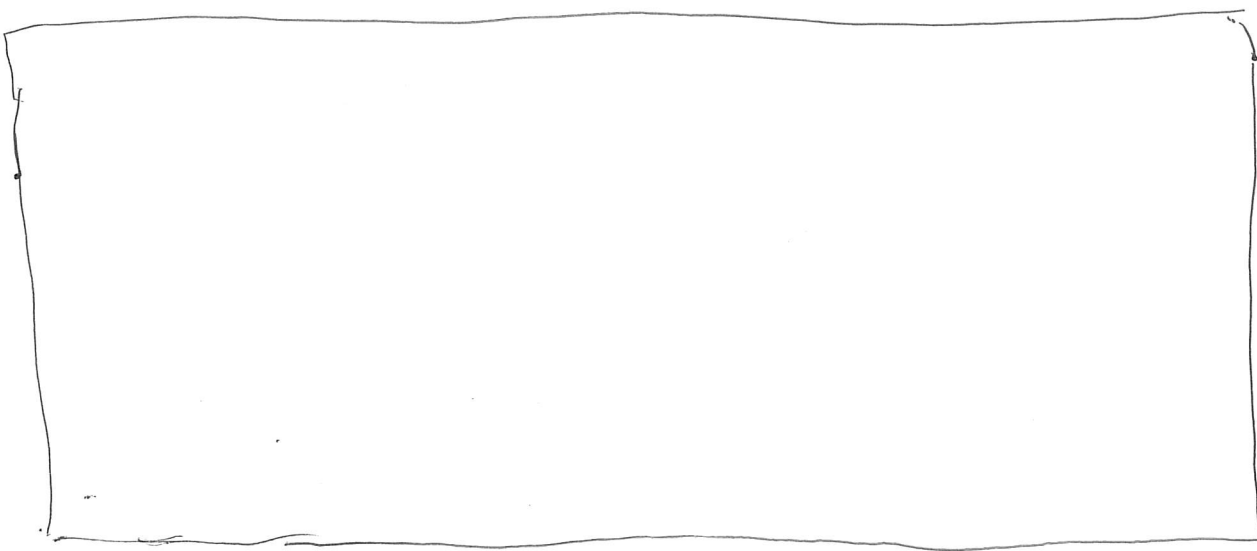
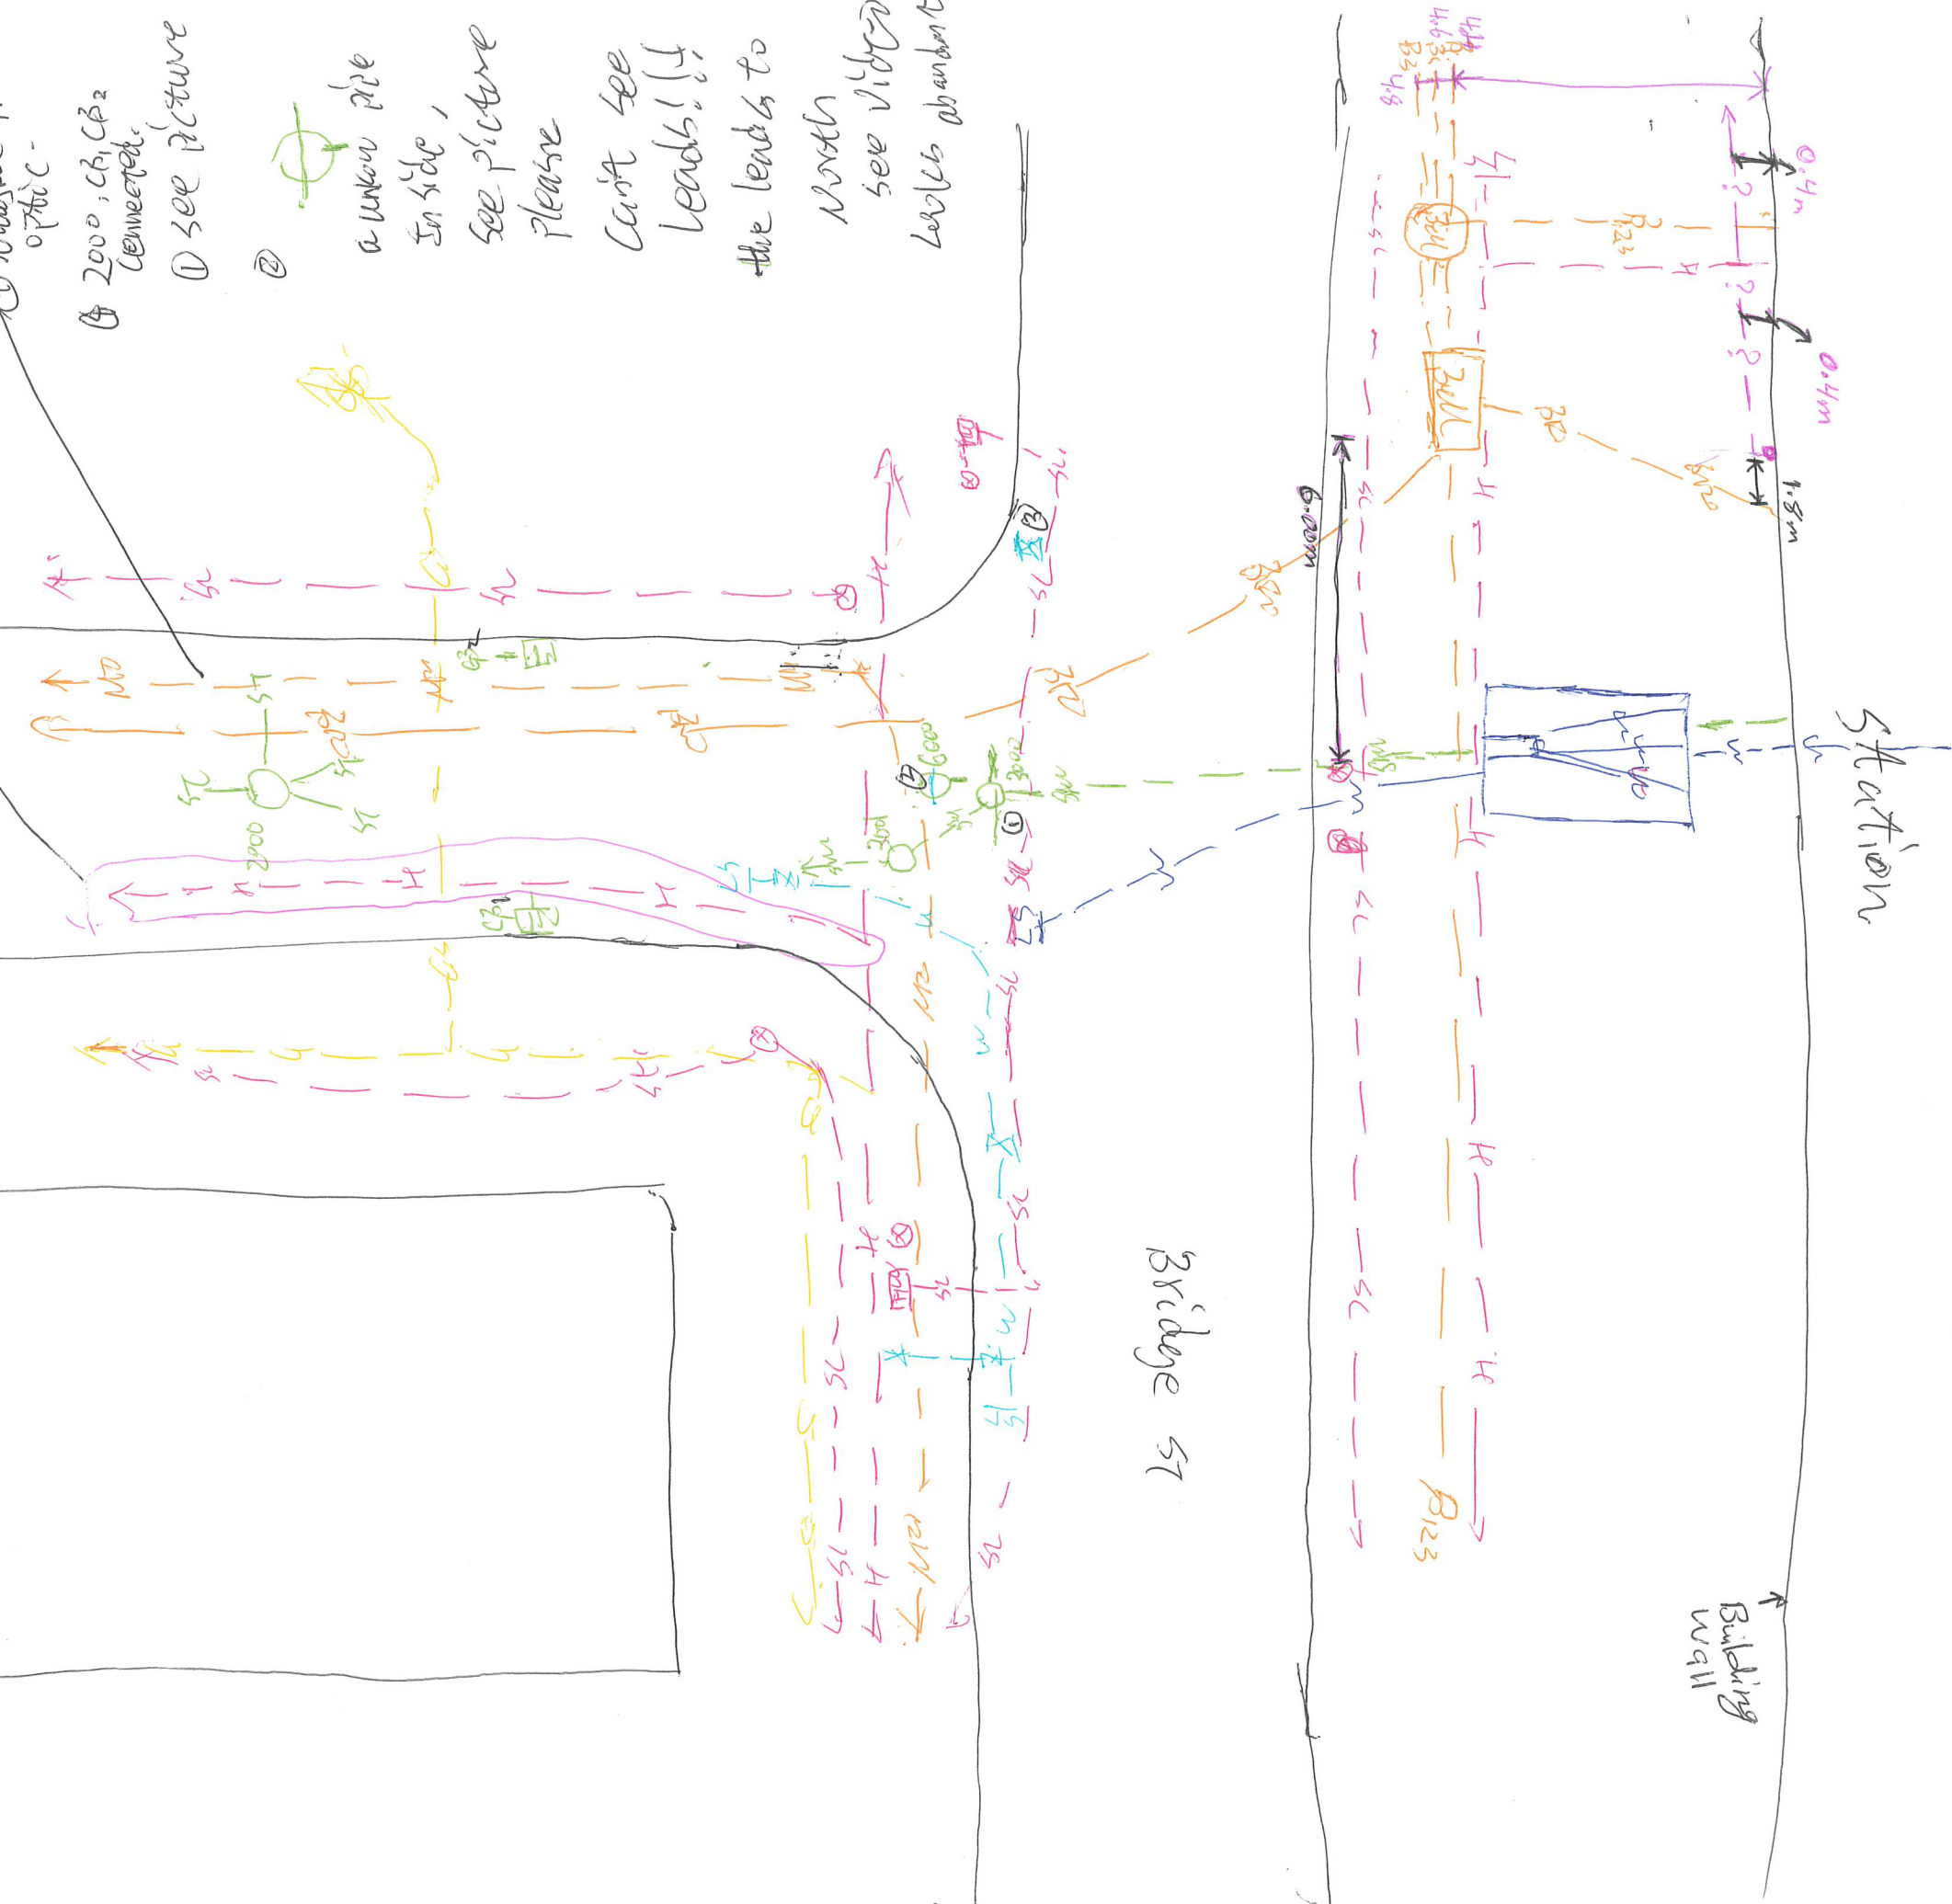
No Circled segment
Hor connection B.W. can't open

- ① Master Fibn optic
- ② 2000, CP1, CP2 Connected
- ③ see picture
- ④ a unknown pipe inside, see picture please
- ⑤ can't see leads!!!
- ⑥ the leads to north see video leads abundant.
