At the request of Tacoma Engineers (the Client), Durham EHS is pleased to provide this report on the designated substance survey (DSS) completed within select locations of the Erin Community Center, 14 Boland Drive, Erin, Ontario (the Site). The DSS was required prior to renovation and was conducted by Durham EHS on March 25th, 2024.

Erin Community Centre, 14 Boland Drive, Erin, ON

Job/Project Name: Erin Community Center

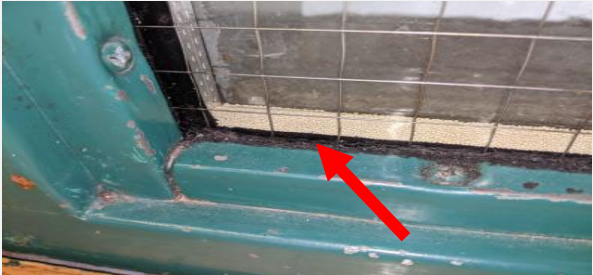
MATERIAL & LOCATION	RECOMMENDATIONS
<p><u>Black Glazing on Interior Windows; Second Floor Multipurpose Room, OPP Office, Ground Floor Main Corridor, 1977 build</u></p> <p>Samples 14A-C, approximately 95 linear meters of non-friable black interior window glazing, contains 2% chrysotile. The glazing was noted in good condition.</p>

<ul style="list-style-type: none"> • Manage in place. If there's potential for disturbance, remove the window glazing prior to renovation. • The window glazing can be removed following Type 1 procedures provided only non-powered hand-tools are used, and the material remains wetted during disturbance.

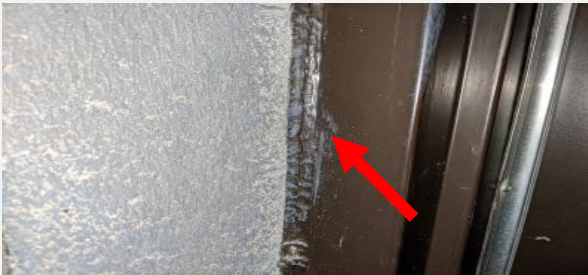
MATERIAL & LOCATION	RECOMMENDATIONS
<p><u>Grey Caulking Around Interior Window and Door Frames; Throughout The Ground Floor, 1977 build</u></p> <p>Samples 15A-C, approximately 50 linear meters of non-friable grey interior caulking around door frames and windows, contains 1% chrysotile. Some sections of the caulking are painted brown. The caulking was noted in good condition.</p>

<ul style="list-style-type: none"> • Manage in place. If there's potential for disturbance, remove the grey interior door and window caulking (some sections painted brown) prior to renovation. • The caulking can be removed following Type 1 procedures provided only non-powered hand-tools are used, and the material remains wetted during disturbance.
<p><u>White Caulking on Roof Flashing; East and West Roof, 1977 build</u></p> <p>Samples 18A-C, approximately 12 linear meters of non-friable white caulking on roof flashing contains 1% chrysotile. The caulking was noted in good condition.</p>
