Hazardous Building Materials Assessment (Pre-Construction)

Gym Renovations
Rosedale Elementary School
25 Erindale Avenue, Hamilton,
Ontario

March 28, 2024

Pinchin File: 336572.005

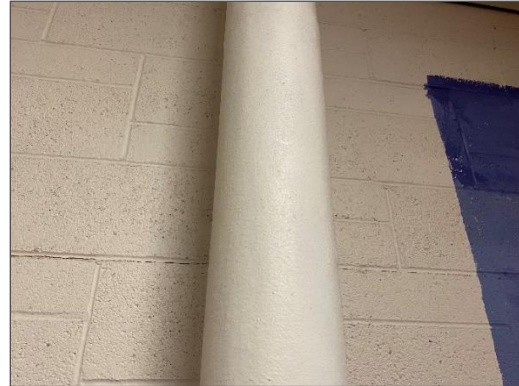
Photo 2

A white corrugated paper insulation (trade name Aircell), containing asbestos, is present on straight sections of pipes in the Stage (samples S0032A-C, photo 2).
