Asbestos Assessment

Allendale
185 Ontario Street South, Milton,
ON, L9T 2M4

Halton Region
1151 Bronte Road
Oakville, Ontario, L6M 3L1

September 25, 2023

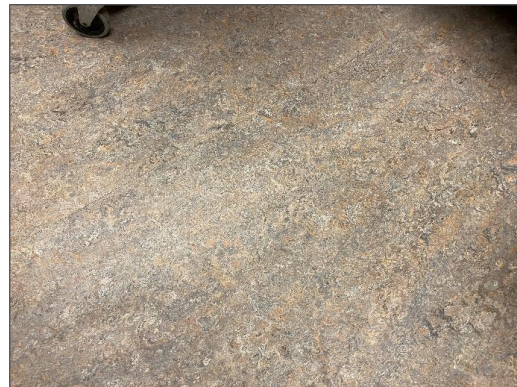
Photo 2

Pattern, and Number	Colour Photo	Sample Locations	Sample Number	Asbestos Type	Asbestos Type (Adhesive)
Beige with sparkles, photo 1		Preparation Kitchen, Laundry Room / Office (Locations 8 and 15)	S0008A-C	None detected	None detected
Multi-colour wave pattern, photo 2		Storage (Location 21)	S0016A-C	None detected	N/A
Green wave pattern, photo 3		Storage (Location 22)	S0017A-C	None detected	None detected
Wood style, photo 4		Reception and Corridors, Cafeteria (Locations 26 and 27)	S0021A-C	None detected	None detected

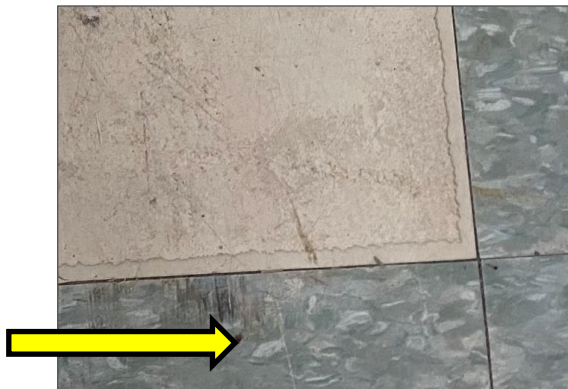
Photo 1

Size, Pattern, Colour	Sample Locations	Sample Number	Asbestos Type (tile)	Asbestos Type (mastic)
12"x12", light blue with white fleck, photo 1	Storage, Garage Bays and Corridor (Location 3, 4 and 10)	S0006A-C	None detected	None detected
12"x12", dark blue	Storage (Location 13)	S0007A-C	None detected	None detected
12"x12", beige peel and stick (3 layers)	Corridor (Location 10)	S0011A-C	None detected	N/A
12"x12", brown with light brown and white fleck, photo 2	Corridor (Location 10)	S0012A-C	None detected	None detected
12"x12" grey with brown and white fleck, photo 3	Corridor (Location 10)	S0013A-C	None detected	None detected
12"x12", blue with dark blue and white fleck	Corridor (Location 10)	S0014A-C	None detected	None detected
12"x12", white with black dots/splatter, photo 4	Bronte House (Location 29)	S0024A-C	None detected	None detected
12"x12", grey with beige streaks, photo 5	Stairwells (Location 36)	S0025A-C	None detected	None detected

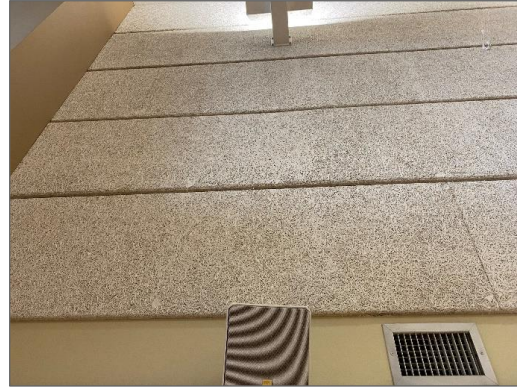
Photo 2

Description	Sample Location (Location #)	Sample Number	Asbestos
Paint on concrete block walls, photo 1	Generator / Electrical / Sprinkler / Workshop, Corridor, Corridor and Staff Washrooms and Changerooms (Location 1, 2, 10 and 19)	S0001A-G	No
Tectum wall covering, photo 2	Cafeteria and Auditorium (Location 27 and 28)	S0022A-C	No
Blue wave pattern epoxy, photo 3	Courtyard Vestibule (Location 33)	S0034A-C	No
