THE REGIONAL MUNICIPALITY OF NIAGARA

PROJECT-SPECIFIC DESIGNATED SUBSTANCES AND HAZARDOUS MATERIALS SURVEY

5853 PEER STREET, NIAGARA FALLS, ON - INTERIOR
RENOVATION PROJECT

JULY 26, 2019

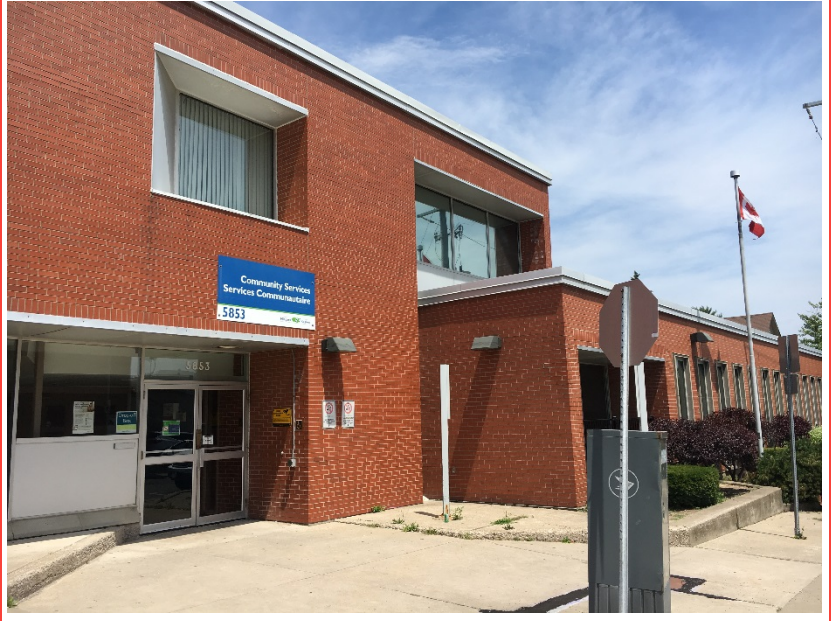
| PHOTO NO. | MATERIAL DESCRIPTION & LOCATION | PHOTO |
|---|---|--|
| 1 | <p>Exterior view of the Niagara Falls SAEO Office located at 5853 Peer Street in Niagara Falls, Ontario.</p> | |
