Attachment C

Designated Substance Survey

Commissioners Transfer Station MRF Building, EXP, February 2023

Re: BRM-22028009-A0 Asbestos Analytical Results - Commissioners Transfer Station
MRF Building - 400 Commissioners Street, Toronto, ON

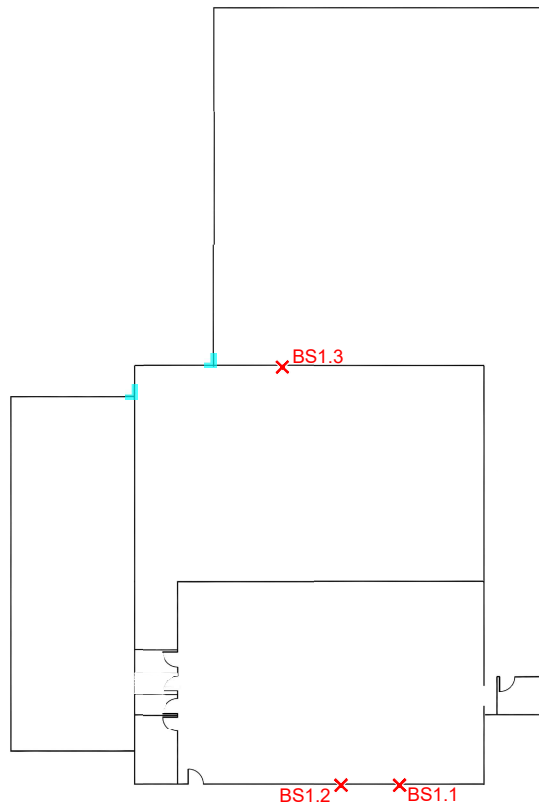
JOB NO: BRM-22028009-A0	DRAWN BY: HY
SCALE: NTS	CHECKED BY: MA
DATE: FEBRUARY 2023	FIG NO.: 2

TITLE AND LOCATION
LOCATION OF IDENTIFIED ACMS
BULK SAMPLING FOR ASBESTOS
MRF BUILDING - 400 COMMISSIONERS STREET
TORONTO, ONTARIO
