**Re: 40 Rossmore Road – William Bolton Arena (Ward 11)**

## Arborist Report

Central Tree Care Ltd. has been retained by the City of Toronto. to provide a professional arborist report for the proposed work at 40 Rossmore Road at the William Bolton Arena.

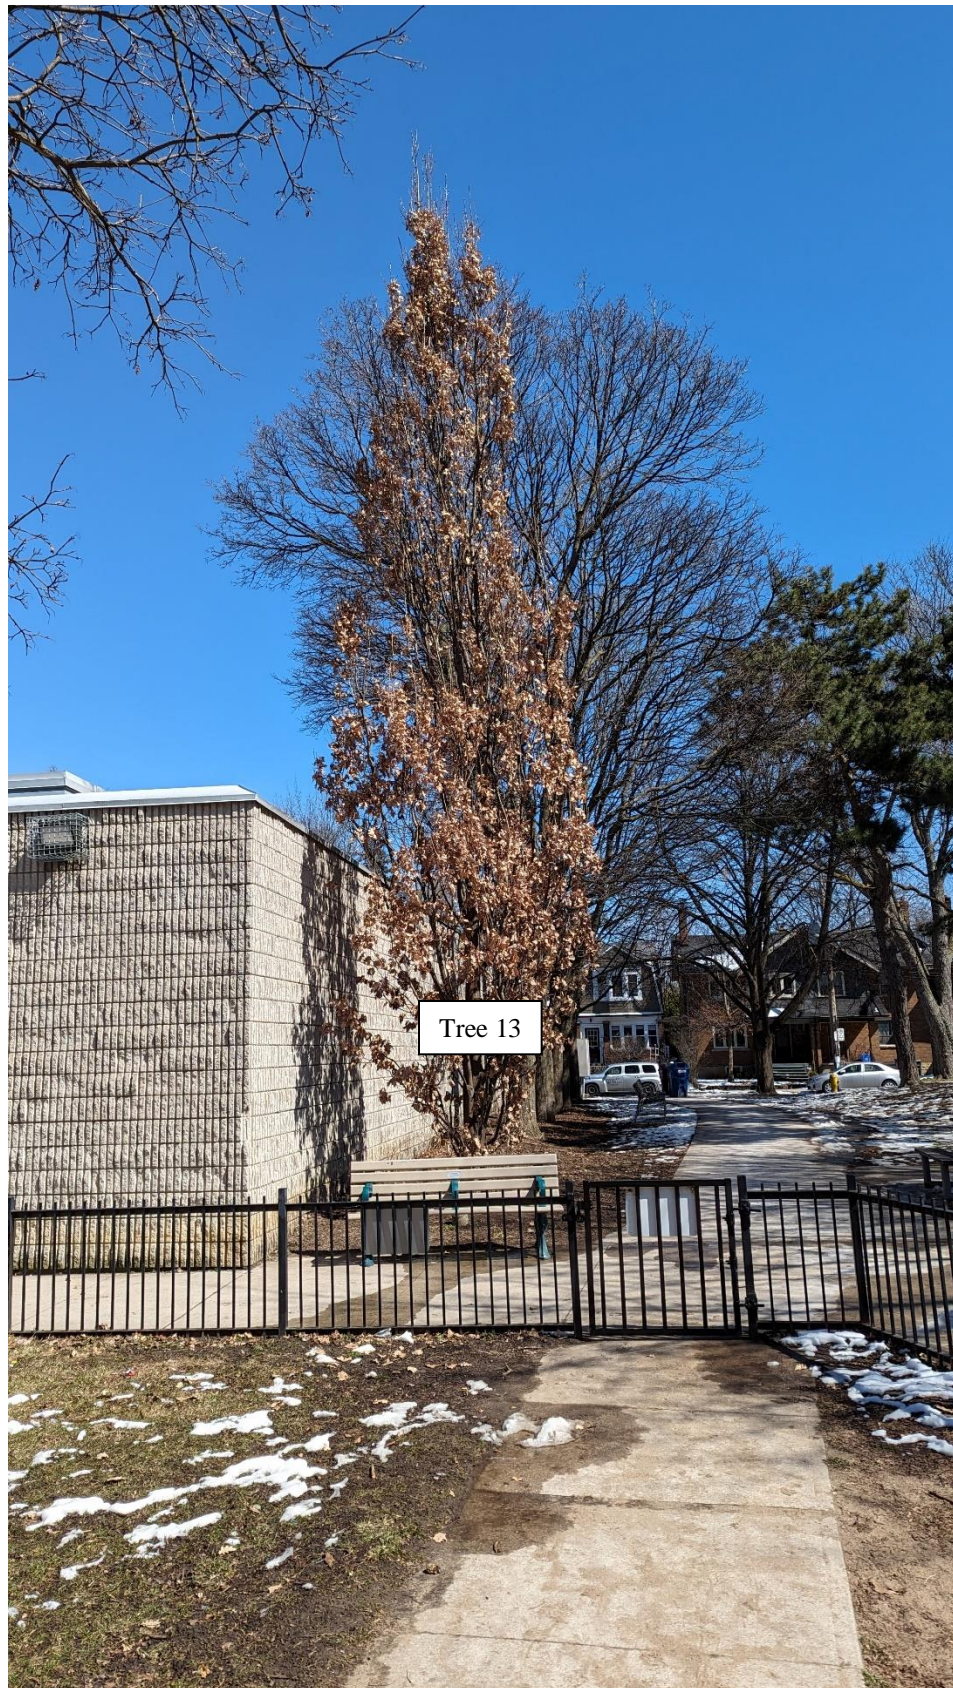
**Figure 23.** South side of the building (facing east).

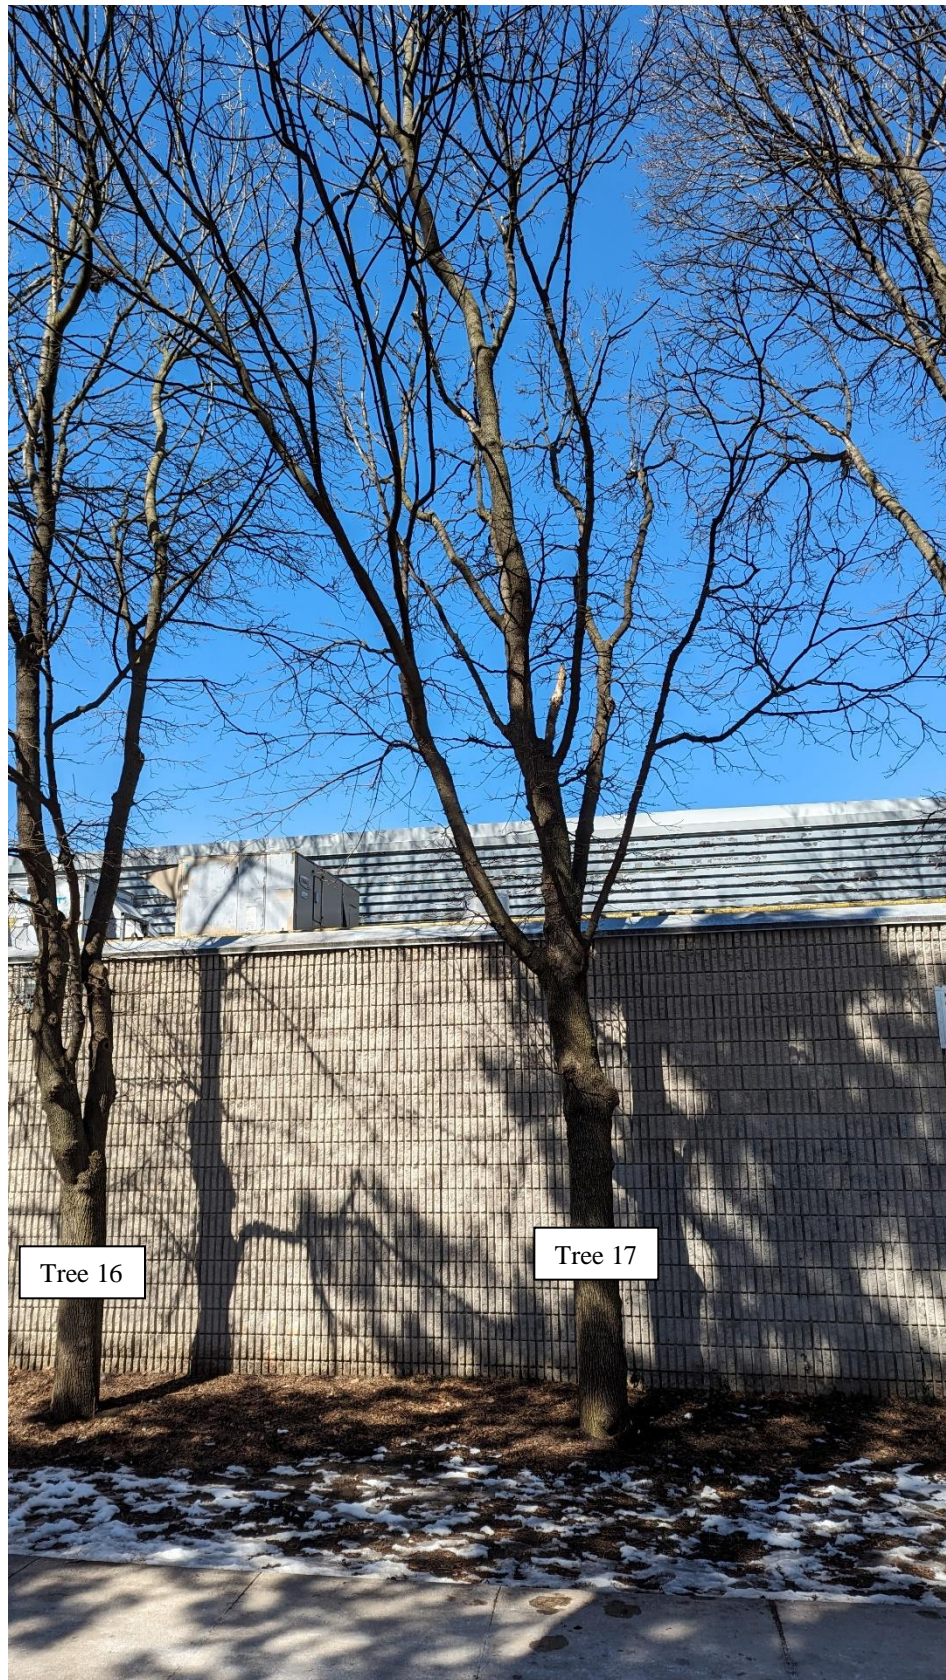
**Figure 30.** Trees 16 and 17 (facing northwest).

*16	Norway maple	<i>Acer platanoides</i>	34.5	2.4	Fair poor	Fair	Co-dominant stem. Decay shadow on both stems. Epicormic growth. Deadwood in canopy of tree. Flat root flare. Tree appears to be suppressed on its east and west side.	Requires pruning	3
*17	Norway maple	<i>Acer platanoides</i>	35	2.4	Fair	Good fair	Deadwood, some lateral branches are dead. Flat root flare. Epicormic growth.	Requires pruning	3
*18	Norway maple	<i>Acer platanoides</i>	46	3	Good fair	Fair	Co-dominant stem on ~3m. Suspected soil cavity in main union. Frost crack on main stem, running vertically up the stem to the main union, crack has reaction wood on it. Epicormic growth. Small deadwood in canopy of tree.	No pruning required	3
