DESIGNATED SUBSTANCES AND HAZARDOUS BUILDING MATERIALS ASSESSMENT REPORT

Demolition Project
1615 Dufferin Street
Toronto, Ontario

Safetech Project Number: 1-3240937

Date of Site Work: December 18, 2024
Date of Issue: January 13, 2025

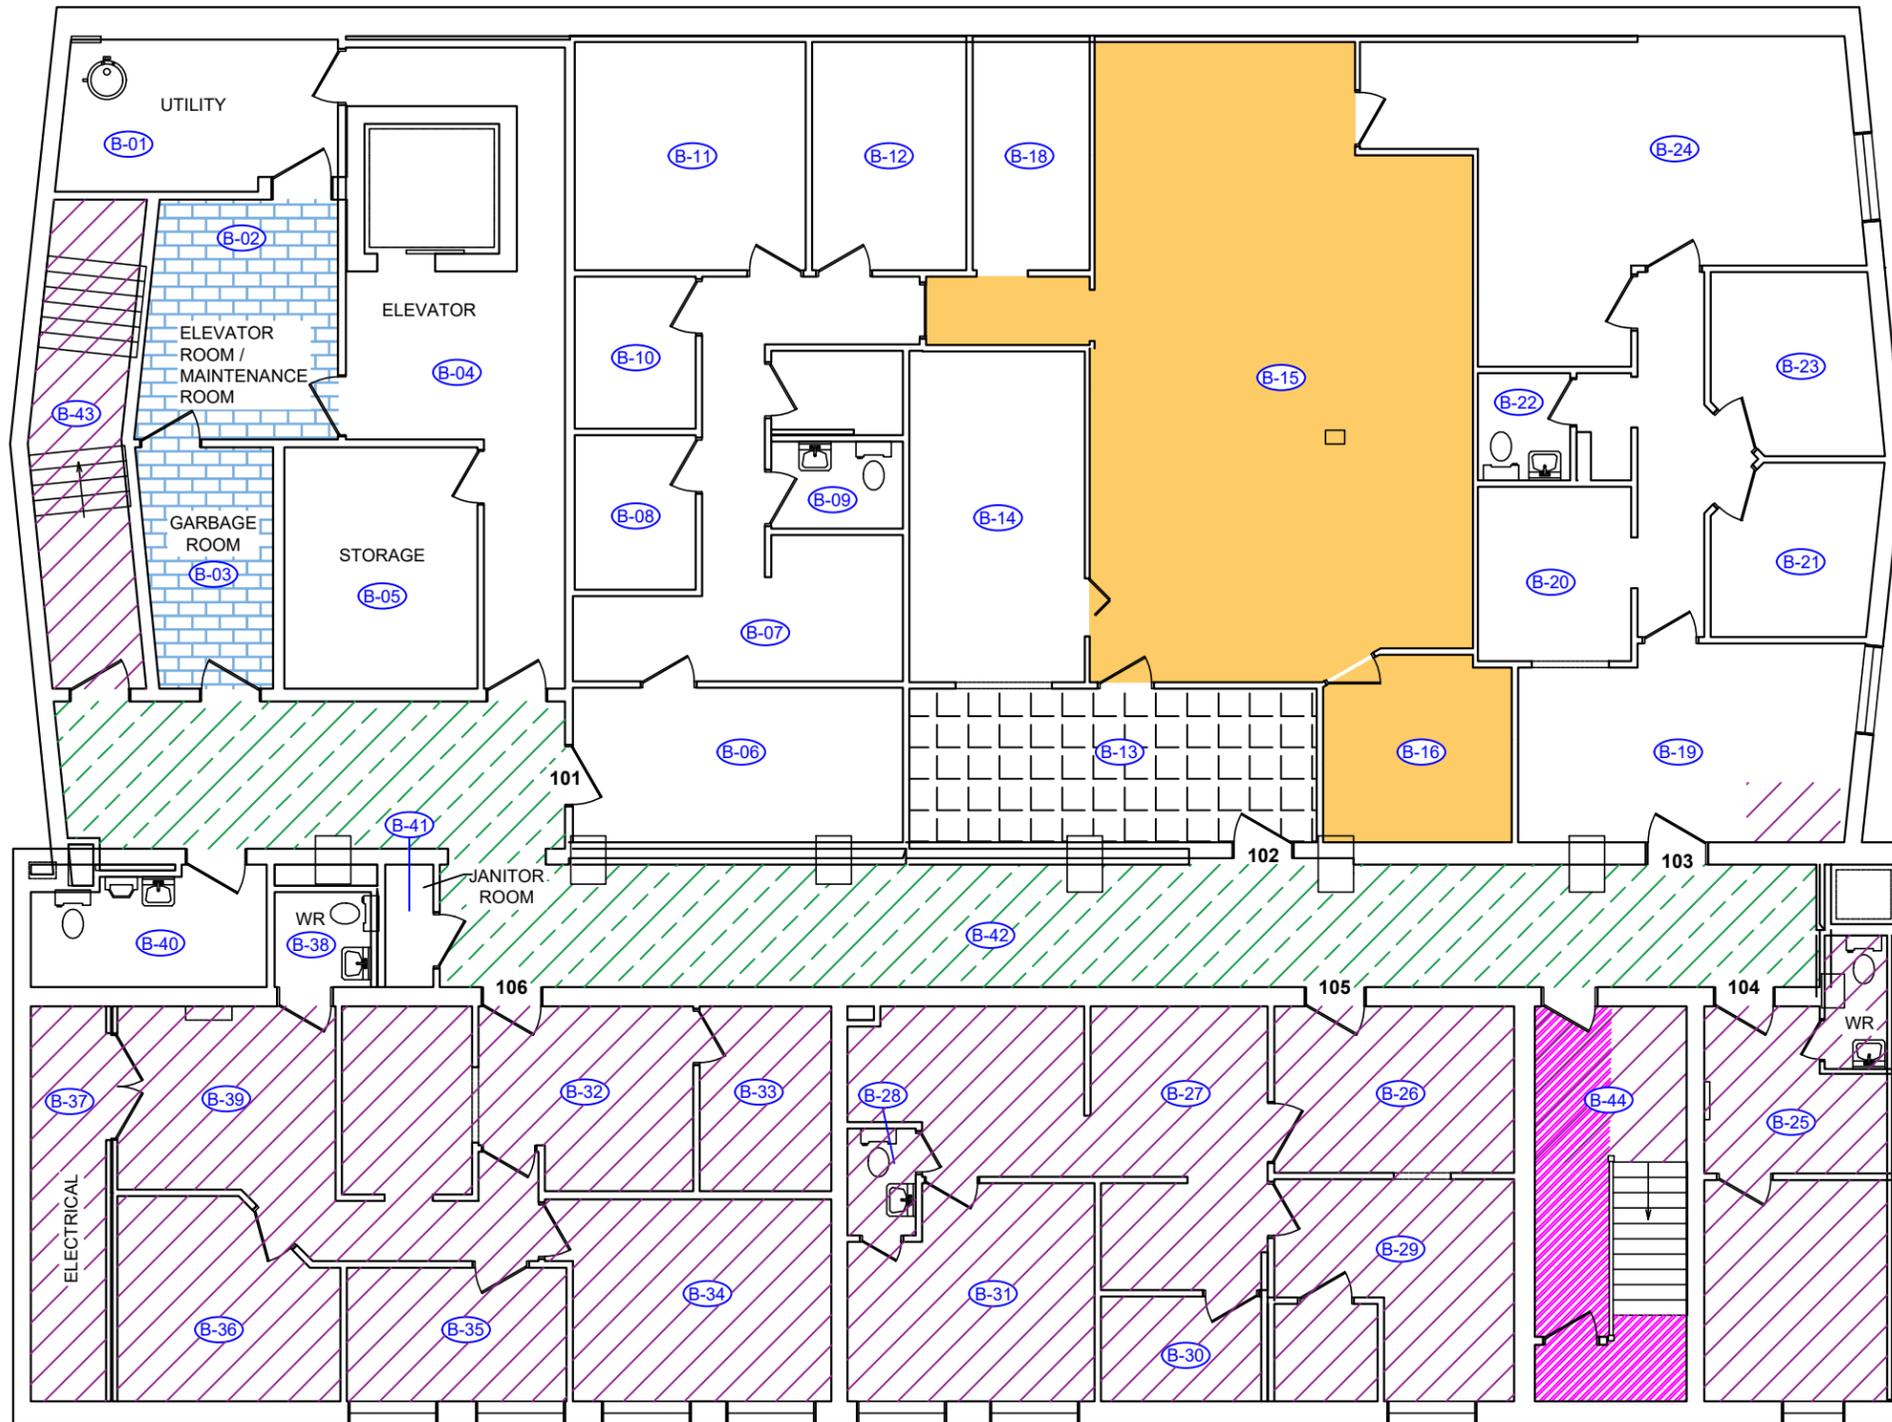
BASEMENT

- 1) Asbestos-containing heat shields were present above ceiling tiles (covered by sprayed fireproofing insulation) in various areas
- 2) Asbestos-containing caulking was identified on interior and exterior areas of the building

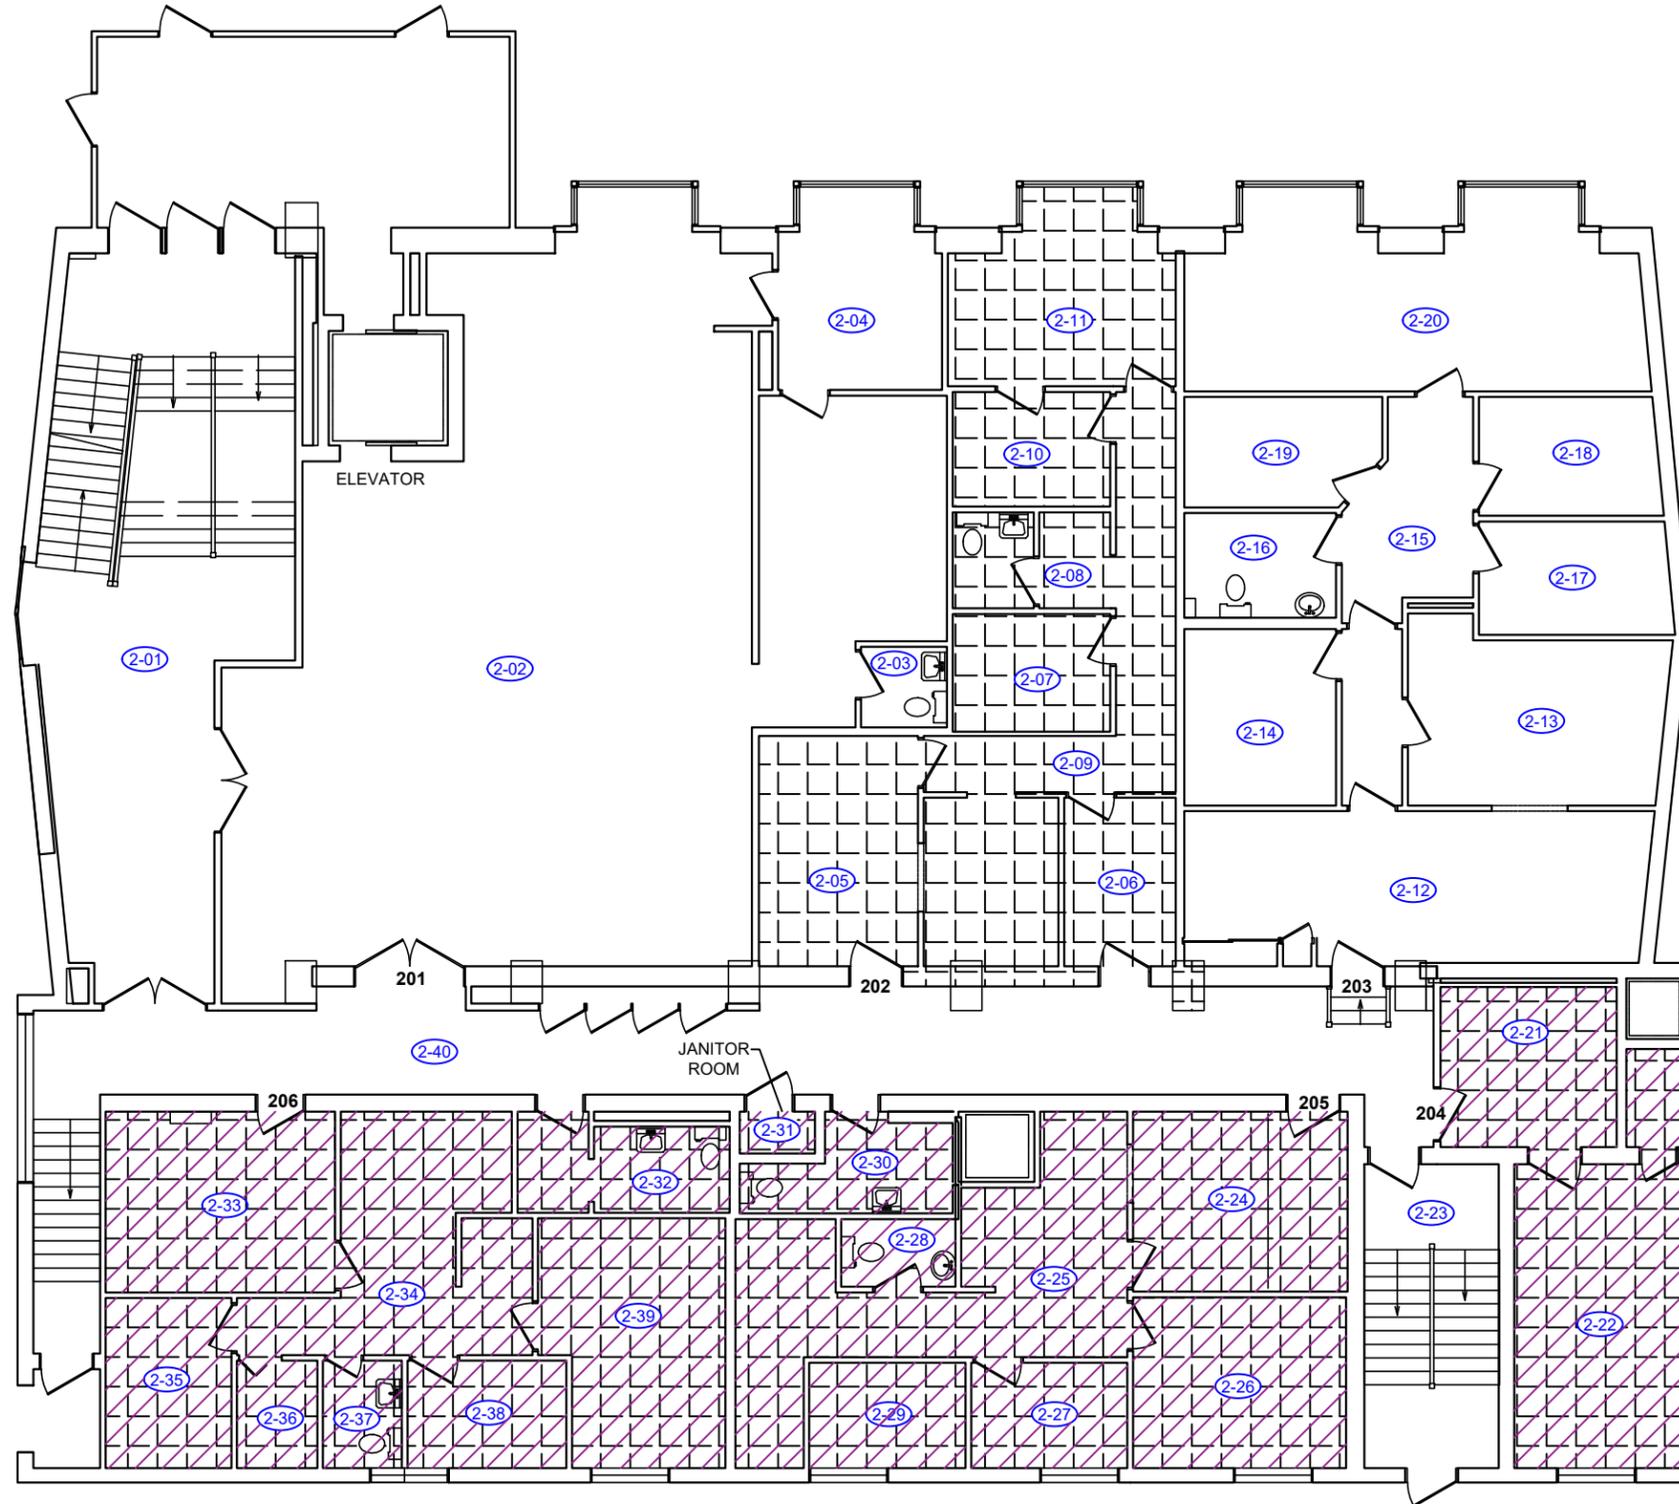
2ND FLOOR

- 1) Asbestos-containing heat shields were present above ceiling tiles (covered by sprayed fireproofing insulation) in various areas
- 2) Asbestos-containing caulking was identified on interior and exterior areas of the building

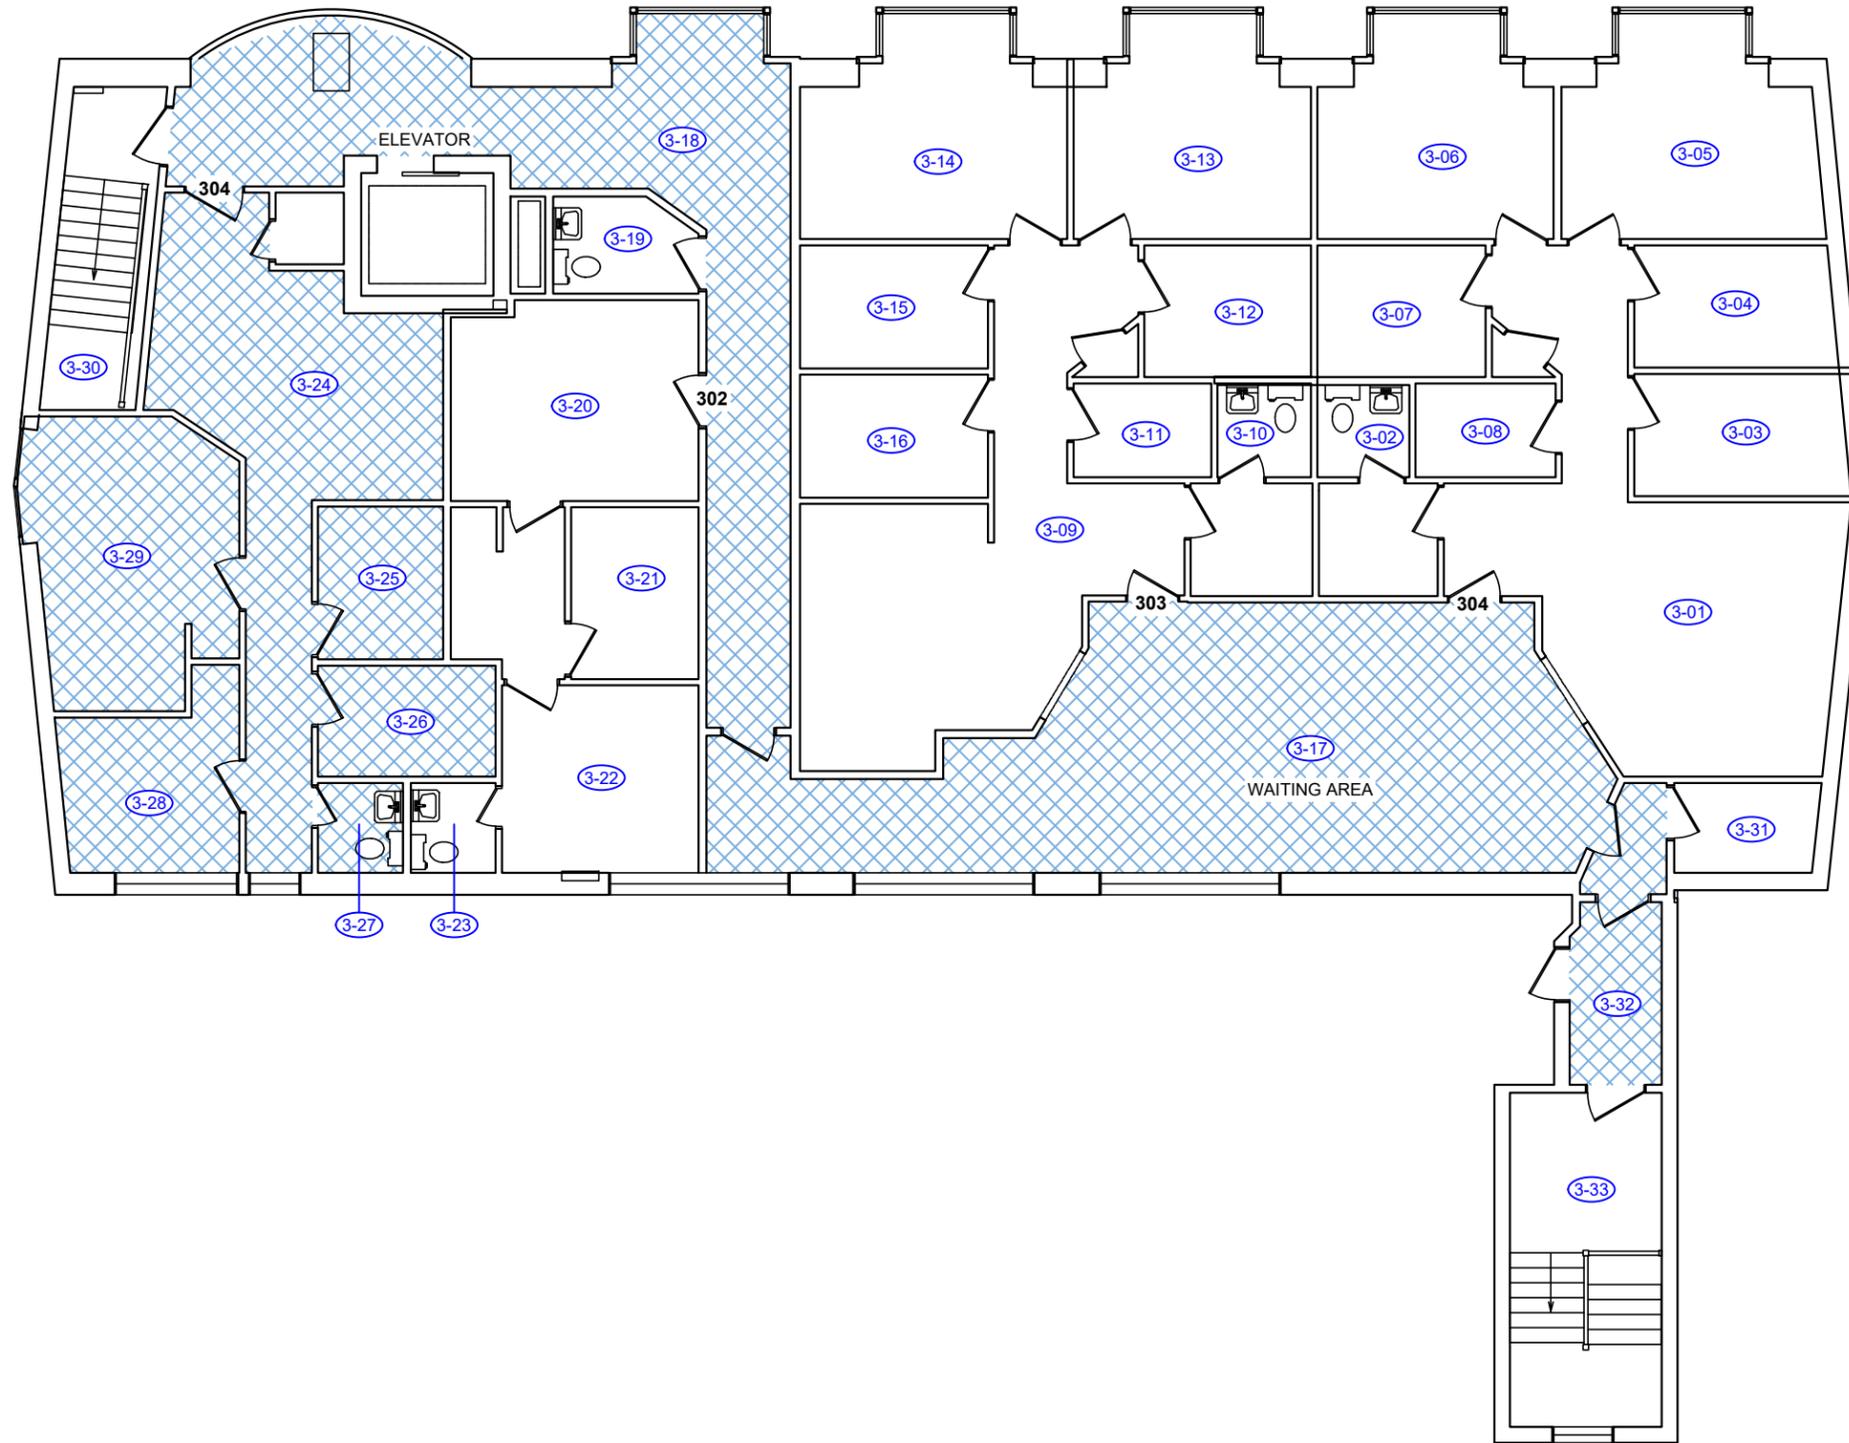
3RD FLOOR
 DEMOLITION PROJECT
 1615 DUFFERIN STREET

- 1) Asbestos-containing heat shields were present above ceiling tiles (covered by sprayed fireproofing insulation) in various areas
- 2) Asbestos-containing caulking was identified on interior and exterior areas of the building
