**TSSS DUFFERIN**

1615 DUFFERIN ST  
TORONTO, ON

**SPECIFICATIONS  
DEMOLITION SCOPE**

Designated Substances and Hazardous Building Materials Assessment Report, dated 13 January 2025, prepared by Safetech Environmental Ltd., Project No. 1-3240937 (90 pages)

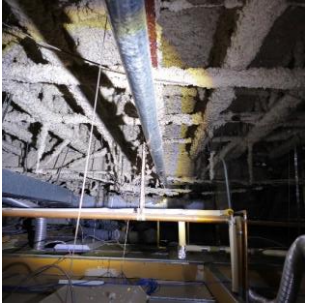
Sprayed and Loose Fill Insulating Materials	Location/Description	
Sprayed Fireproofing	<p>Sprayed fireproofing was observed in the subject building. Based on the existing report the material is considered to be not asbestos-containing.</p> <p>Confirmatory bulk samples were collected during the assessment and results of analysis confirmed that this building material is not asbestos-containing. Refer to sample set 24 in Table 2.</p>

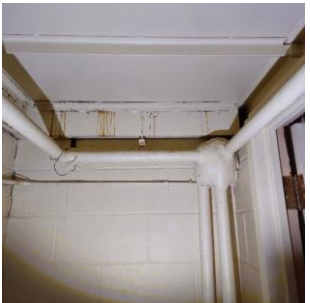
Mechanical Pipe Insulation – Fittings (elbows, valves, tees, hangars, etc.)	<b>Pipe fitting insulation</b> was observed in the subject building. Based on the existing report this building material contains <b>60% chrysotile</b> asbestos. Refer to the location, condition, friability, and estimated quantity in Appendix A.

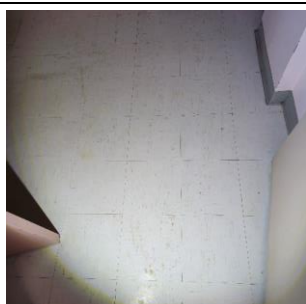
<p>VFT8 - 12"x12" Off-white with Blue Streaks was observed in the subject building. Based on the existing report the material is considered to be not asbestos-containing.</p> <p>Confirmatory bulk samples were collected during the assessment and results of analysis confirmed that this building material is not asbestos-containing. Refer to sample set 43 in Table 2.</p>

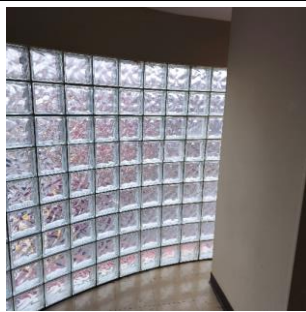
<p>Glass Block Mortar was observed in the subject building. Bulk samples were collected during the assessment and results of analysis confirmed that this building material is not asbestos-containing. Refer to sample set 40 in Table 2.</p>

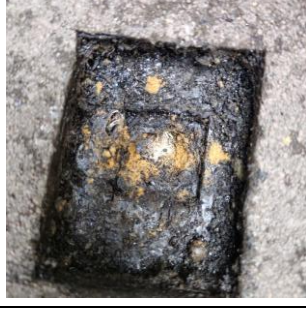
<p>Roof Felt – Old /Underlying were observed in the subject building. Bulk samples were collected during the assessment and results of analysis confirmed that this building material is not asbestos-containing. Refer to sample set 13 in Table 2.</p>

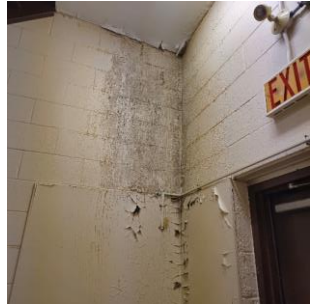
2-23 Stairwell	
<p><b>Findings:</b></p> <ul style="list-style-type: none"> <li>Water damage and mould growth was observed to drywall ceiling and drywall wall and concrete block wall by the door.</li> </ul>

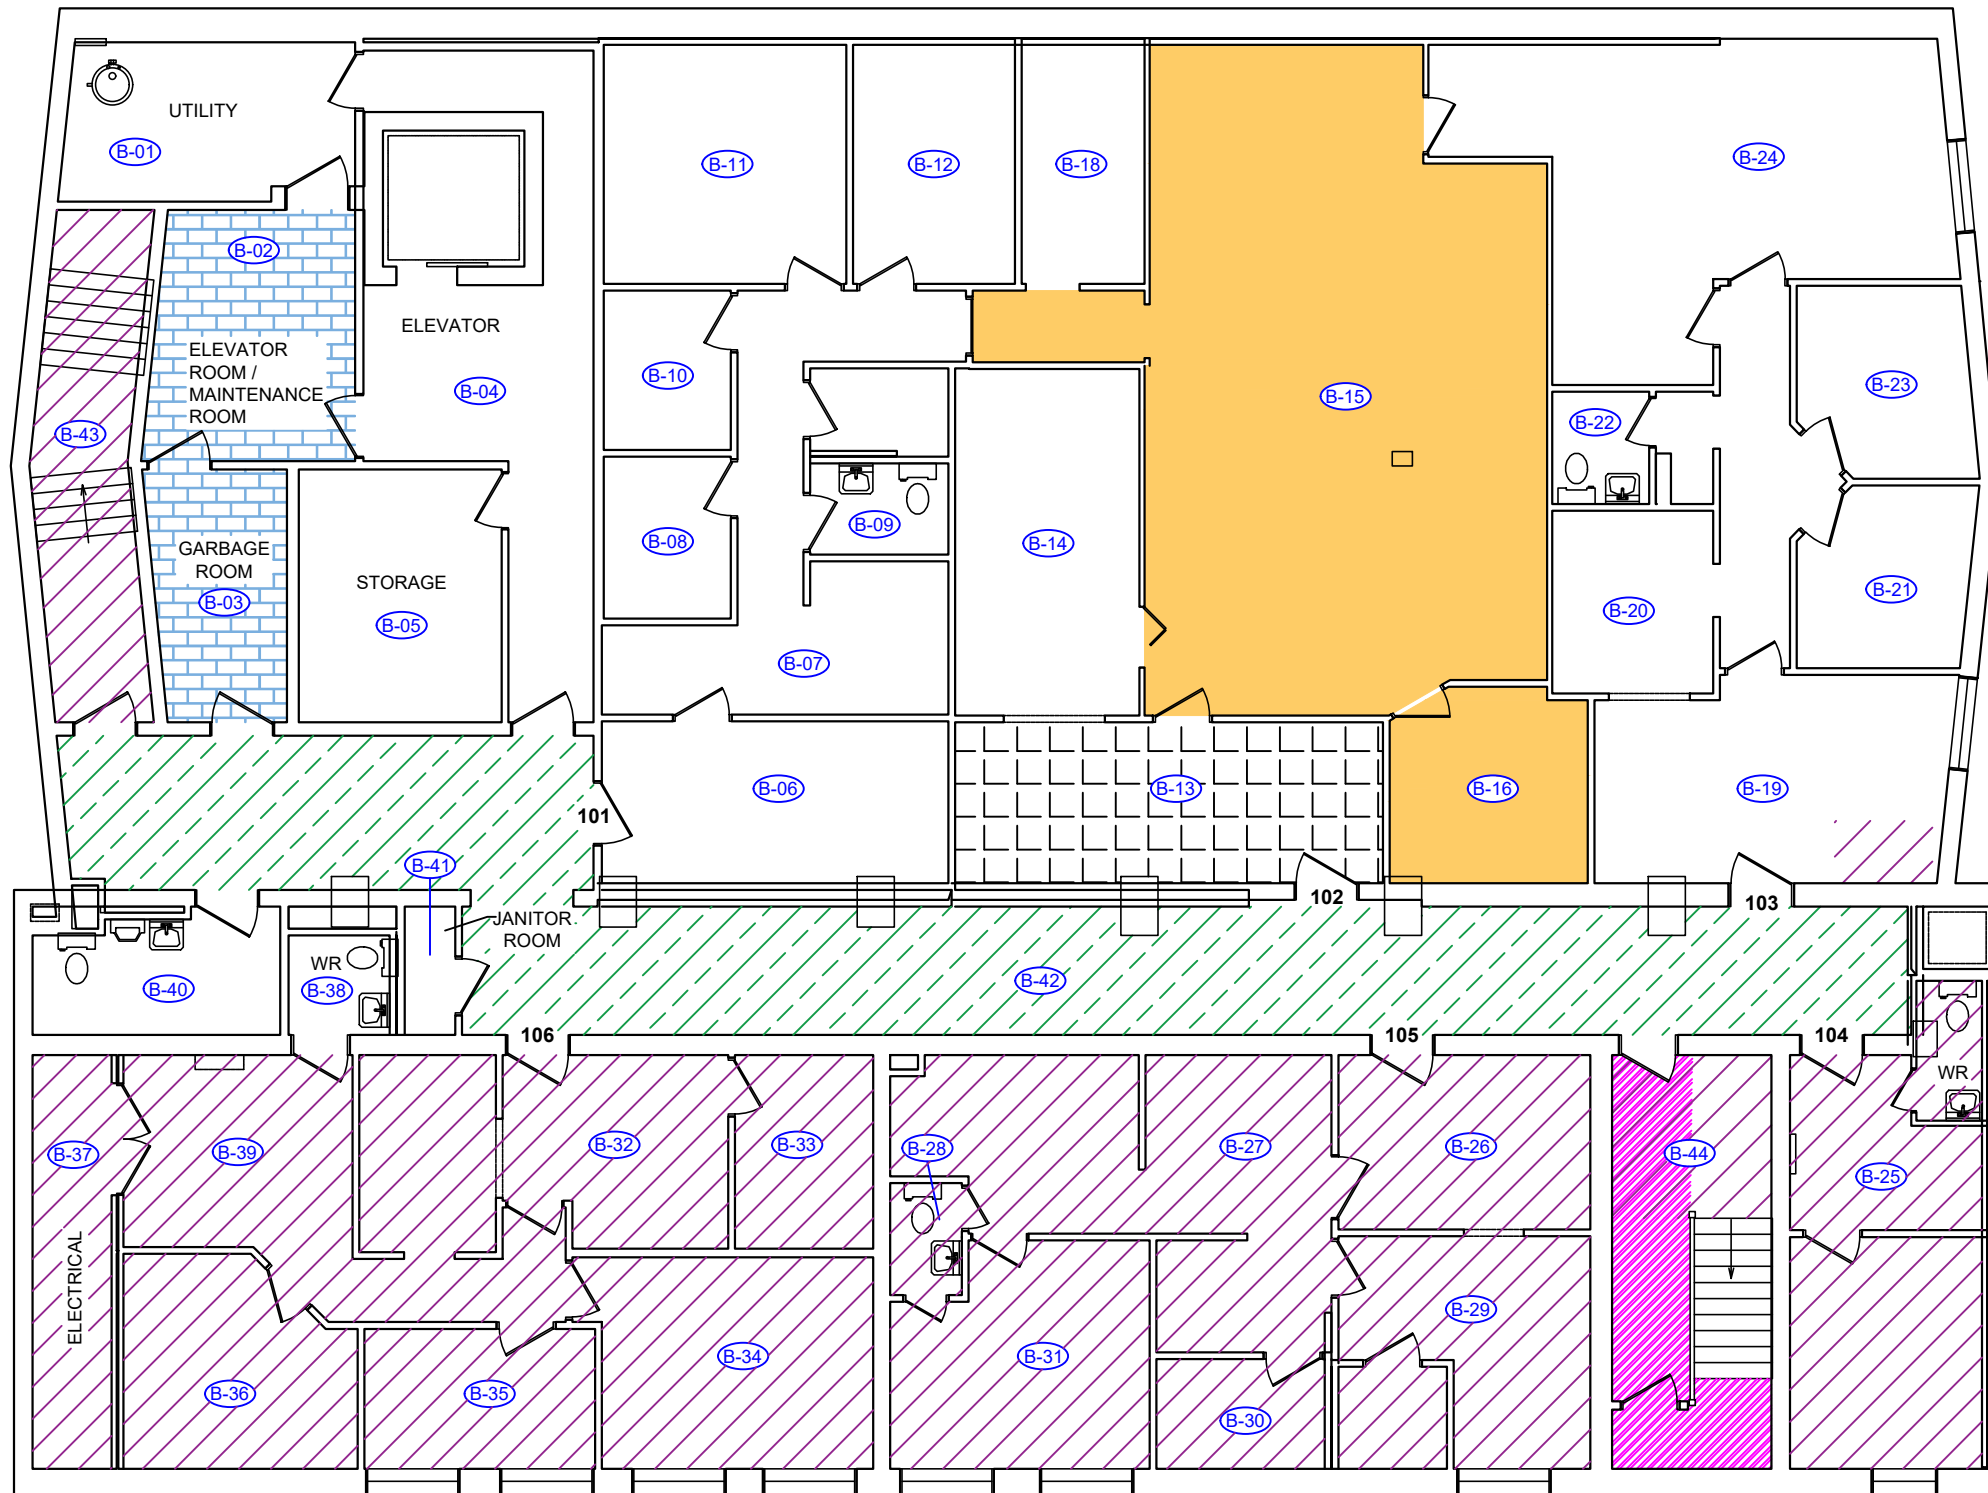
BASEMENT

- 1) Asbestos-containing heat shields were present above ceiling tiles (covered by sprayed fireproofing insulation) in various areas
- 2) Asbestos-containing caulking was identified on interior and exterior areas of the building

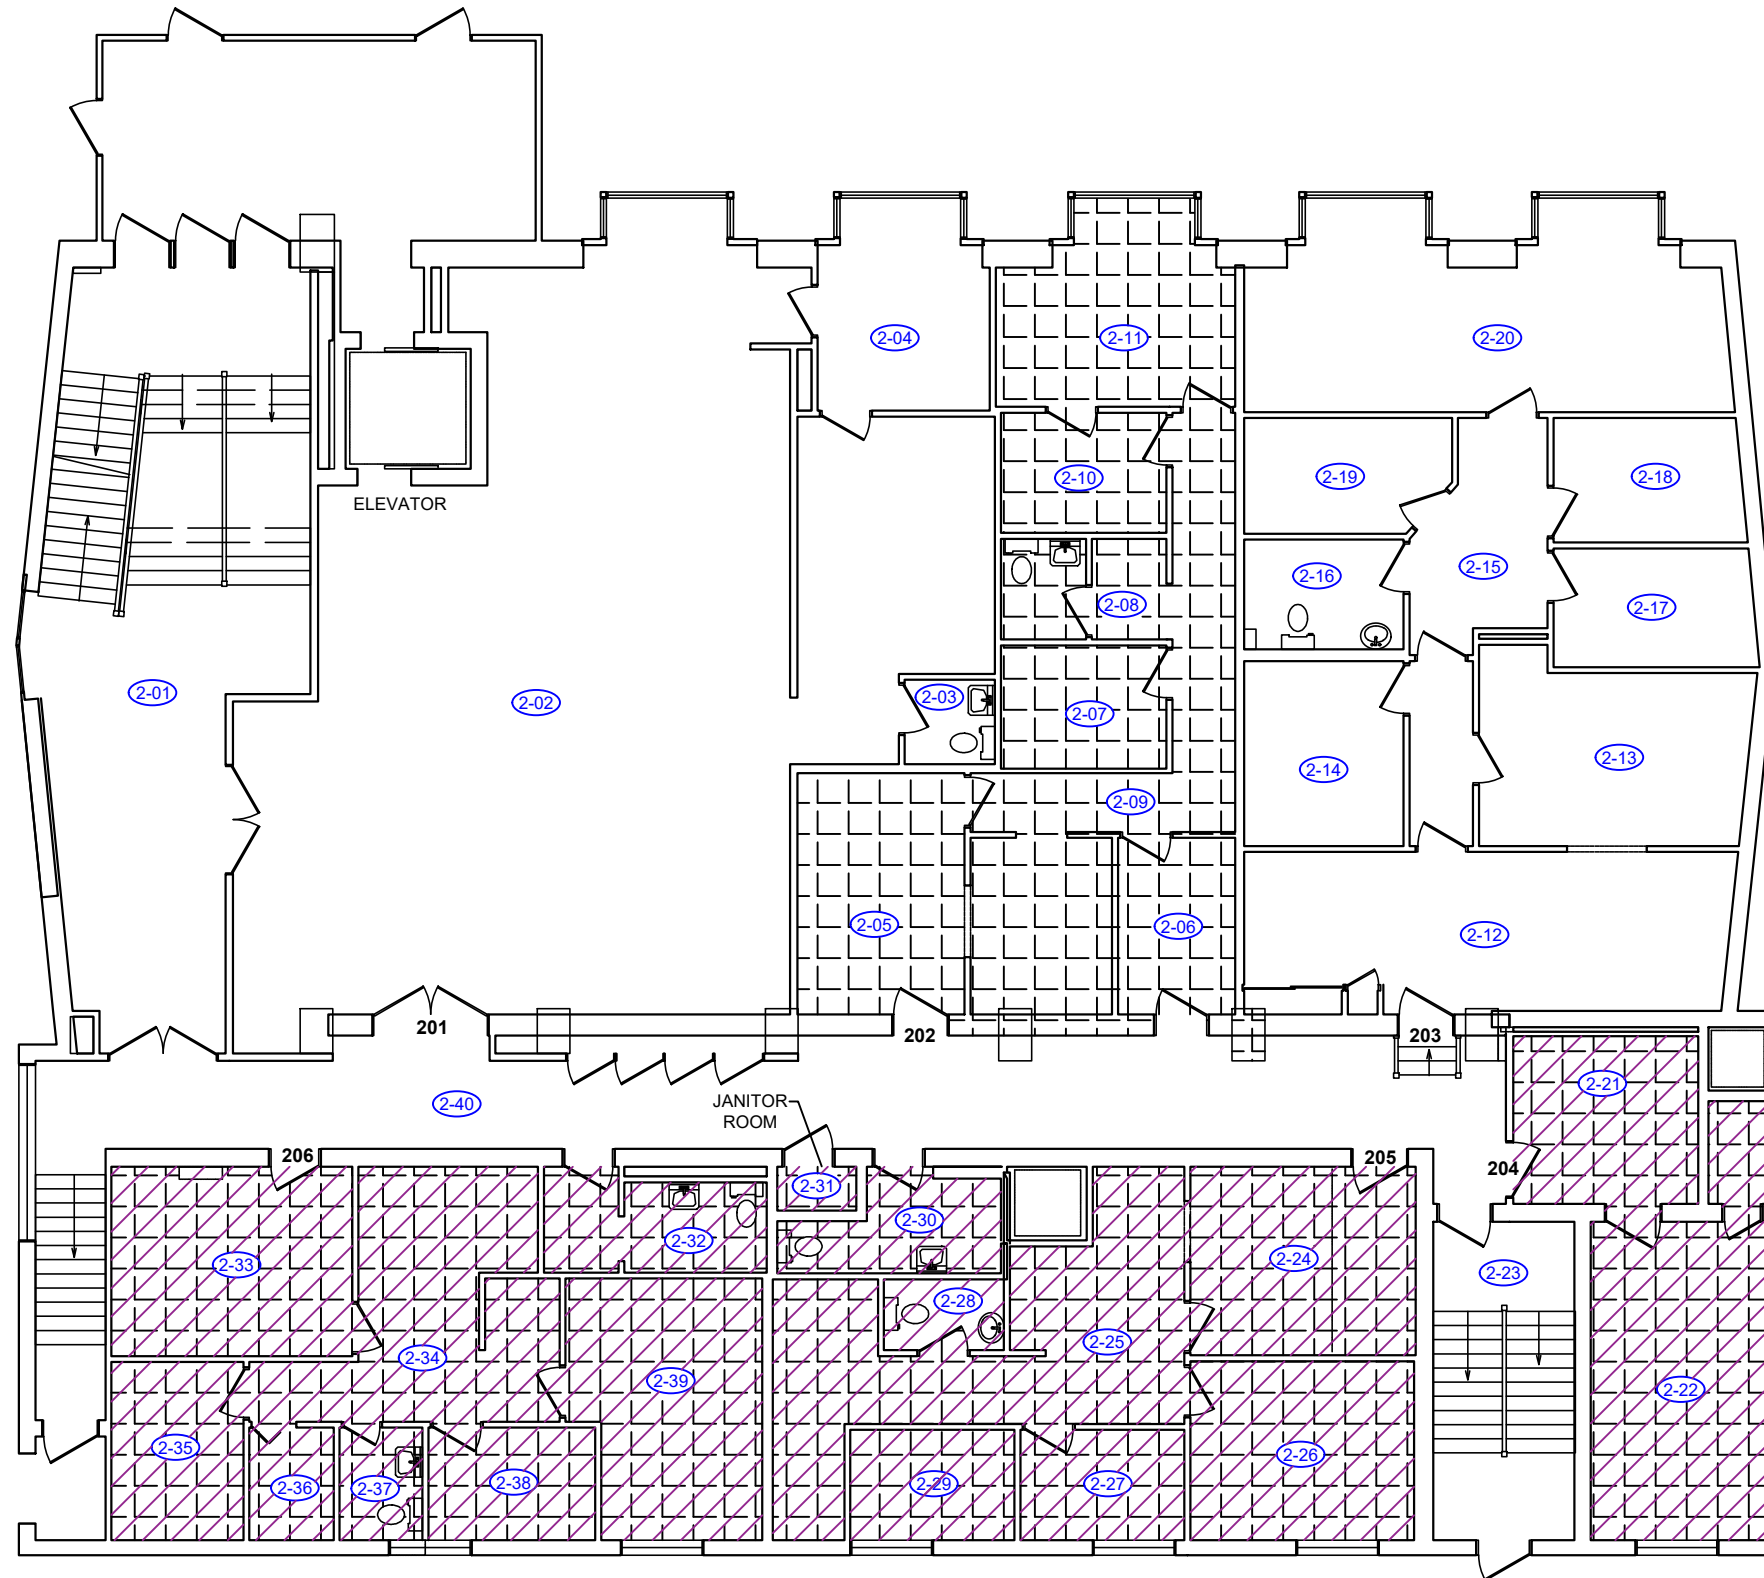
2ND FLOOR

- 1) Asbestos-containing heat shields were present above ceiling tiles (covered by sprayed fireproofing insulation) in various areas
- 2) Asbestos-containing caulking was identified on interior and exterior areas of the building

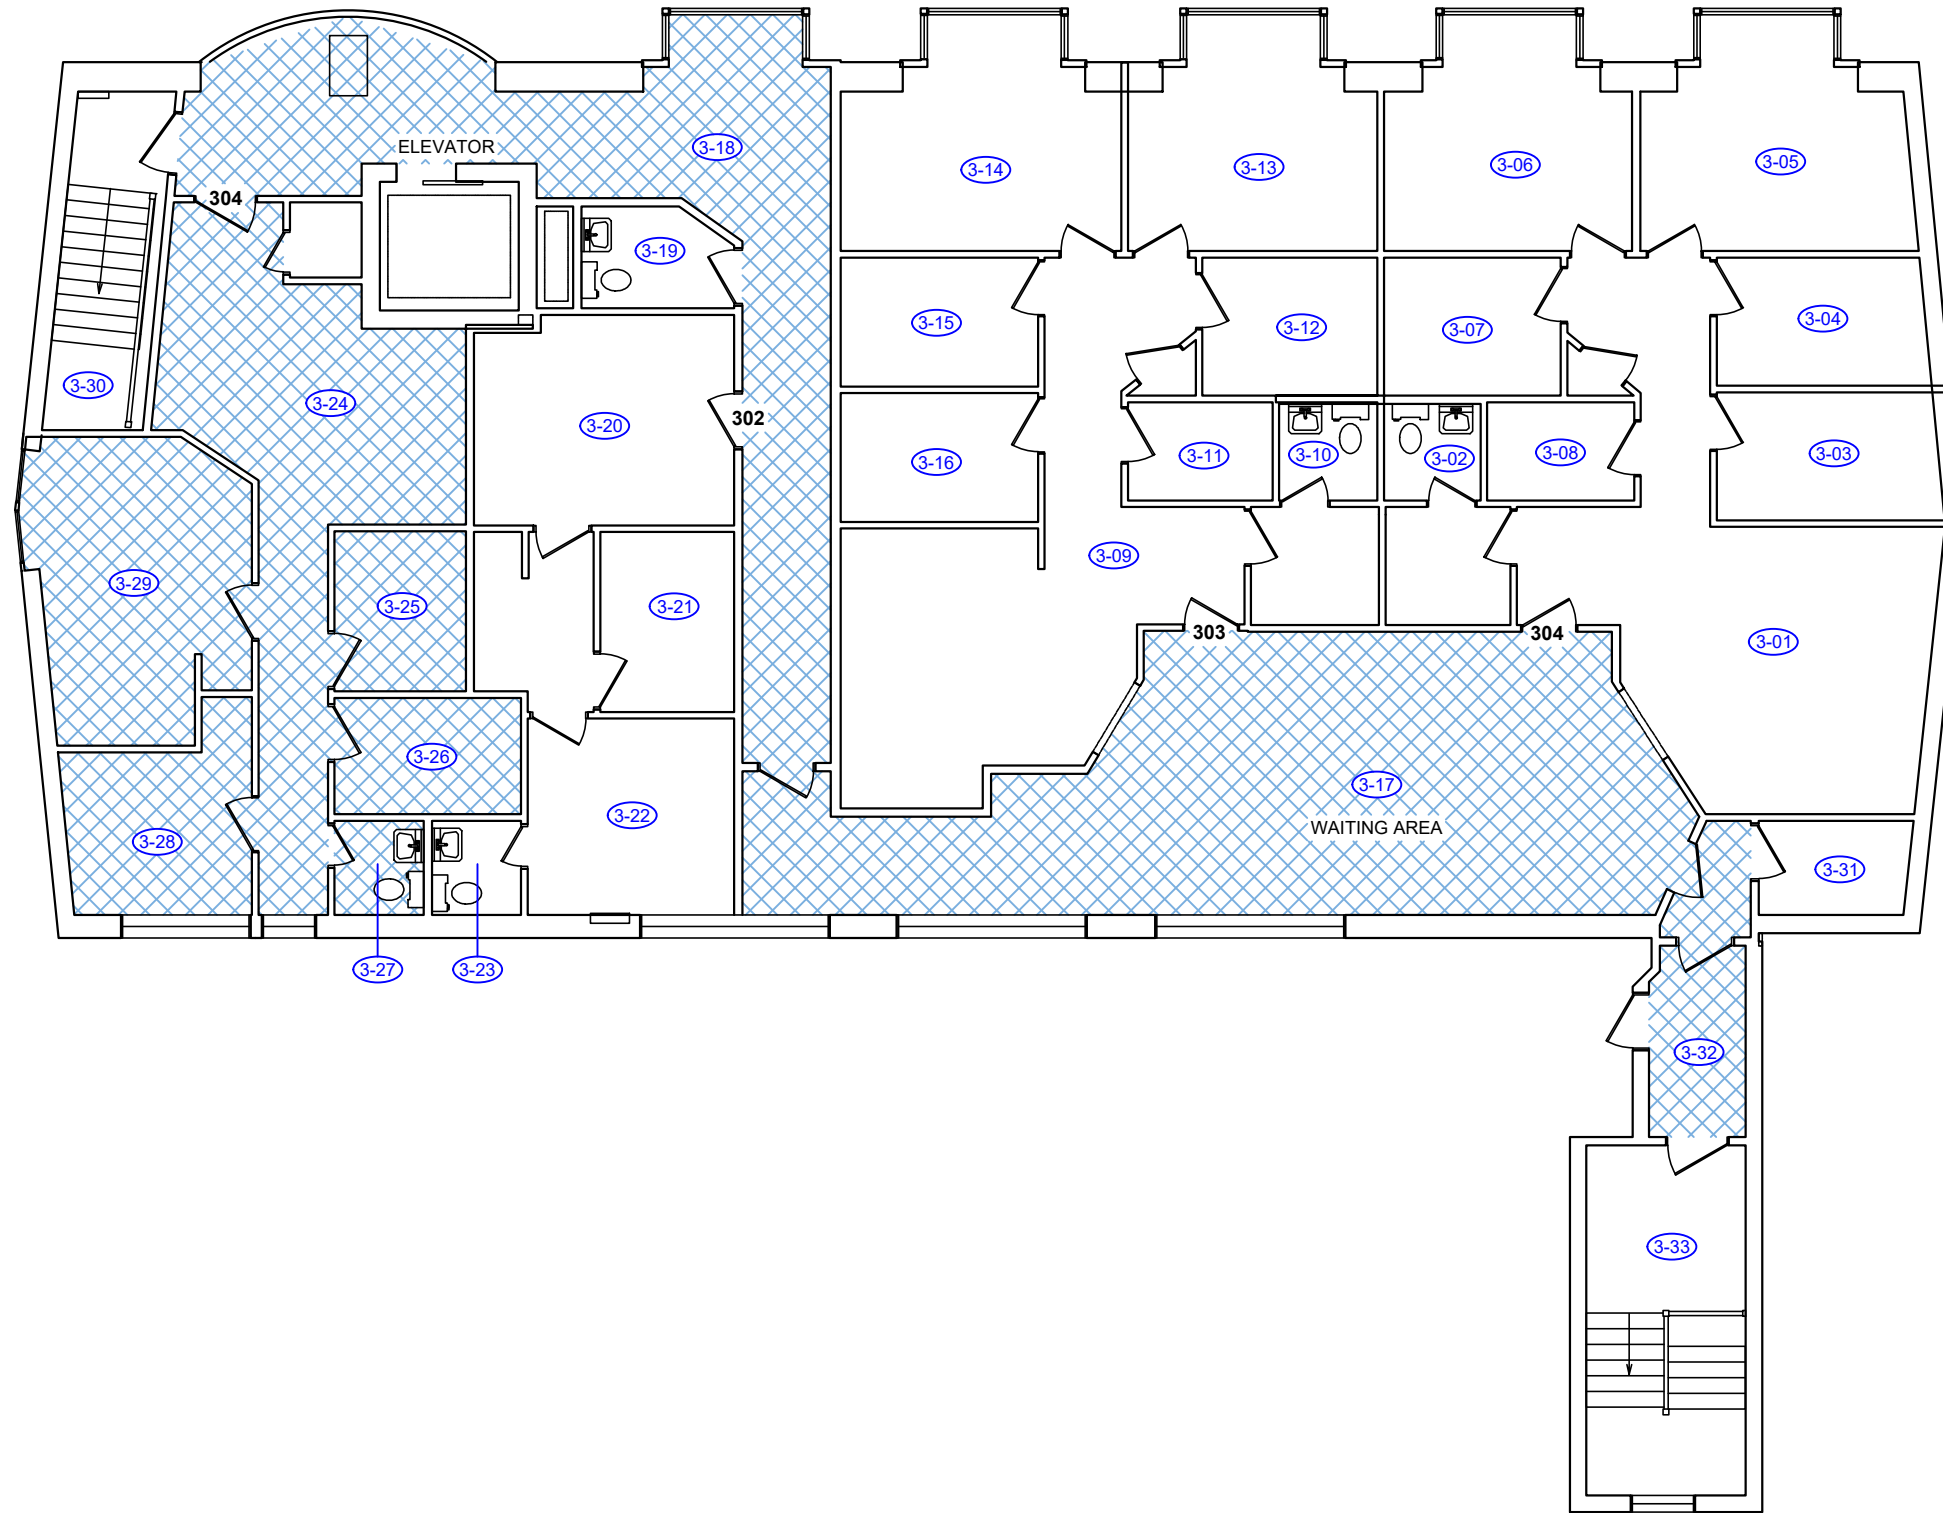
3RD FLOOR  
 DEMOLITION PROJECT  
 1615 DUFFERIN STREET

- 1) Asbestos-containing heat shields were present above ceiling tiles (covered by sprayed fireproofing insulation) in various areas
- 2) Asbestos-containing caulking was identified on interior and exterior areas of the building
