Limited Designated Substance Survey Report

Ajax High School

105 Bayly Street East, Ajax, Ontario

February 3, 2025
Parasol Project No: 13275

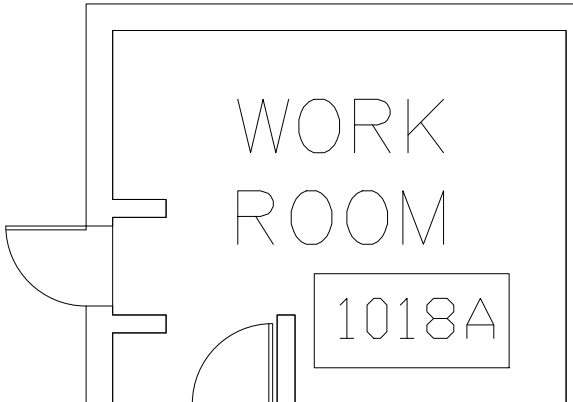
- 1) Drywall finishes where present within the surveyed area are confirmed to contain Chrysotile asbestos. Sampling is required in specific areas to prove non-ACM.
 - 2) Transite cement panels located within the fume hoods are suspected to contain asbestos. Sampling of the material is required to prove them non-ACM.
 - 3) Black desk tops where present throughout the surveyed are confirmed to contain Chrysotile asbestos.
- Refer to Main Report.
