# Hazardous Building Materials Assessment (Pre-construction)

P01970 Dust Collector Replacement Project Orchard Park Secondary School 200 Dewitt Road, Stoney Creek, Ontario

# Hamilton-Wentworth District School Board

February 19, 2025

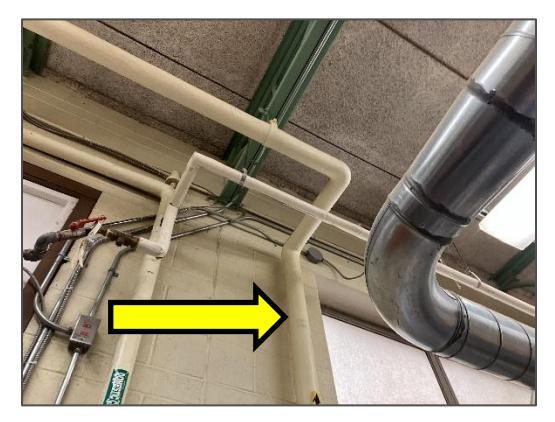
Photo 3

Sweatwrap insulation (brown layered paper) present on straight sections of various system pipes in the assessed area does not contain asbestos (samples 030a-c, lab reference No. b63840, photo 3).
