September 2, 2025

**Re: Asbestos Reassessment**

St. John the Evangelist Catholic Element, 1103 Giffard Street, Whitby, Ontario  
Pinchin File: 358839.000

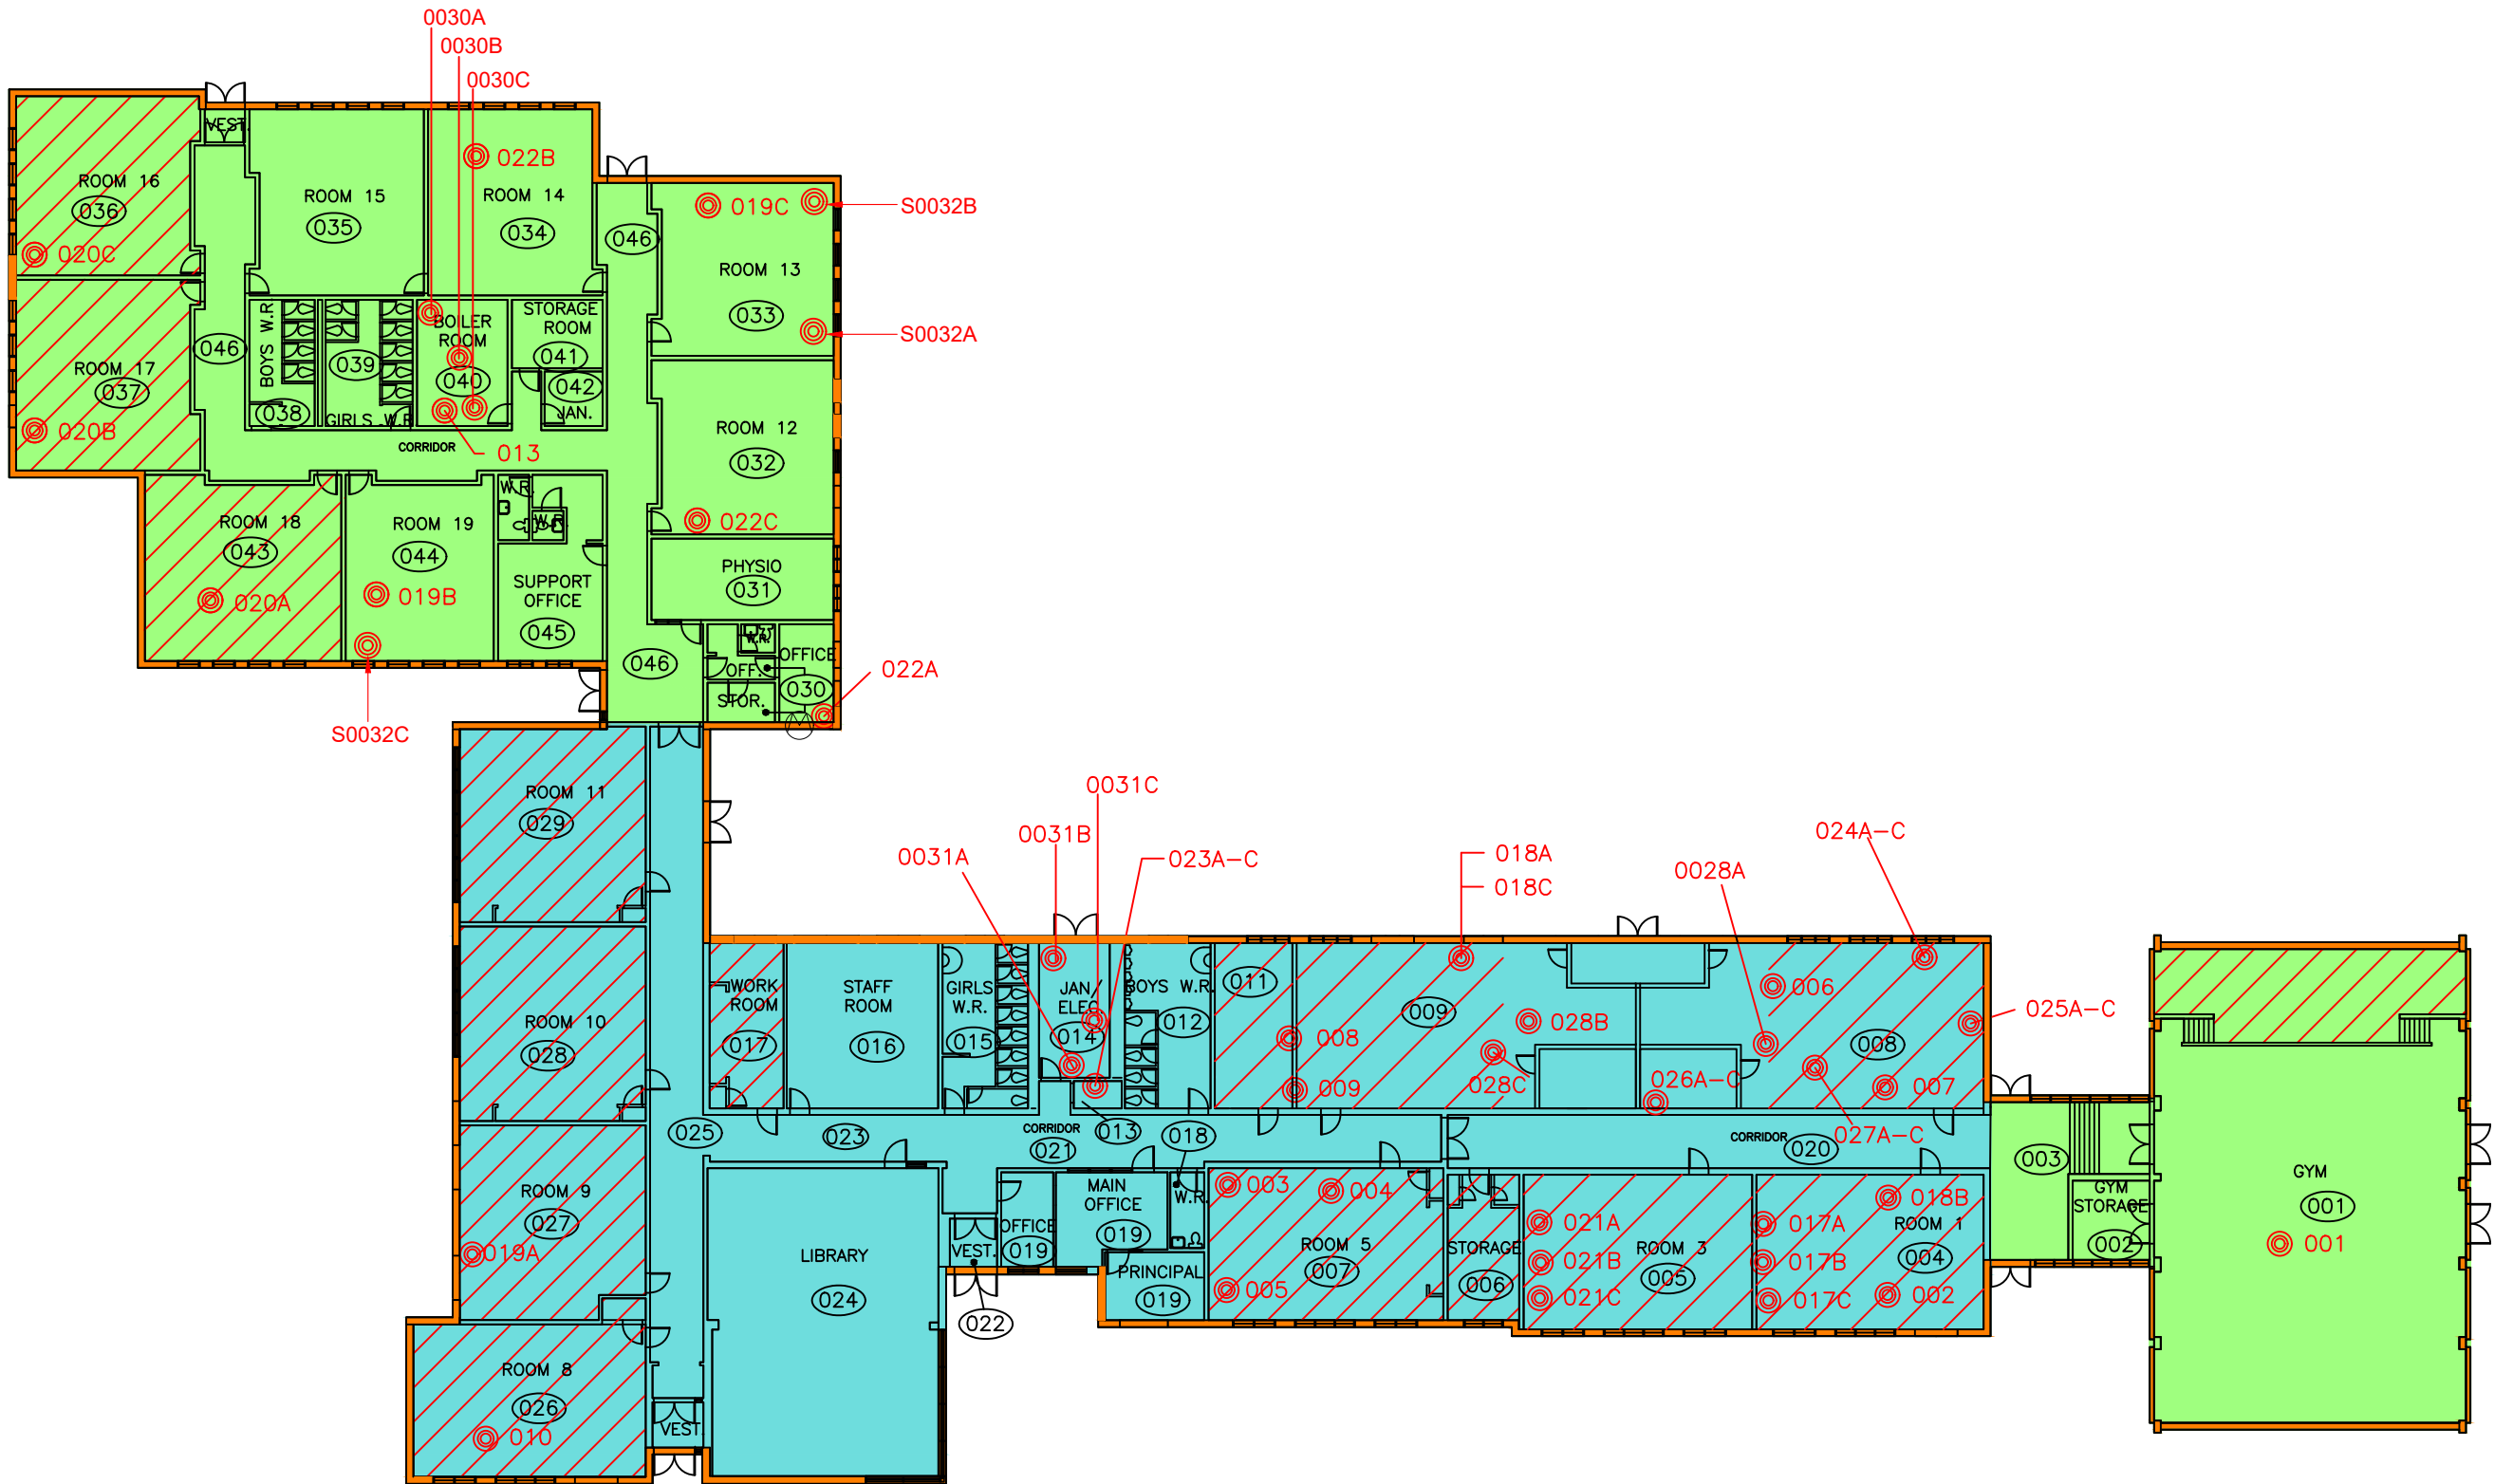
**APPENDIX I**  
**Drawings**

- LEGEND**
- PINCHIN LOCATION NUMBER
  - ASBESTOS BULK SAMPLE
  - VERMICULITE DRILLHOLE
  - ORIGINAL PHASE OF CONSTRUCTION
  - 1970 PHASE OF CONSTRUCTION
- ASBESTOS-CONTAINING MATERIALS:**
- VINYL FLOOR TILES
  - VERMICULITE
