## Addendum #1

Issued April 21, 2026

## **Hazardous Building Materials Assessment (Pre-construction)**

Window Replacement  
Renovations

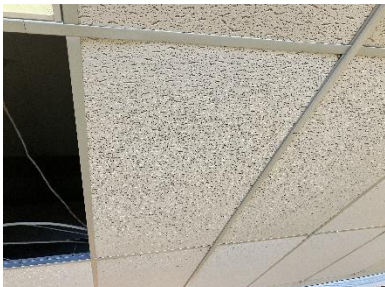
Description	Sample Location	Sample number, Date Code	Asbestos	Photo
24"x48" lay-in, pinhole with width-wise fissures	Throughout the assessed area	Stamped 10/26/93	No

Ceiling tiles are presumed to be non-asbestos based on the date of manufacture determined from the date stamp applied to the top of the tiles. The tiles were manufactured after asbestos stopped being used in acoustic ceiling tiles.

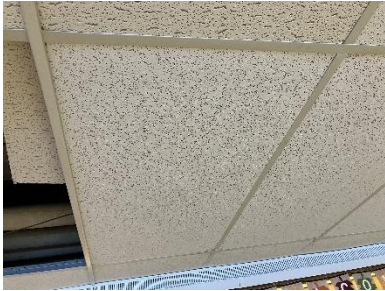
Description	Sample Location	Sample number, Date Code	Asbestos	Photo
24"x48" lay-in, pinhole with fleck	Throughout the assessed area	Stamped 07/28/03	No

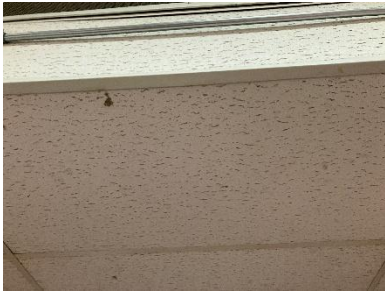
24"x48" pinhole with length-wise fissures	Corridor between the Gymnasium and Classrooms (Location 1685)	S0020A-C	No
