**Designated Substances and
Hazardous Materials Survey**

17150 Yonge Street
Newmarket, ON L3Y 8V3

Submitted To:	Regional Municipality of York
Issued:	March 21, 2024
Revision:	1 of 1 April 2024
OESN Project No.	00310.005

Report Title: Designated Substances and Hazardous Materials Survey -
17150 Yonge Street, Newmarket, Ontario

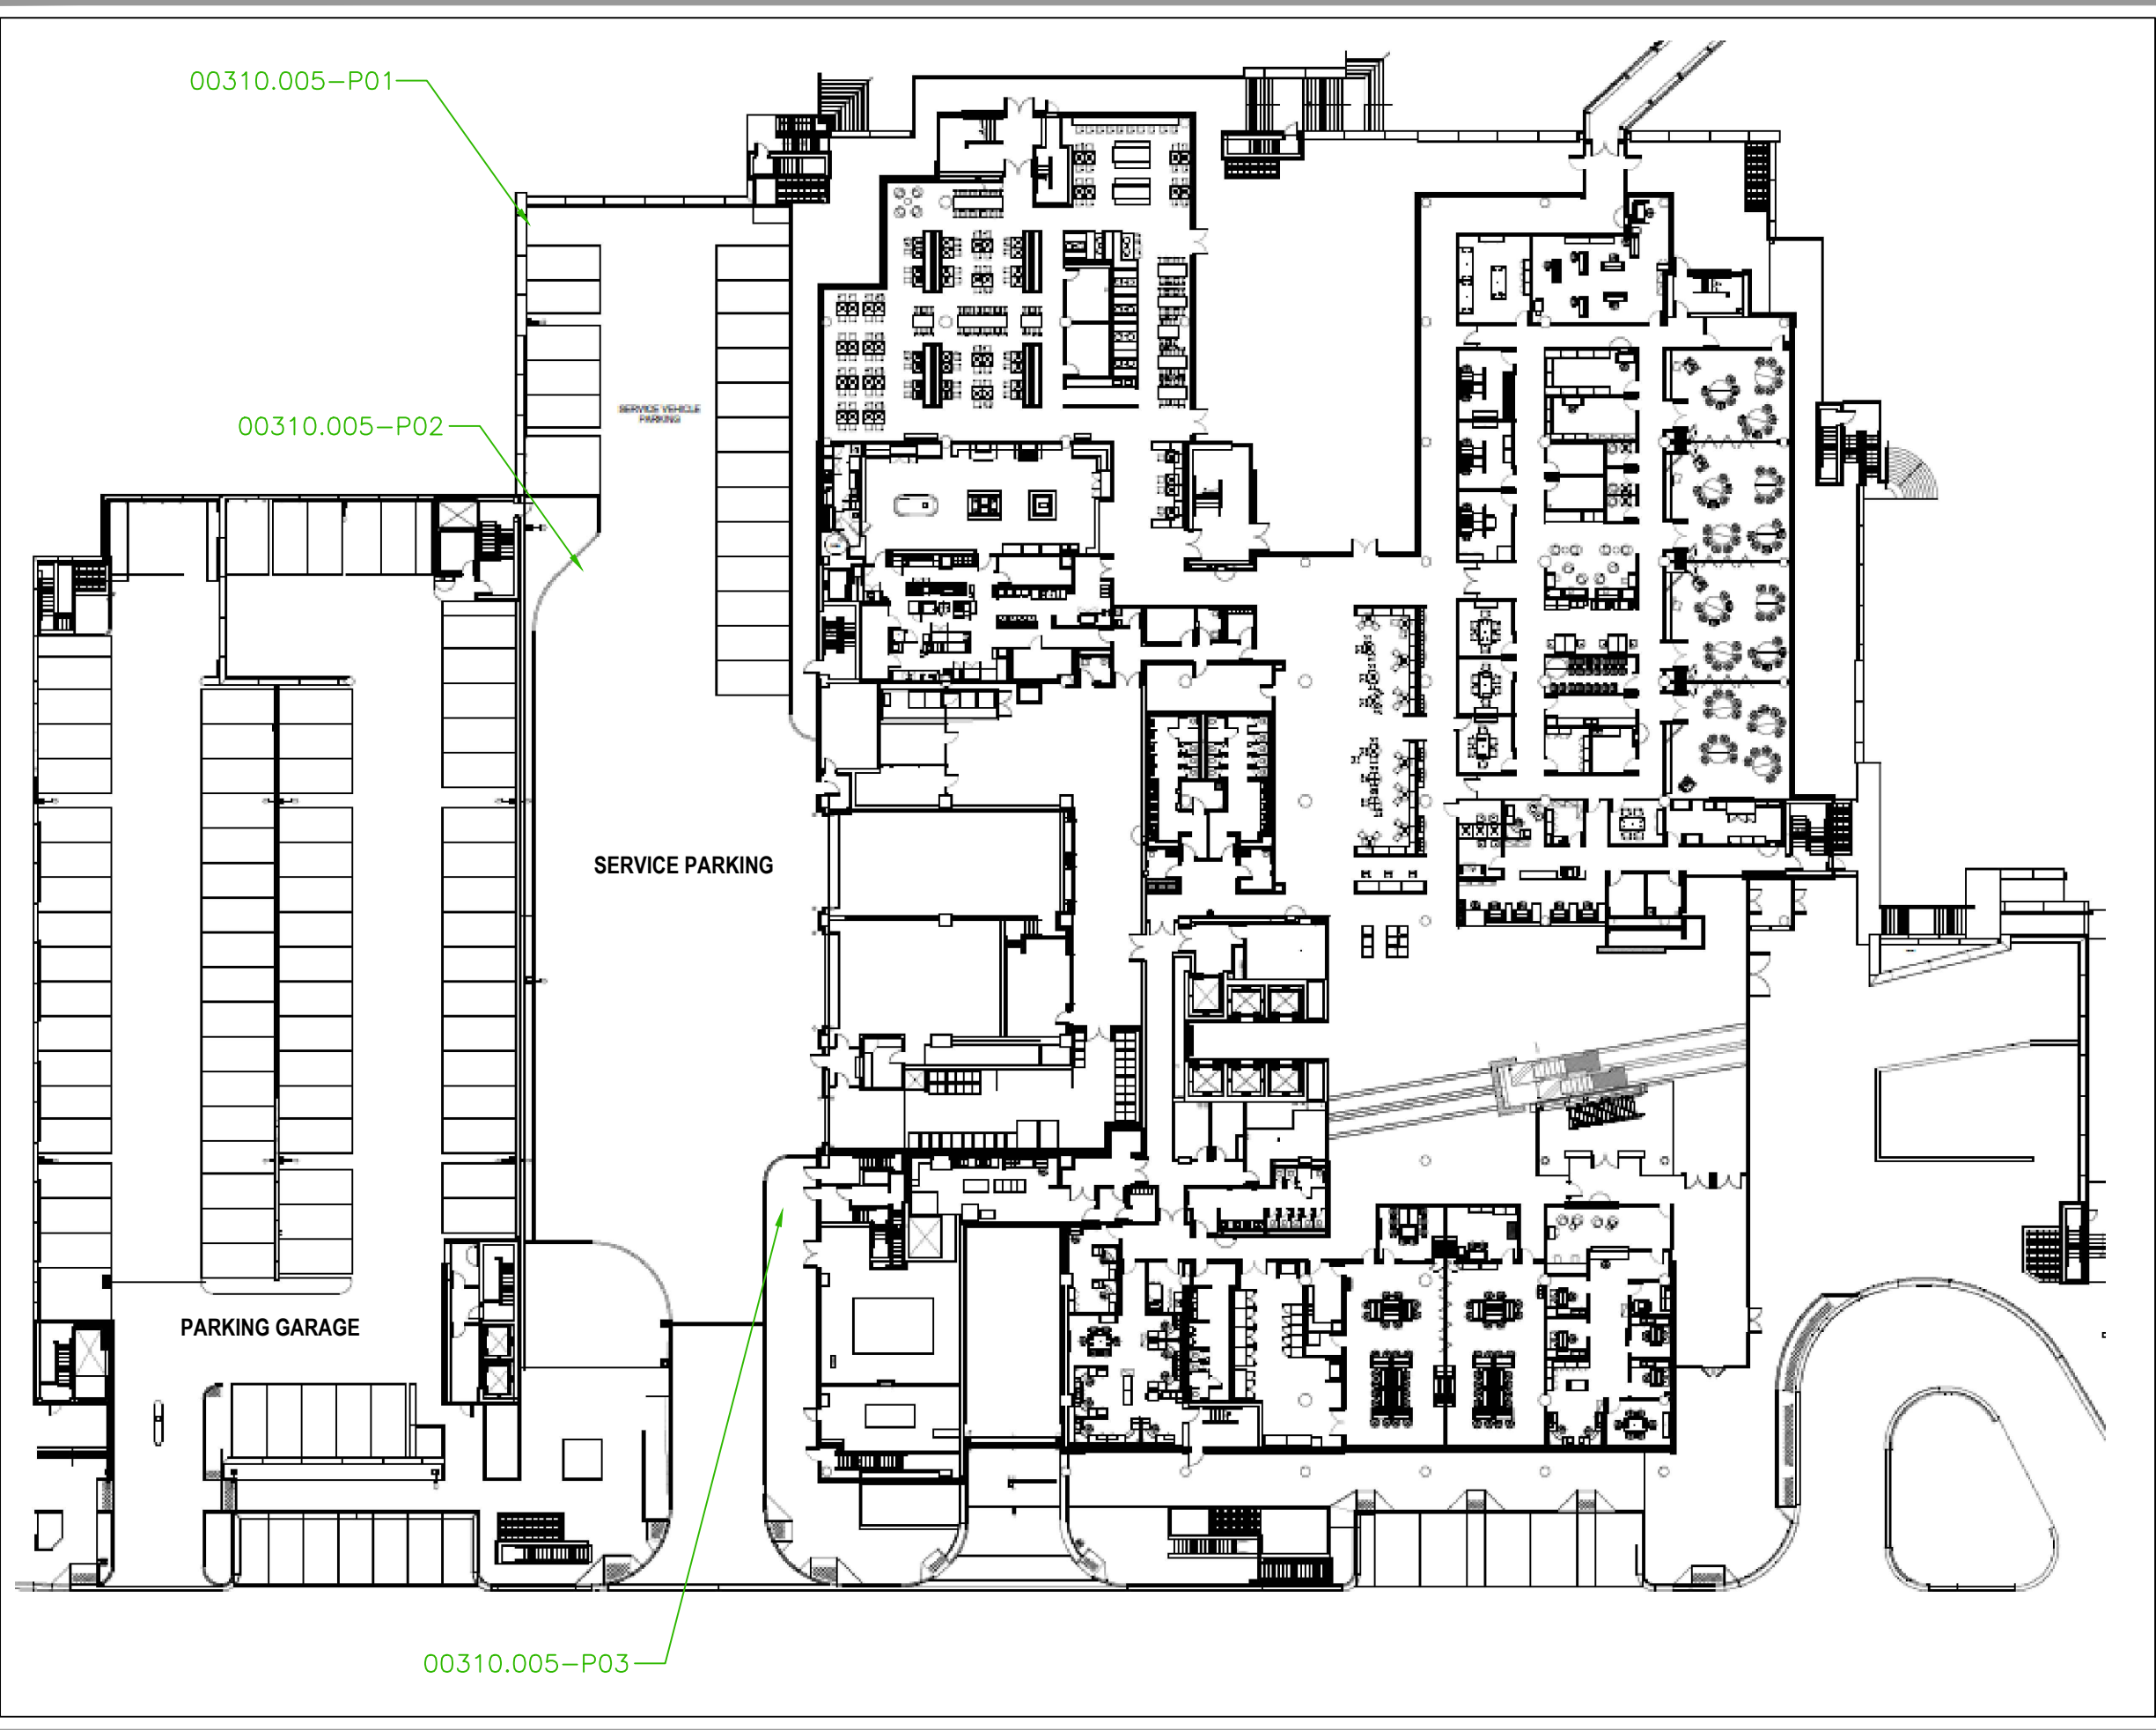
REV.	0	SCALE:	NTS
DRAWN BY:	T.C.	CHECKED BY:	S.H.
DATE:	APRIL 2024		
OESN JOB No:	00310.005		
DWG #:	17150YONGE-DSS-001

- (1) OESN LTD. DID NOT OBSERVE BUILDING MATERIALS SUSPECTED TO CONTAIN ASBESTOS MINERALS.
- (2) OESN LTD. DID NOT OBSERVE MATERIALS TO CONTAIN MERCURY.
- (3) CONCRETE PRODUCTS ASSUMED TO CONTAIN SILICA.
- (4) DRAWINGS SHOULD NOT BE USED FOR CONSTRUCTION OR QUANTITY TAKE-OFF PURPOSES.
