Pre-Renovation Designated Substances and Hazardous Materials Survey

**École élémentaire Nouvel Horizon
621 Quaker Road, Welland, Ontario**

March 11, 2024

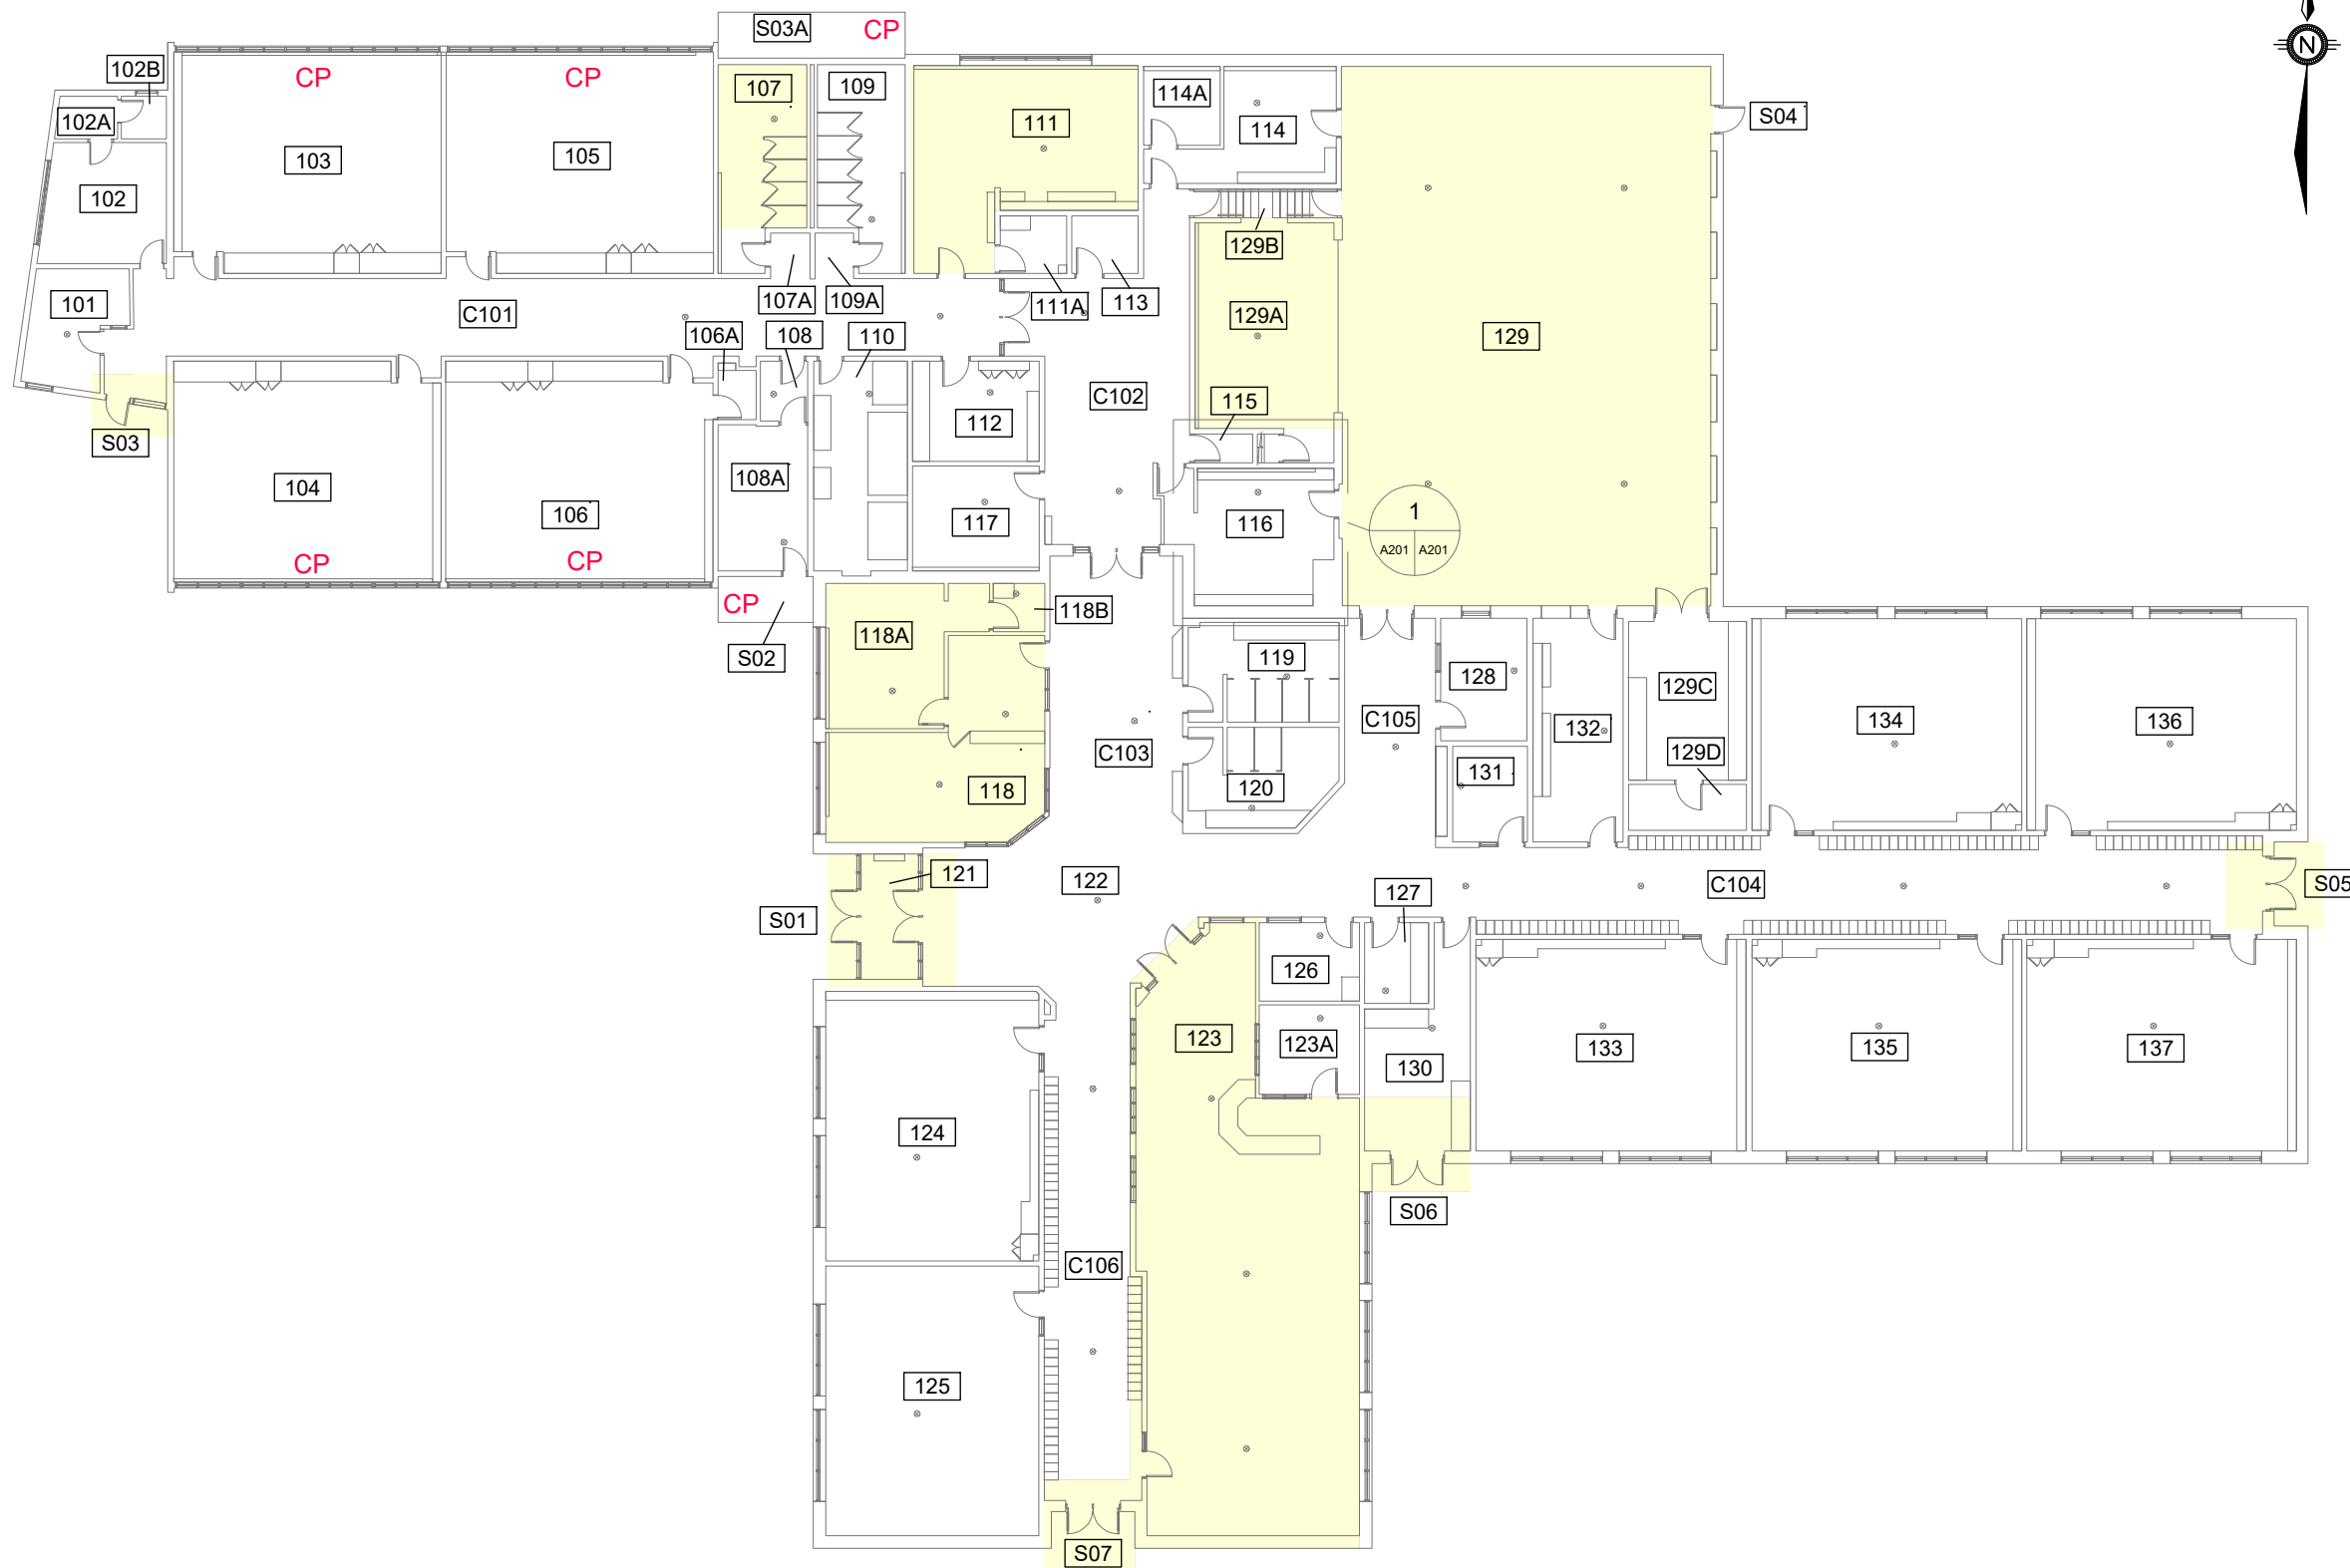
GROUND FLOOR PLAN

- 101 FUNCTIONAL SPACE
- CP ASBESTOS CEMENT PRODUCT
- STUDY AREA
