**THE REGIONAL MUNICIPALITY OF HALTON**

**Contract # T-687-24**

**Resident Door Replacement at Allendale Long Term Care Home**

# Asbestos Assessment

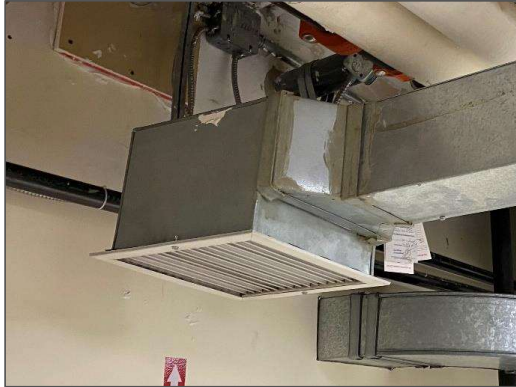
Photo 1

Grey duct mastic present on seams / joints on ducts throughout the assessed area does not contain asbestos (samples S0010A-C, photo 1).

Ducts are either uninsulated or insulated with non-asbestos fibreglass (foil-faced or canvas).

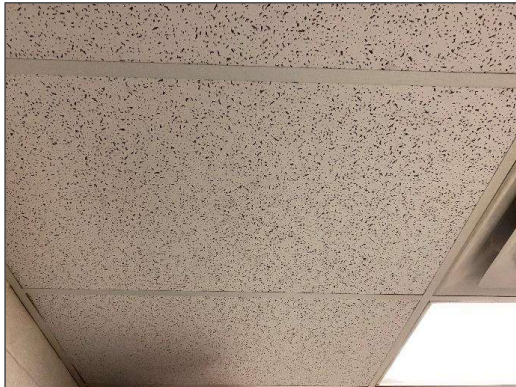
Photo 1

Size, Type, Pattern	Sample Number or Date Code	Asbestos Type
24"x48", pinhole with fleck, photo 1	03/07/22	Non-asbestos
24"x48", pinhole with width wise fissure, photo 2	08/16/08	Non-asbestos
24"x48", gypsum tiles, photo 3	Not sampled	Non-asbestos
Mechanically fastened wood fibre	Not sampled	Non-asbestos

Ceiling tiles are presumed to be non-asbestos based on the date of manufacture determined from the date stamp applied to the top of the tiles. The tiles were manufactured after asbestos stopped being used in acoustic ceiling tiles.

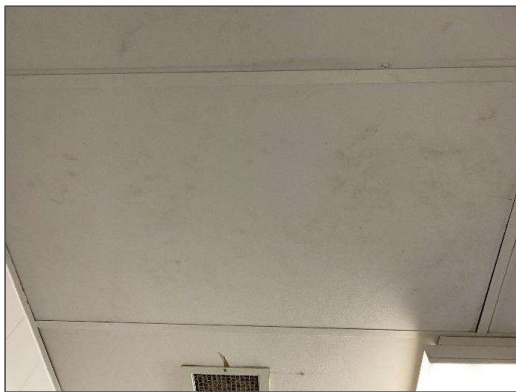
Photo 3

All ceiling tiles are presumed to be non-asbestos based on the composition of the tiles (e.g. wood fibre, gypsum).

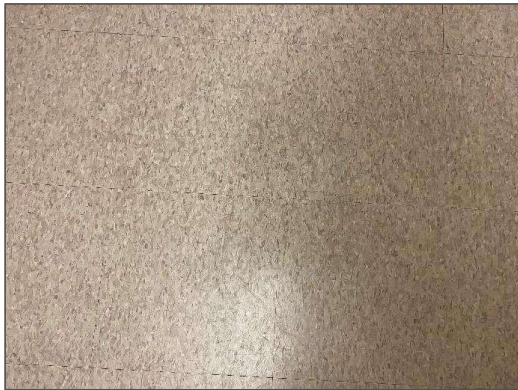
Photo 1

Pattern, and Number	Colour Photo	Sample Locations	Sample Number	Asbestos Type	Asbestos Type (Adhesive)
Beige with sparkles, photo 1		Preparation Kitchen, Laundry Room / Office (Locations 8 and 15)	S0008A-C	None detected	None detected
Multi-colour wave pattern, photo 2		Storage (Location 21)	S0016A-C	None detected	N/A
Green wave pattern, photo 3		Storage (Location 22)	S0017A-C	None detected	None detected
Wood style, photo 4		Reception and Corridors, Cafeteria (Locations 26 and 27)	S0021A-C	None detected	None detected

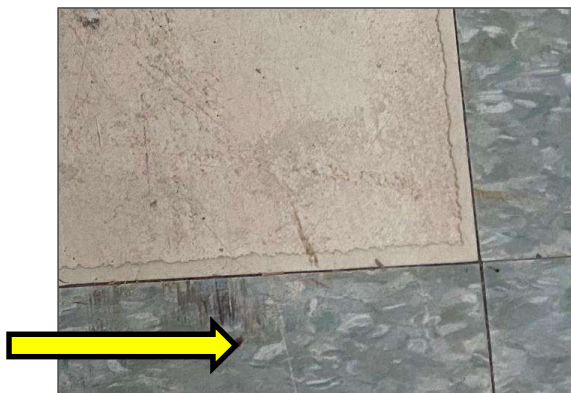
Photo 1

Size, Pattern, Colour	Sample Locations	Sample Number	Asbestos Type (tile)	Asbestos Type (mastic)
12"x12", light blue with white fleck, photo 1	Storage, Garage Bays and Corridor (Location 3, 4 and 10)	S0006A-C	None detected	None detected
12"x12", dark blue	Storage (Location 13)	S0007A-C	None detected	None detected
12"x12", beige peel and stick (3 layers)	Corridor (Location 10)	S0011A-C	None detected	N/A
12"x12", brown with light brown and white fleck, photo 2	Corridor (Location 10)	S0012A-C	None detected	None detected
12"x12" grey with brown and white fleck, photo 3	Corridor (Location 10)	S0013A-C	None detected	None detected
12"x12", blue with dark blue and white fleck	Corridor (Location 10)	S0014A-C	None detected	None detected
12"x12", white with black dots/splatter, photo 4	Bronte House (Location 29)	S0024A-C	None detected	None detected
12"x12", grey with beige streaks, photo 5	Stairwells (Location 36)	S0025A-C	None detected	None detected

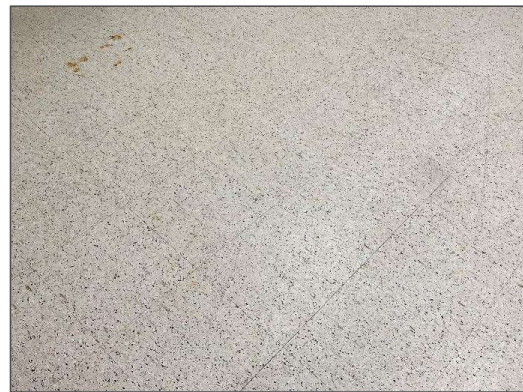
Photo 6

12"x12", grey with dark grey and white fleck, photo 6	Bronte House and Trafalgar House (Location 29 and 32)	S0033A-C	None detected	None detected

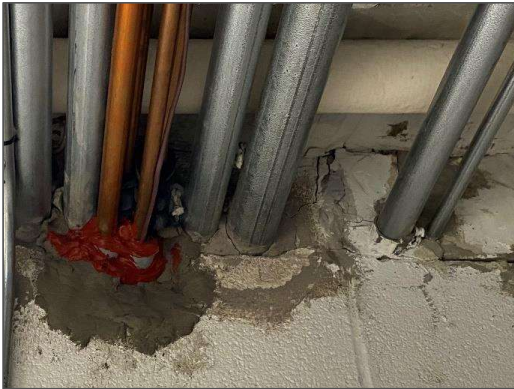
Photo 1

Red, maroon and blue/grey firestopping (sealant) present at pipe and conduit penetrations in the Generator / Electrical / Sprinkler / Workshop, Corridor, Storage and Garbage / Elevator Room (Locations 1, 2, 3 and 11) does not contain asbestos (samples S0002A-C, S0003A-C and S0004A-C, photo 1).

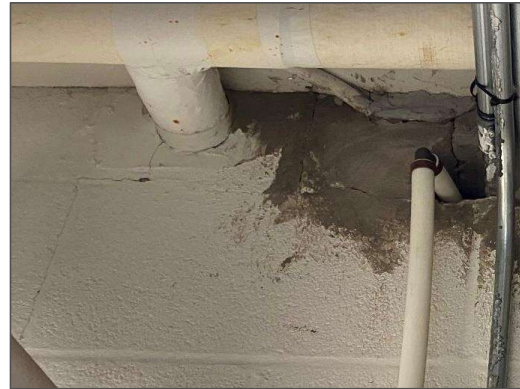
Photo 2

Firestopping (cementitious) is present at pipe and conduit penetrations in the Generator / Electrical / Sprinkler / Workshop (Location 1) does not contain asbestos (samples S0005A-C, photo 2).

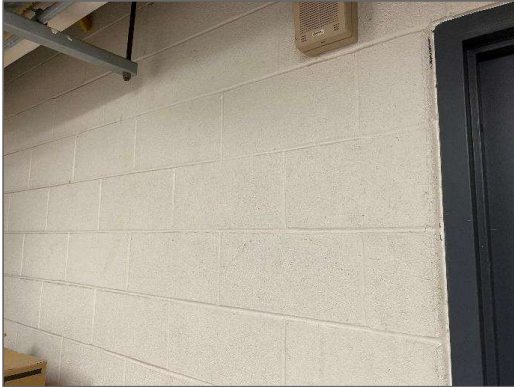
Photo 1

Description	Sample Location (Location #)	Sample Number	Asbestos
Paint on concrete block walls, photo 1	Generator / Electrical / Sprinkler / Workshop, Corridor, Corridor and Staff Washrooms and Changerooms (Location 1, 2, 10 and 19)	S0001A-G	No
Tectum wall covering, photo 2	Cafeteria and Auditorium (Location 27 and 28)	S0022A-C	No
Blue wave pattern epoxy, photo 3	Courtyard Vestibule (Location 33)	S0034A-C	No
