**DESIGNATED SUBSTANCES and HAZARDOUS  
MATERIALS SURVEY**

**DISCO YARD  
150 Disco Road  
Toronto, Ontario**

Project Number: FE 23-12800

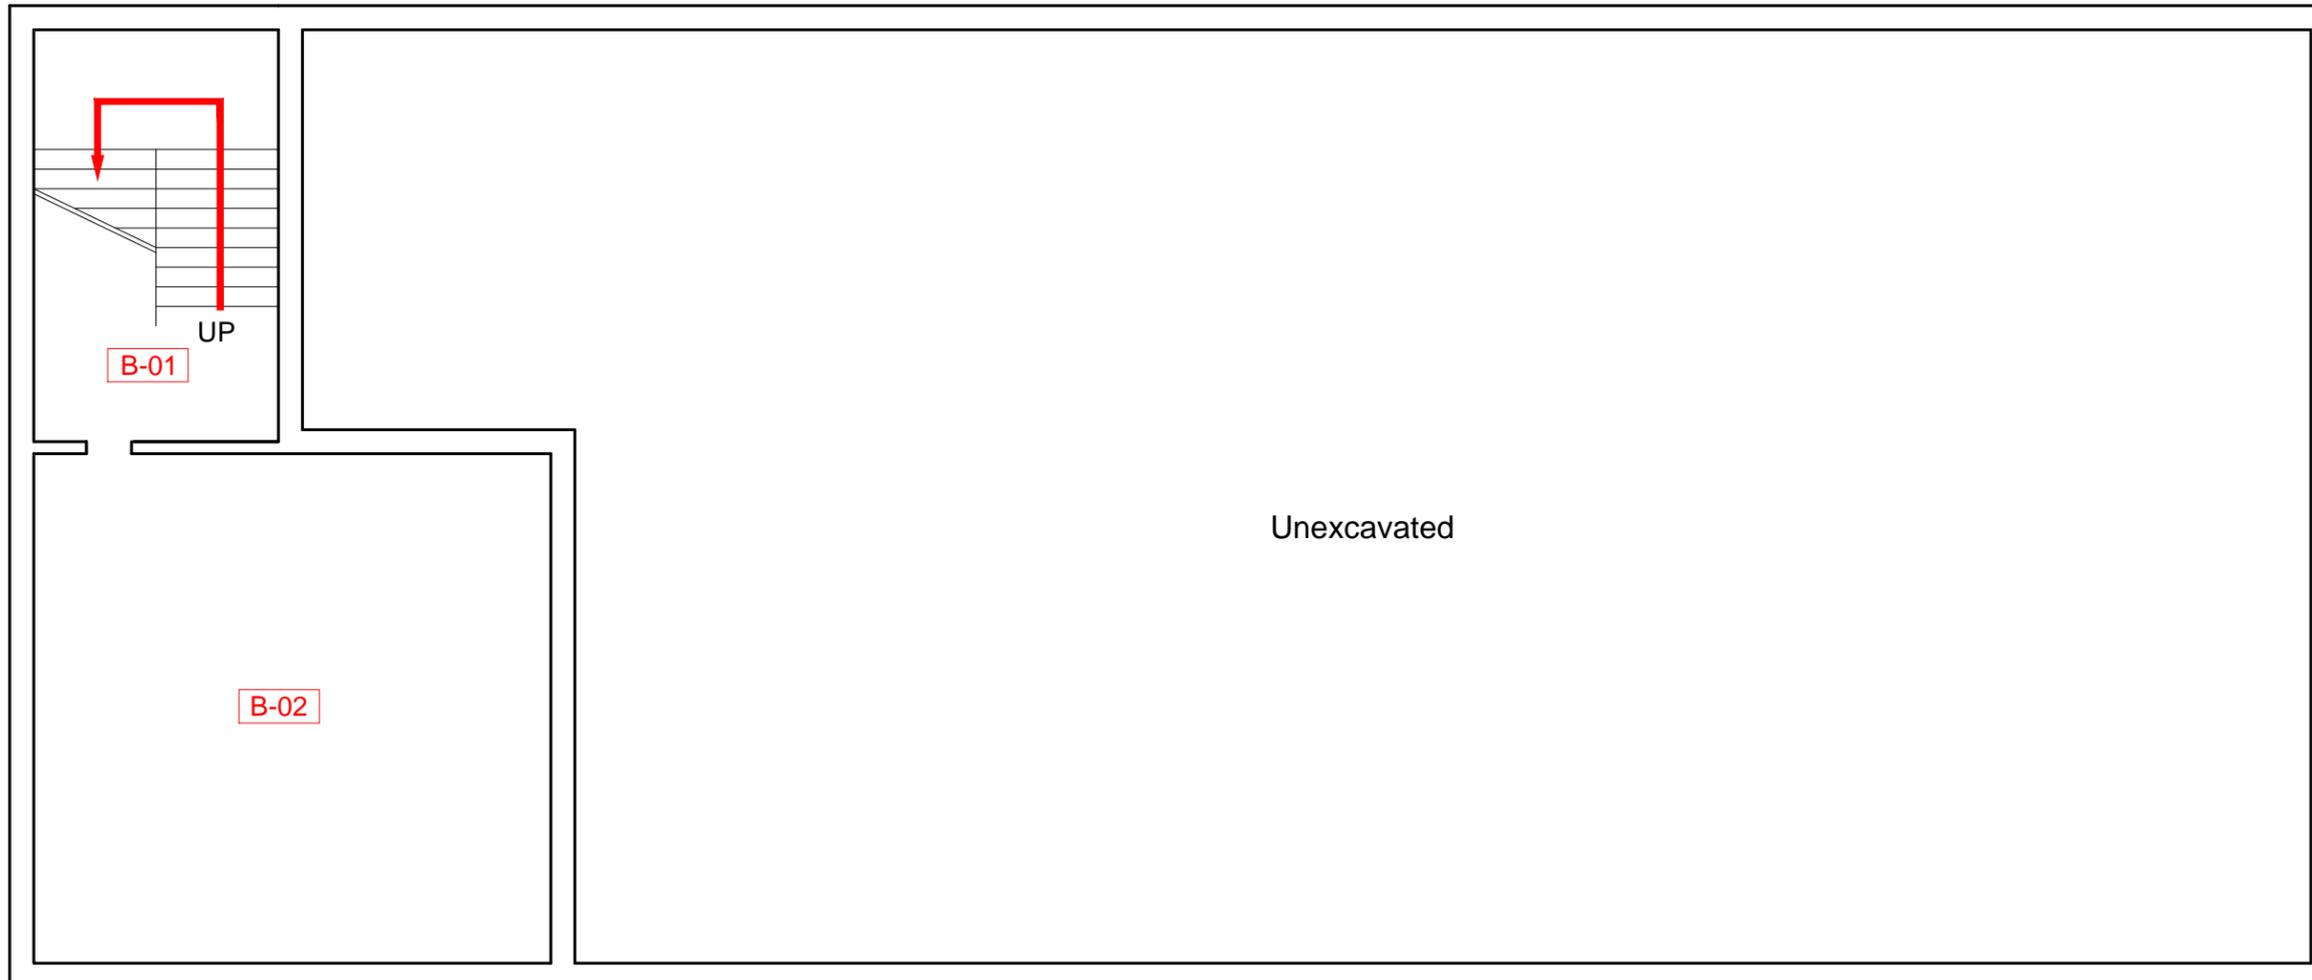
### Figure 2

The drawing does not illustrate locations of drywall joint compound, plaster, window caulking or roofing materials, for reasons discussed in Section 6 of the Standard Operating Procedure for Designated Substance Surveys. Please refer to the Designated Substance Survey Form in Appendix I for information regarding the locations and asbestos or lead-content of these materials.

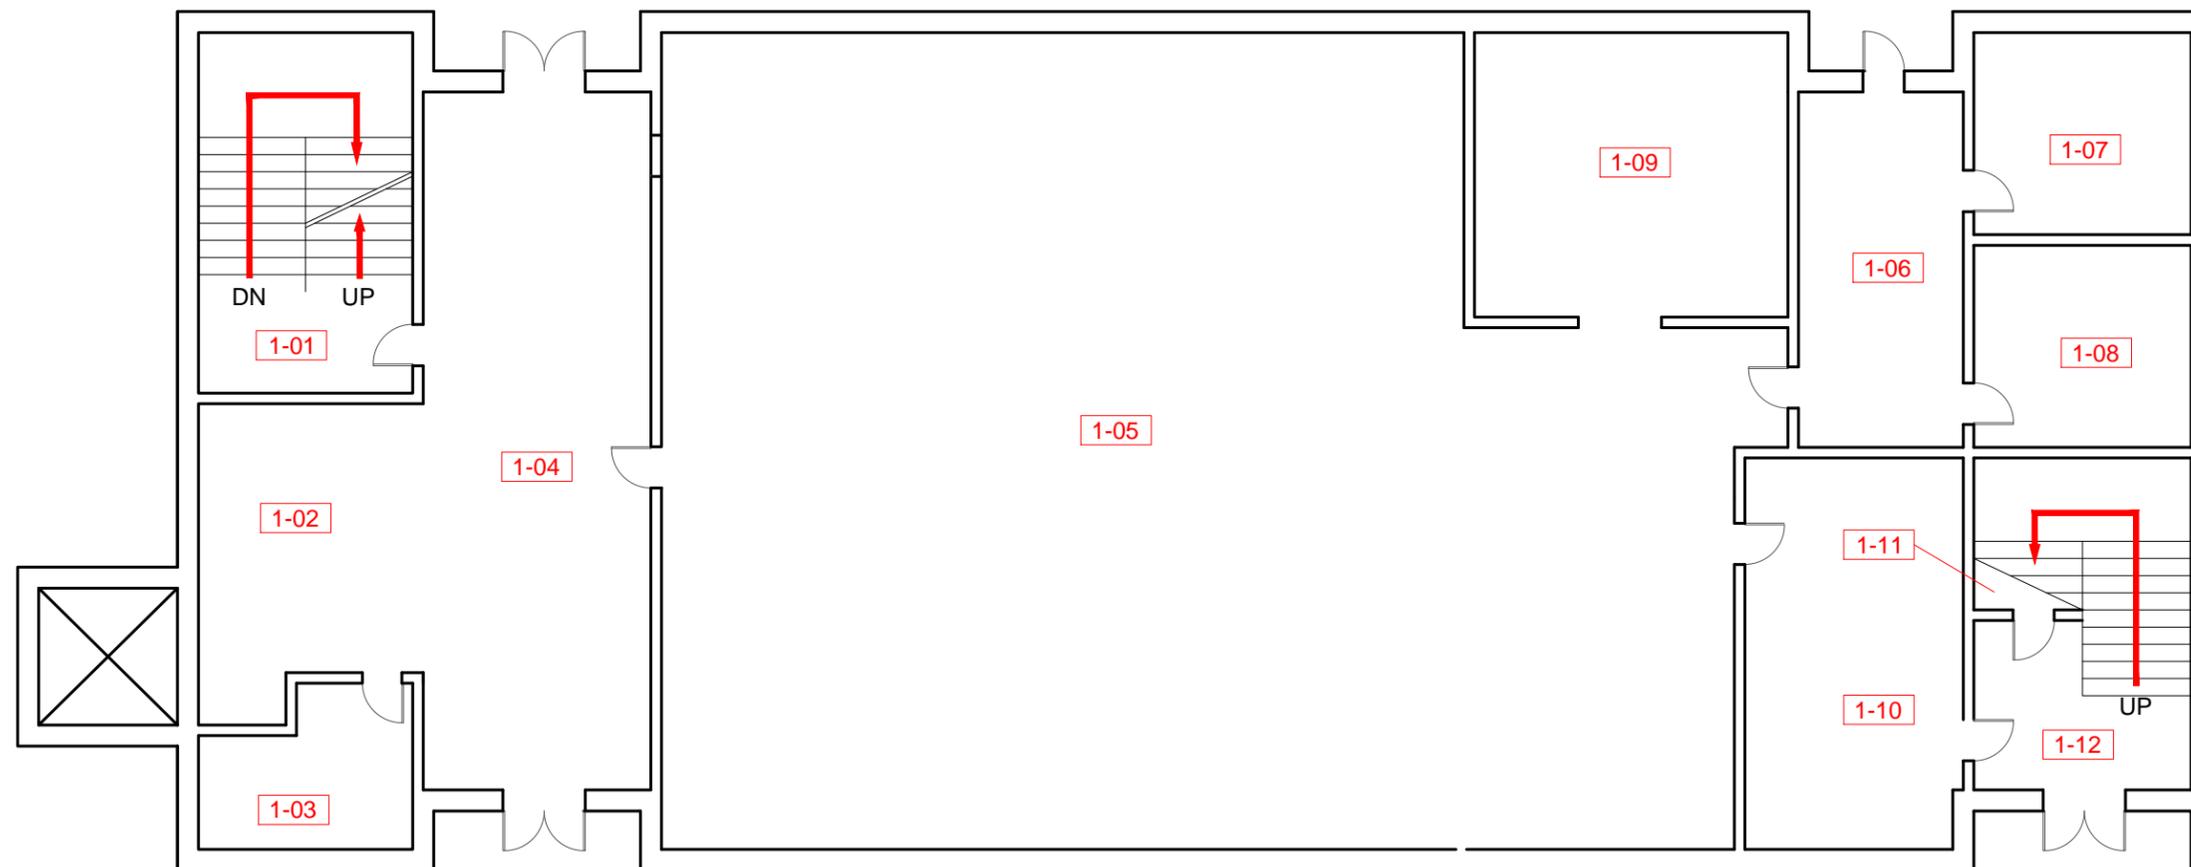
### Figure 3

The drawing does not illustrate locations of drywall joint compound, plaster, window caulking or roofing materials, for reasons discussed in Section 6 of the Standard Operating Procedure for Designated Substance Surveys. Please refer to the Designated Substance Survey Form in Appendix I for information regarding the locations and asbestos or lead-content of these materials.

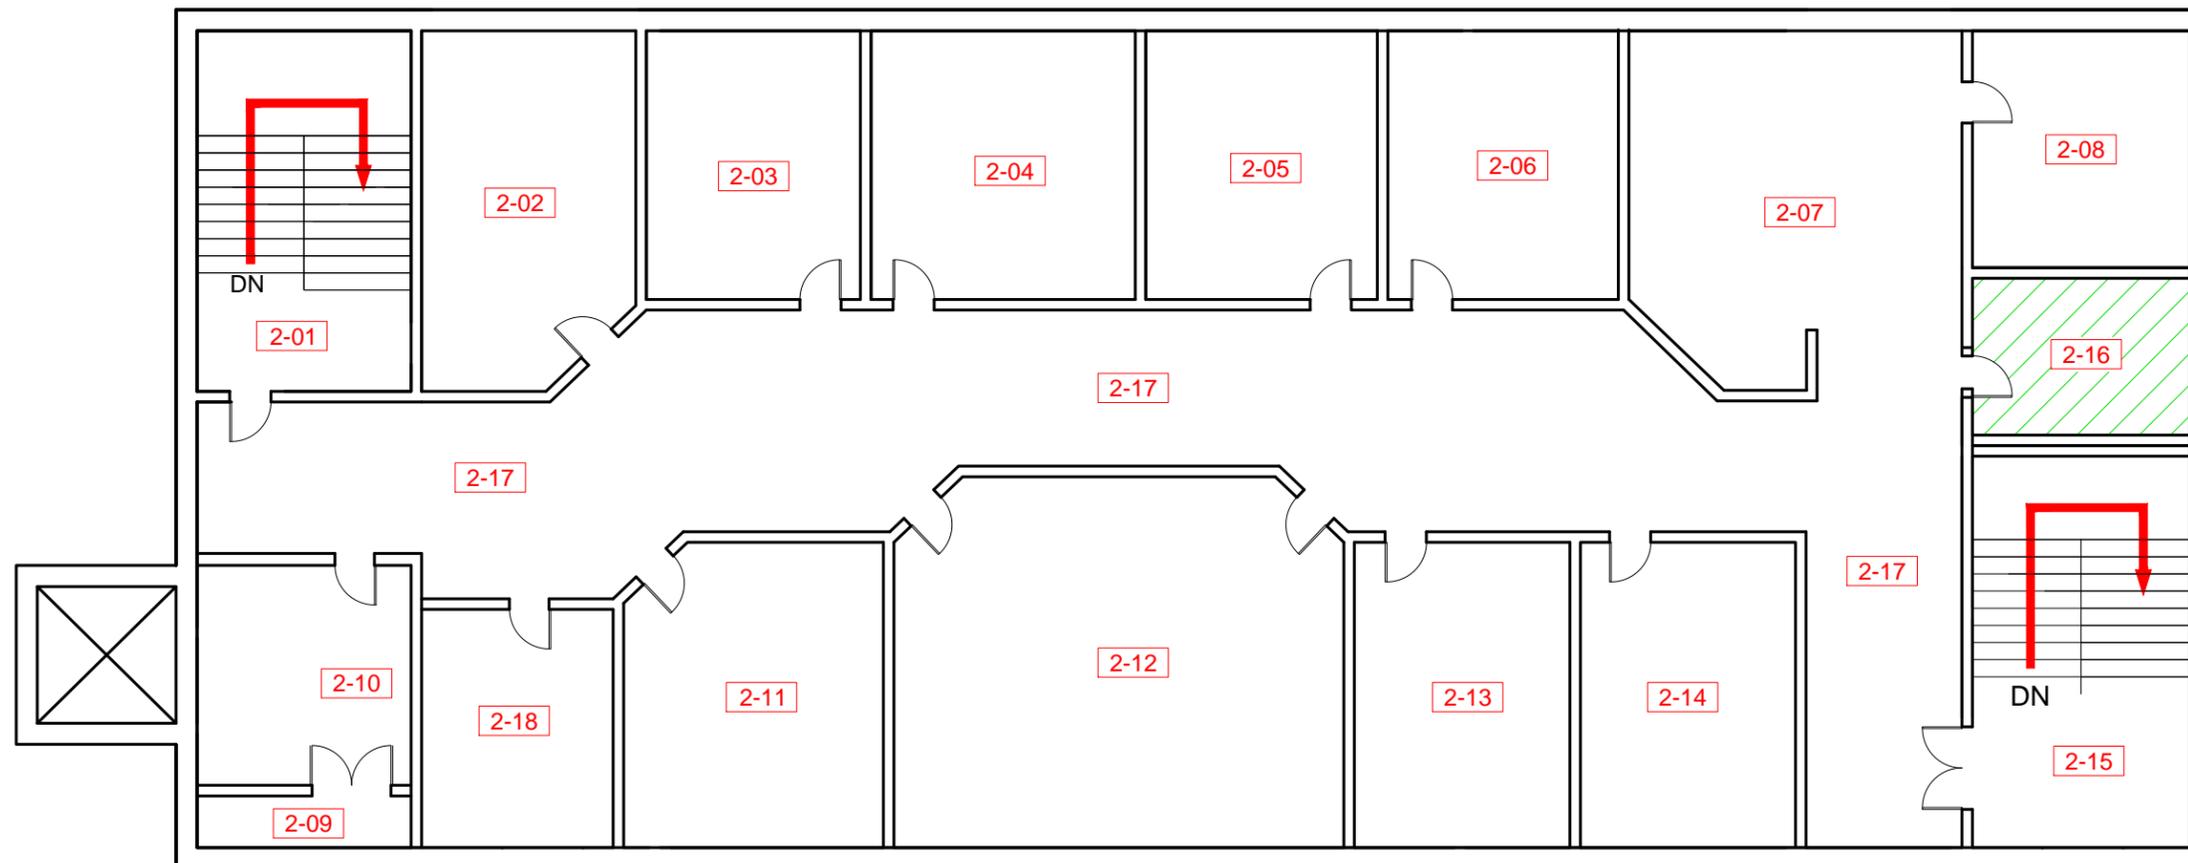
### Figure 4

The drawing does not illustrate locations of drywall joint compound, plaster, window caulking or roofing materials, for reasons discussed in Section 6 of the Standard Operating Procedure for Designated Substance Surveys. Please refer to the Designated Substance Survey Form in Appendix I for information regarding the locations and asbestos or lead-content of these materials.

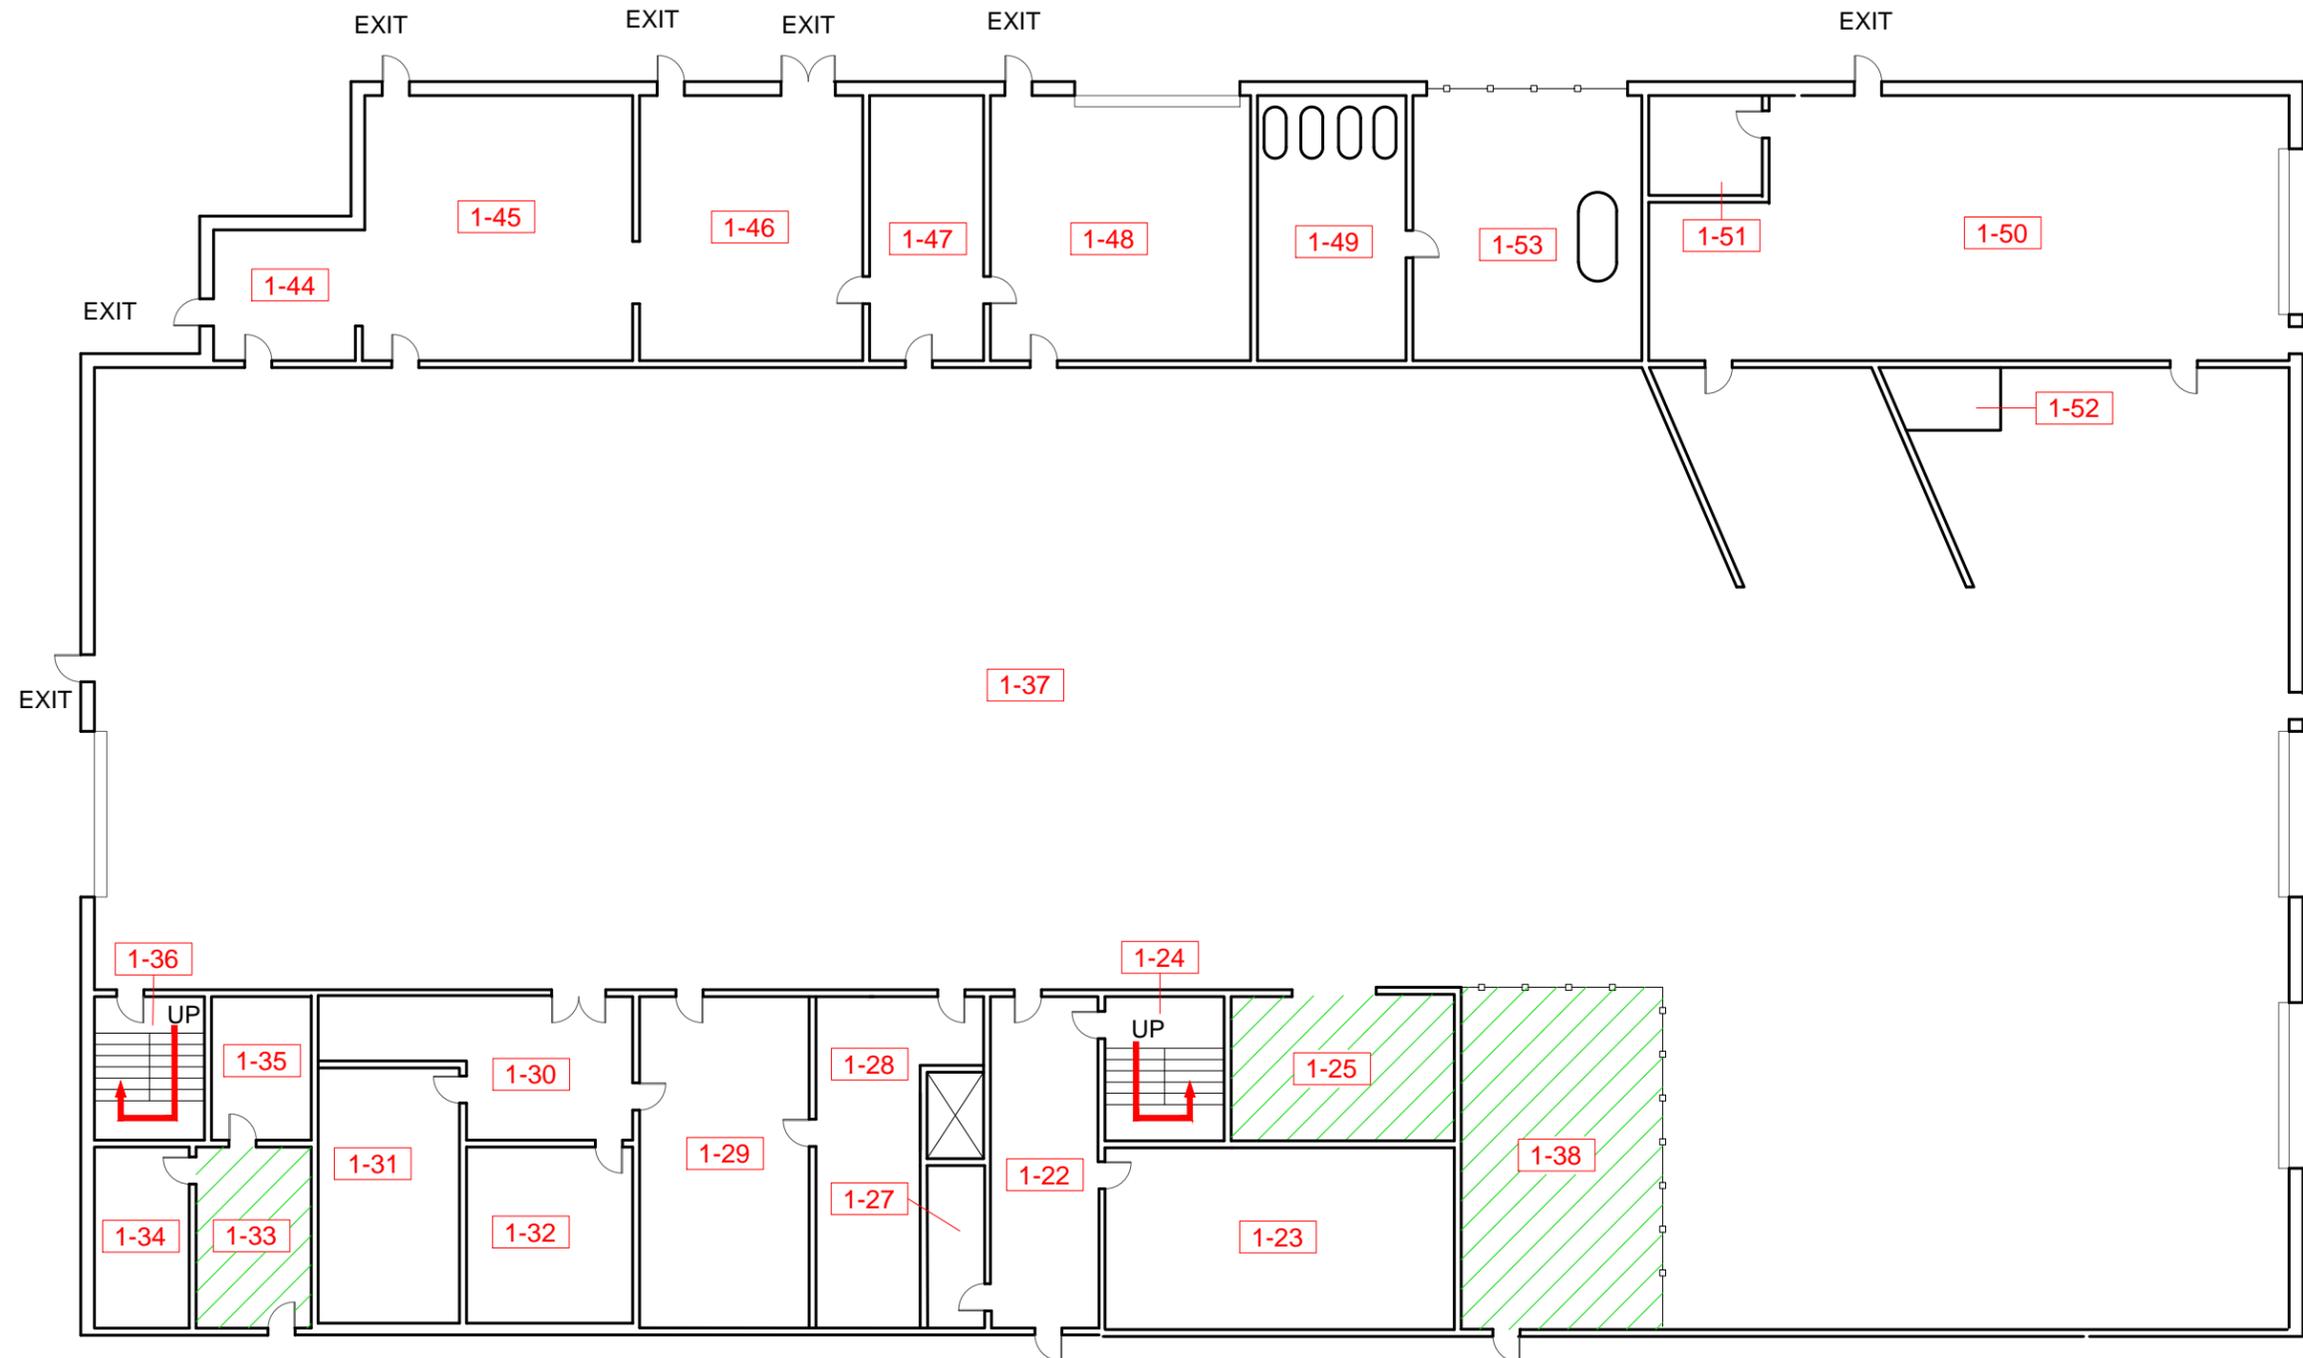
### Figure 6

The drawing does not illustrate locations of drywall joint compound, plaster, window caulking or roofing materials, for reasons discussed in Section 6 of the Standard Operating Procedure for Designated Substance Surveys. Please refer to the Designated Substance Survey Form in Appendix I for information regarding the locations and asbestos or lead-content of these materials.

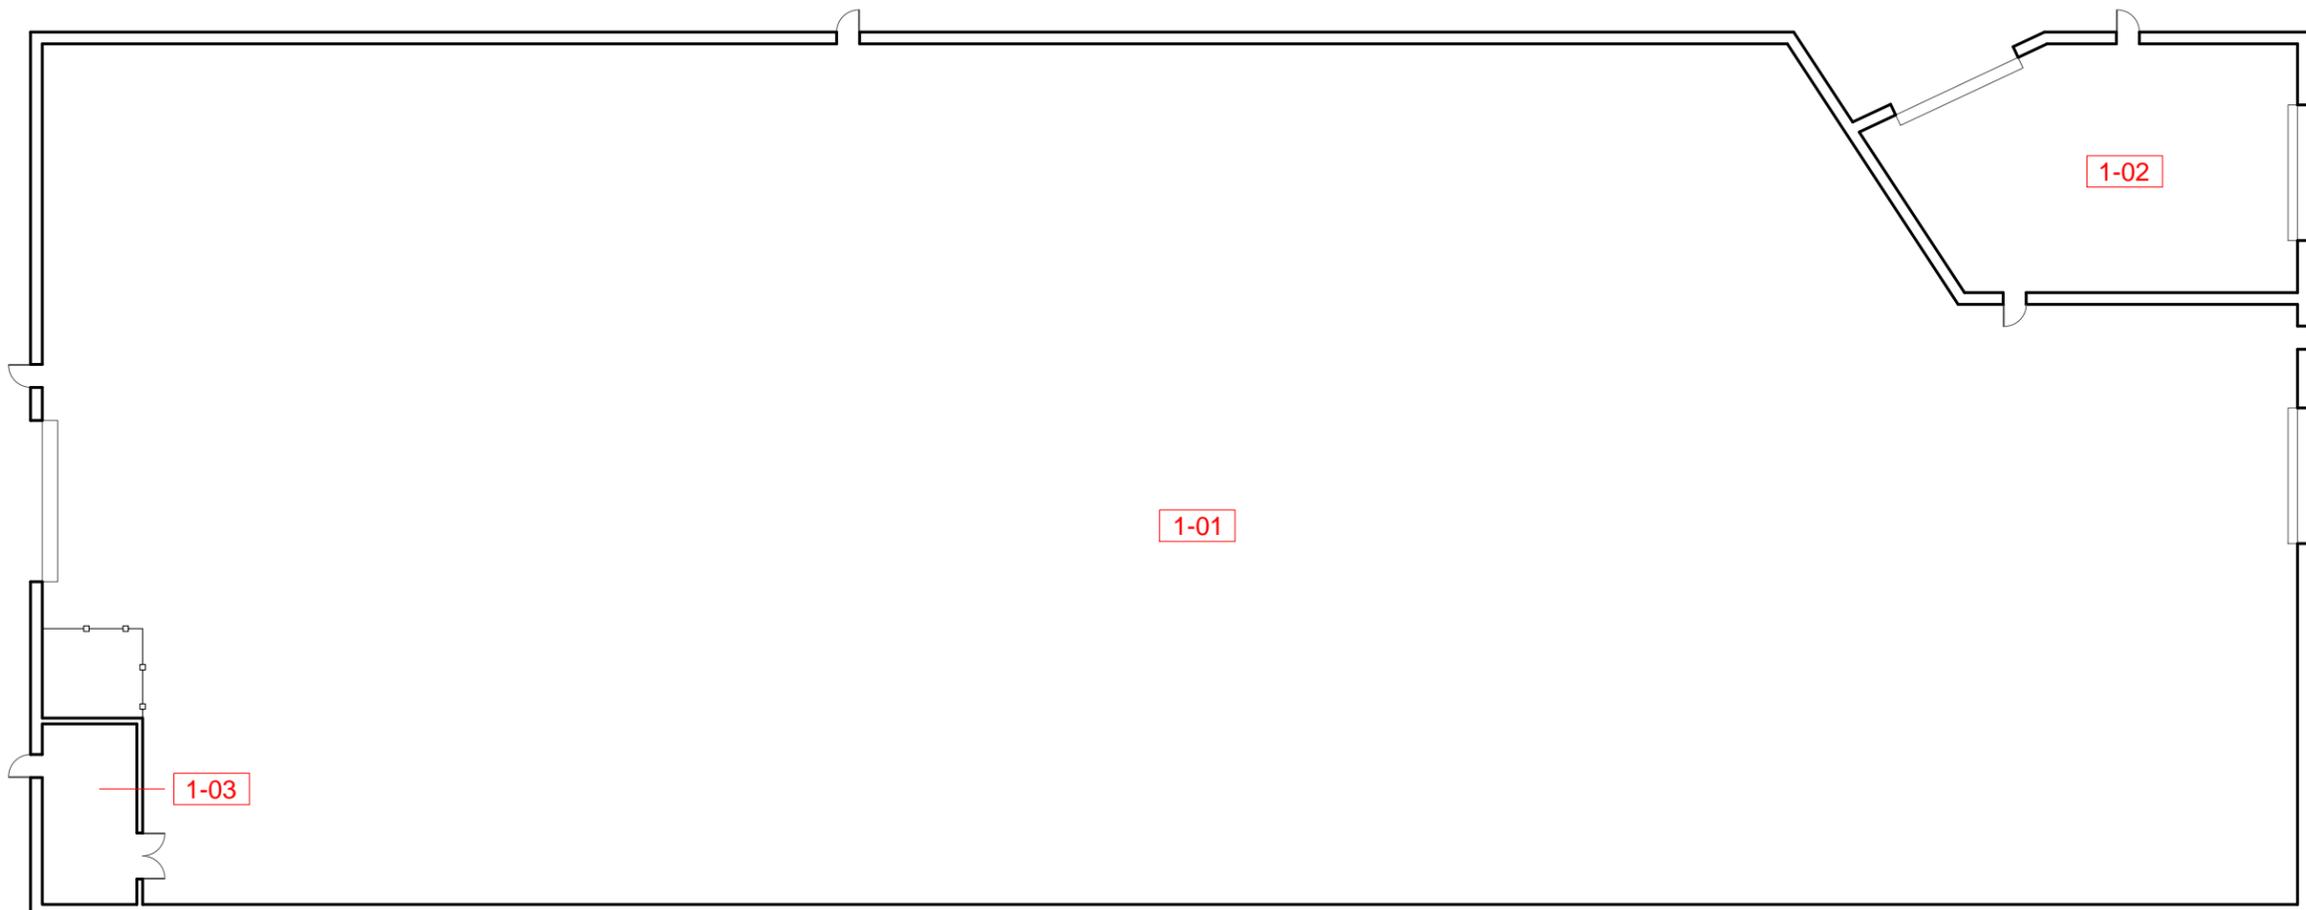
## Figure 8

The drawing does not illustrate locations of drywall joint compound, plaster, window caulking or roofing materials, for reasons discussed in Section 6 of the Standard Operating Procedure for Designated Substance Surveys. Please refer to the Designated Substance Survey Form in Appendix I for information regarding the locations and asbestos or lead-content of these materials.

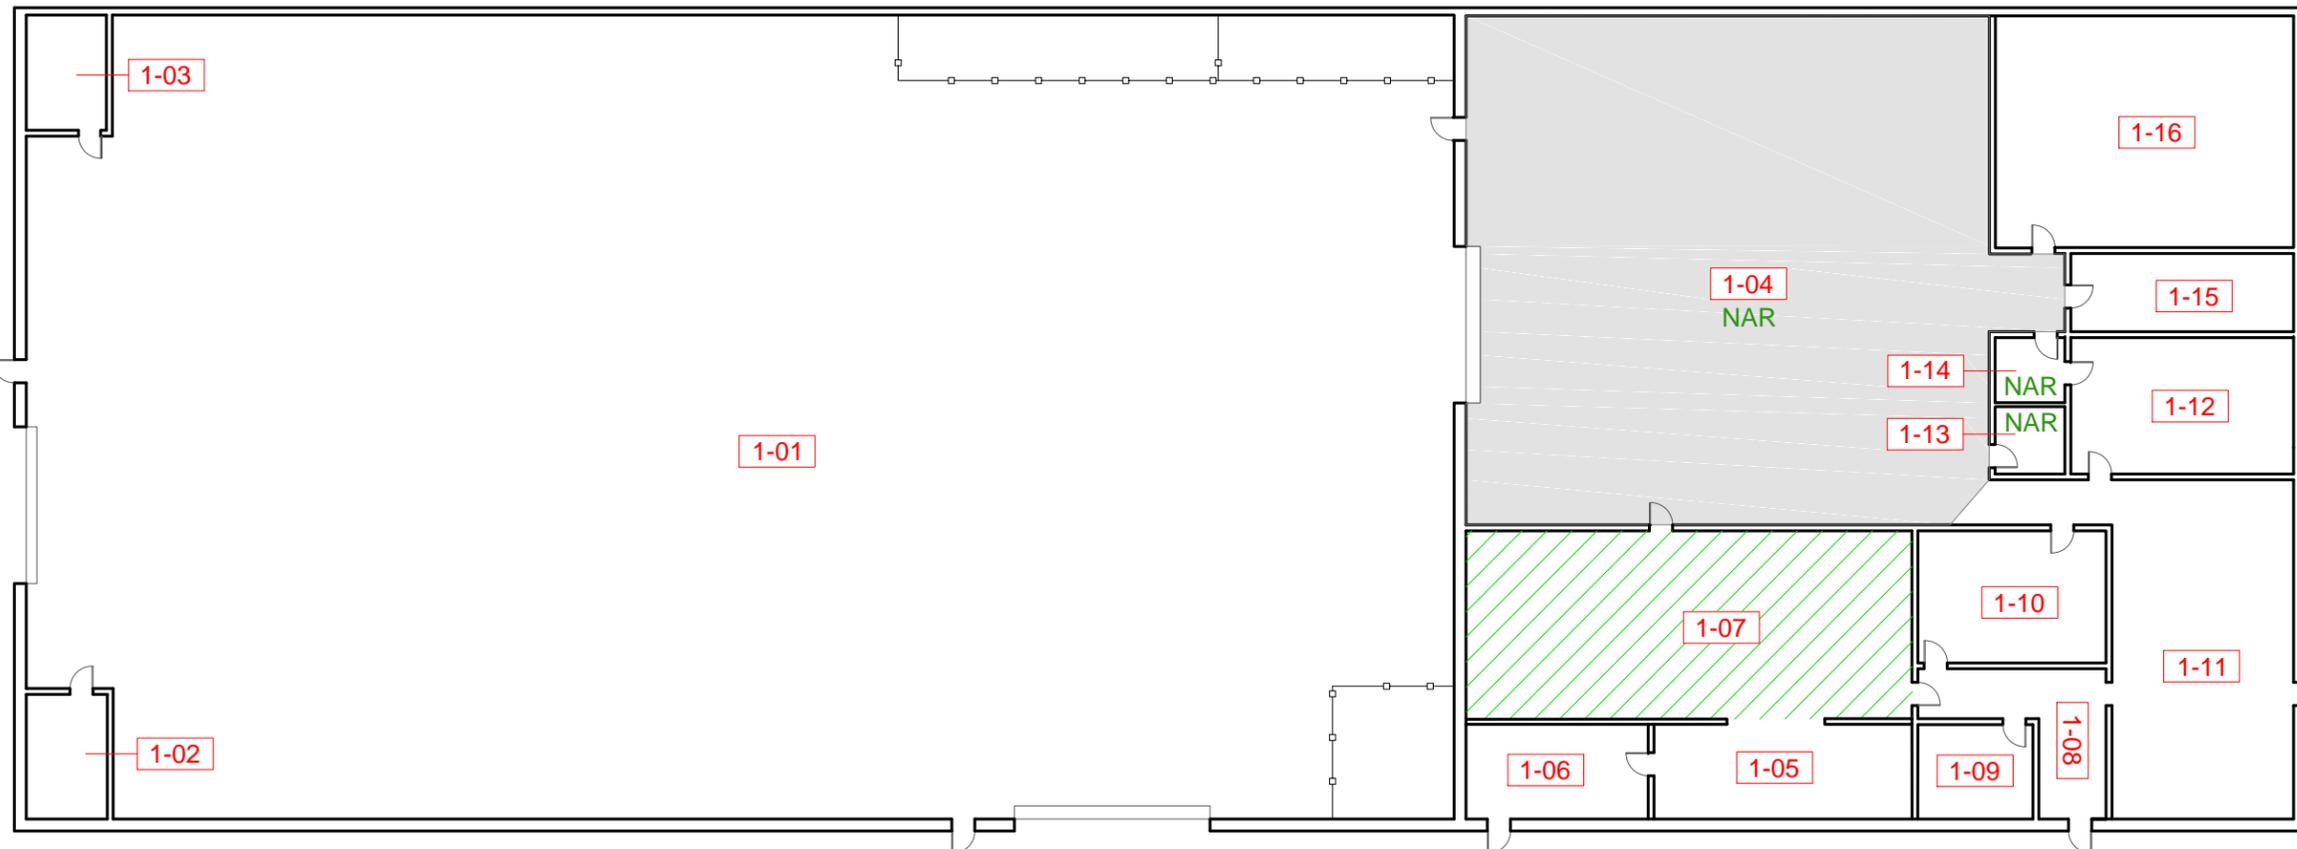
### Figure 9

The drawing does not illustrate locations of drywall joint compound, plaster, window caulking or roofing materials, for reasons discussed in Section 6 of the Standard Operating Procedure for Designated Substance Surveys. Please refer to the Designated Substance Survey Form in Appendix I for information regarding the locations and asbestos or lead-content of these materials.
