## DESIGNATED SUBSTANCE AND HAZARDOUS MATERIALS ASSESSMENT

# BUILDING NO.: 17

200 University Avenue West,  
Waterloo, Ontario

**RE: Designated Substance and Hazardous Materials Assessment  
Mathematics and Computers Building - BUILDING NO.: 17  
200 University Avenue West, Waterloo, Ontario (Site)**

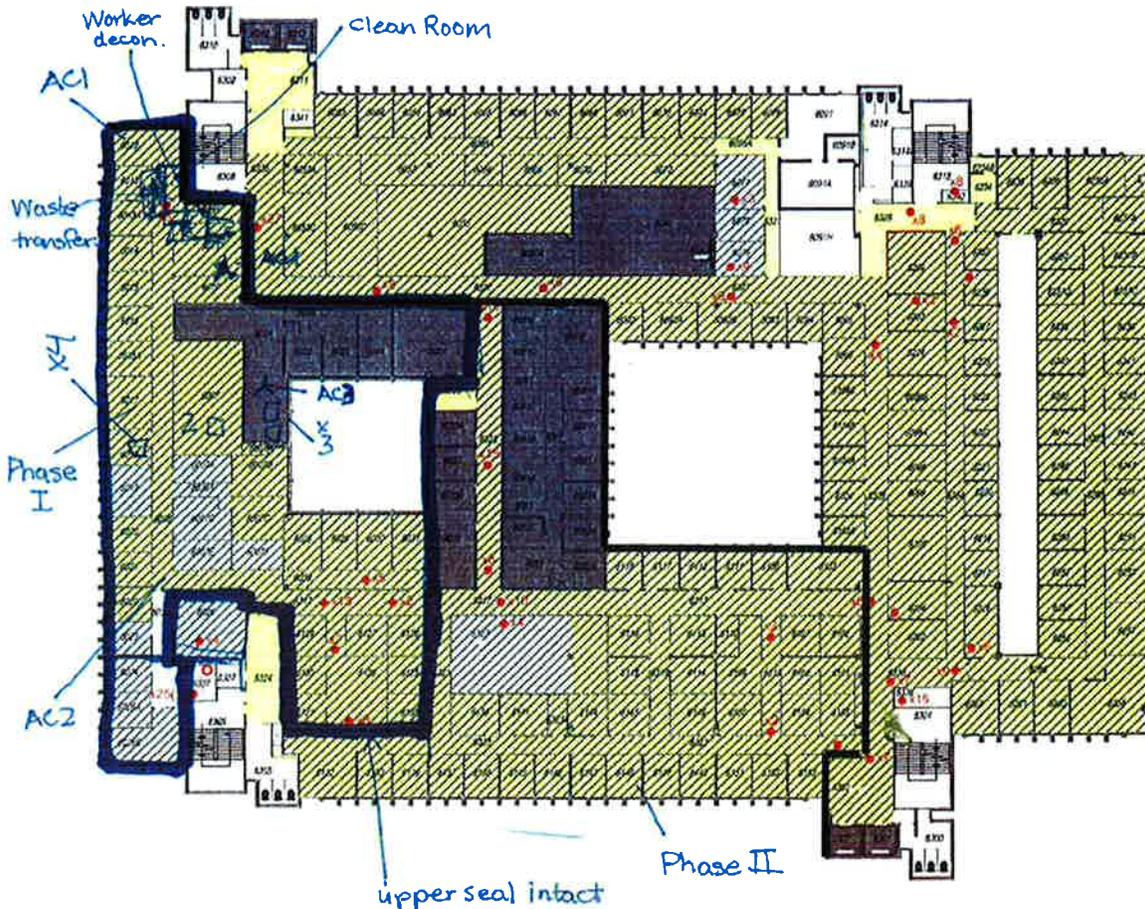
**WORK AREA LOCATION DESCRIPTION & ILLUSTRATION: Math and Computer Bldg. 6<sup>th</sup> Floor Phase I**

Approximate Area of Enclosure:	320	<input checked="" type="checkbox"/> square metres (m <sup>2</sup> ) <input type="checkbox"/> square feet (ft <sup>2</sup> )	1 m <sup>2</sup> = 10.76 ft <sup>2</sup>	Approximate Height of Enclosure:	3.5	<input checked="" type="checkbox"/> metres (m) <input type="checkbox"/> feet (ft)	1 m = 3.28 ft
--------------------------------	-----	--	--	----------------------------------	-----	--	---------------

Notes: All partition walls sealed with polyethylene sheeting

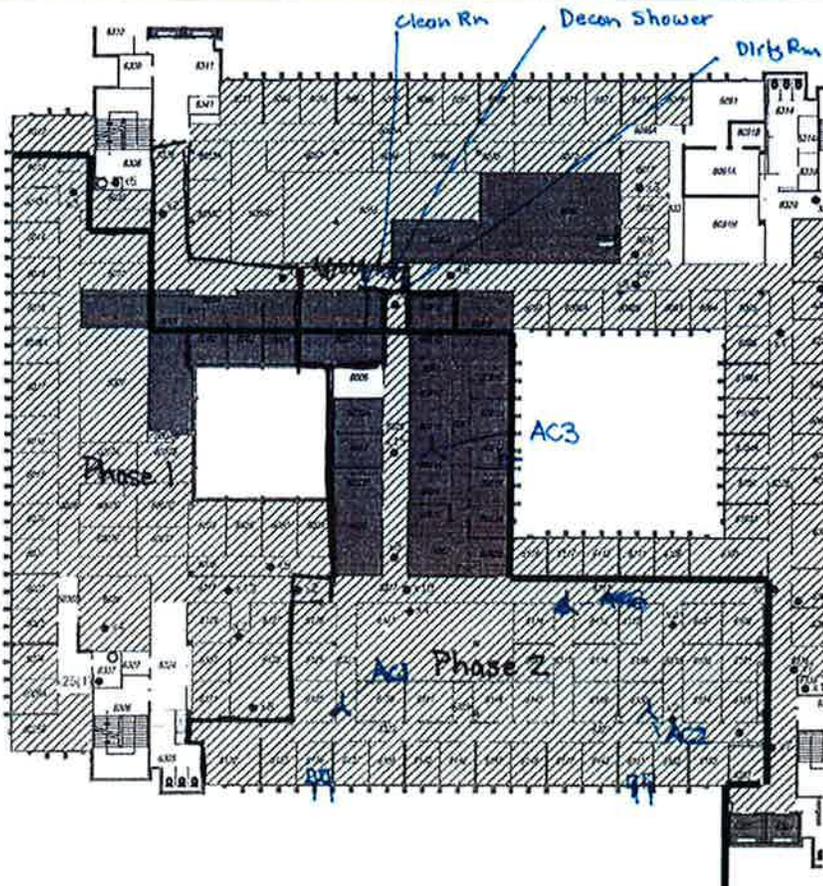
**WORK AREA LOCATION DESCRIPTION & ILLUSTRATION: Math and Computer Bldg. 6<sup>th</sup> Floor Phase 2**

Approximate Area of Enclosure: <u>340</u>	<input checked="" type="checkbox"/> square metres (m <sup>2</sup> )	1 m <sup>2</sup> = 10.76 ft <sup>2</sup>	Approximate Height of Enclosure: <u>3.8</u>	<input checked="" type="checkbox"/> metres (m)	1 m = 3.28 ft
	<input type="checkbox"/> square feet (ft <sup>2</sup> )			<input type="checkbox"/> feet (ft)

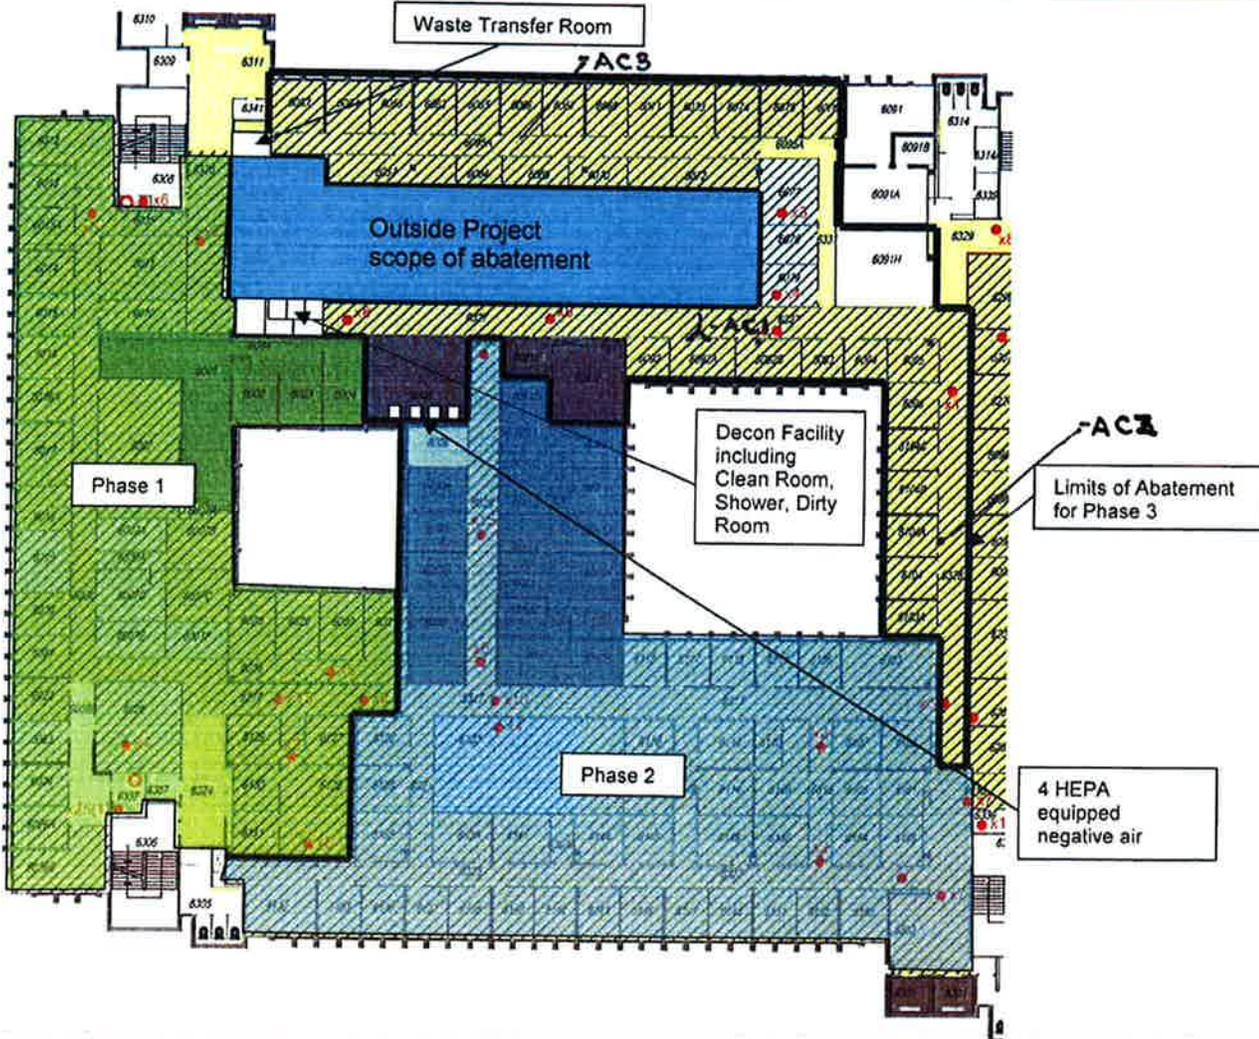
**WORK AREA LOCATION DESCRIPTION & ILLUSTRATION: Math and Computer Bldg. 6<sup>th</sup> Floor Phase 3**

Approximate Area of Enclosure:	<u>310</u>	<input checked="" type="checkbox"/> square metres (m <sup>2</sup> ) <input type="checkbox"/> square feet (ft <sup>2</sup> )	1 m <sup>2</sup> = 10.76 ft <sup>2</sup>	Approximate Height of Enclosure:	<u>3.5</u>	<input checked="" type="checkbox"/> metres (m) <input type="checkbox"/> feet (ft)	1 m = 3.28 ft
--------------------------------	------------	--	---	----------------------------------	------------	--	------------------

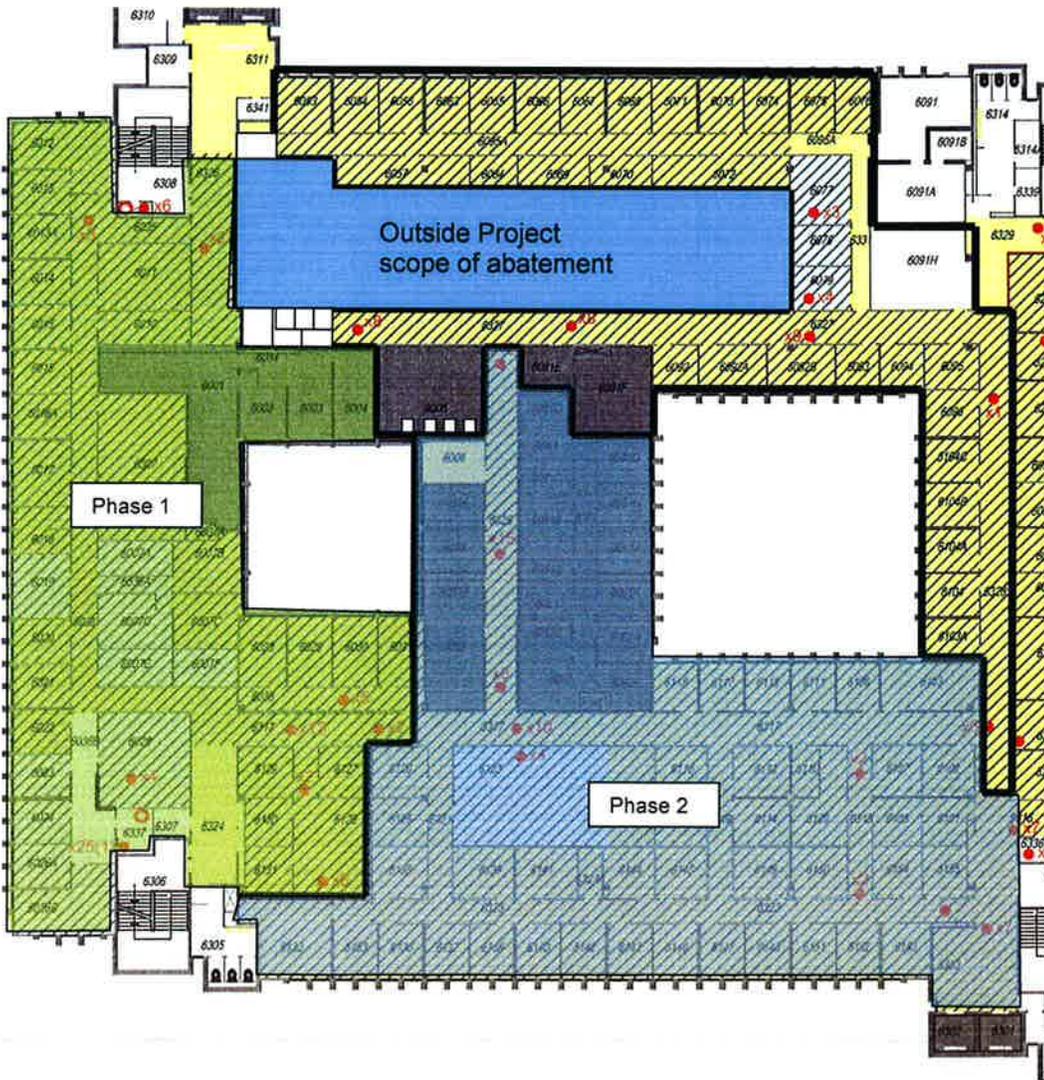
**WORK AREA LOCATION DESCRIPTION & ILLUSTRATION: Math and Computer Bldg. 6<sup>th</sup> Floor**

Approximate Area of Enclosure:	<input type="checkbox"/> square metres (m <sup>2</sup> ) <input type="checkbox"/> square feet (ft <sup>2</sup> )	1 m <sup>2</sup> = 10.76 ft <sup>2</sup>	Approximate Height of Enclosure:	<input type="checkbox"/> metres (m) <input type="checkbox"/> feet (ft)	1 m = 3.28 ft
--------------------------------	---	--	----------------------------------	---	---------------

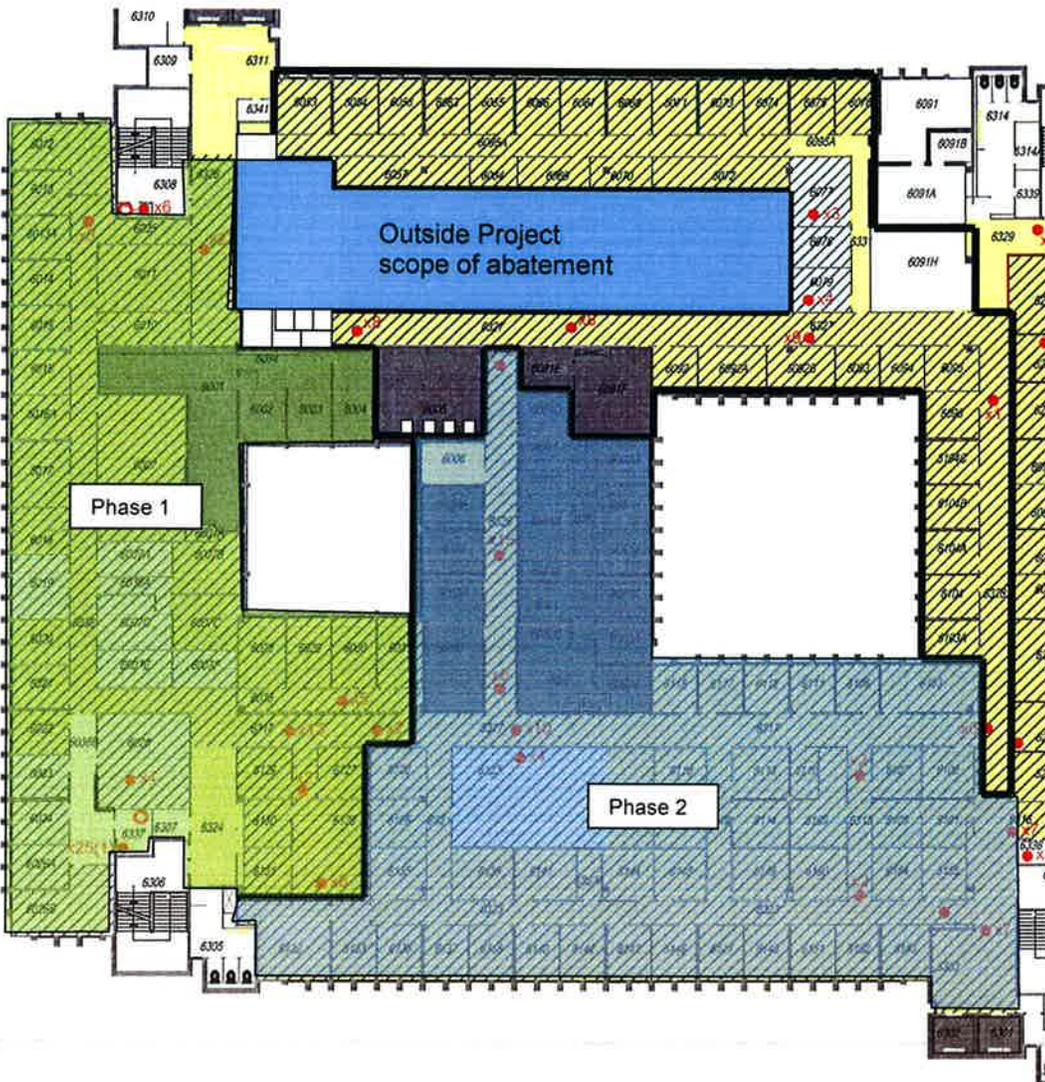
**WORK AREA LOCATION DESCRIPTION & ILLUSTRATION: Math and Computer Bldg. 6<sup>th</sup> Floor**

Approximate Area of Enclosure:	<input type="checkbox"/> square metres (m <sup>2</sup> ) <input type="checkbox"/> square feet (ft <sup>2</sup> )	1 m <sup>2</sup> = 10.76 ft <sup>2</sup>	Approximate Height of Enclosure:	<input type="checkbox"/> metres (m) <input type="checkbox"/> feet (ft)	1 m = 3.28 ft
--------------------------------	---	--	----------------------------------	---	---------------

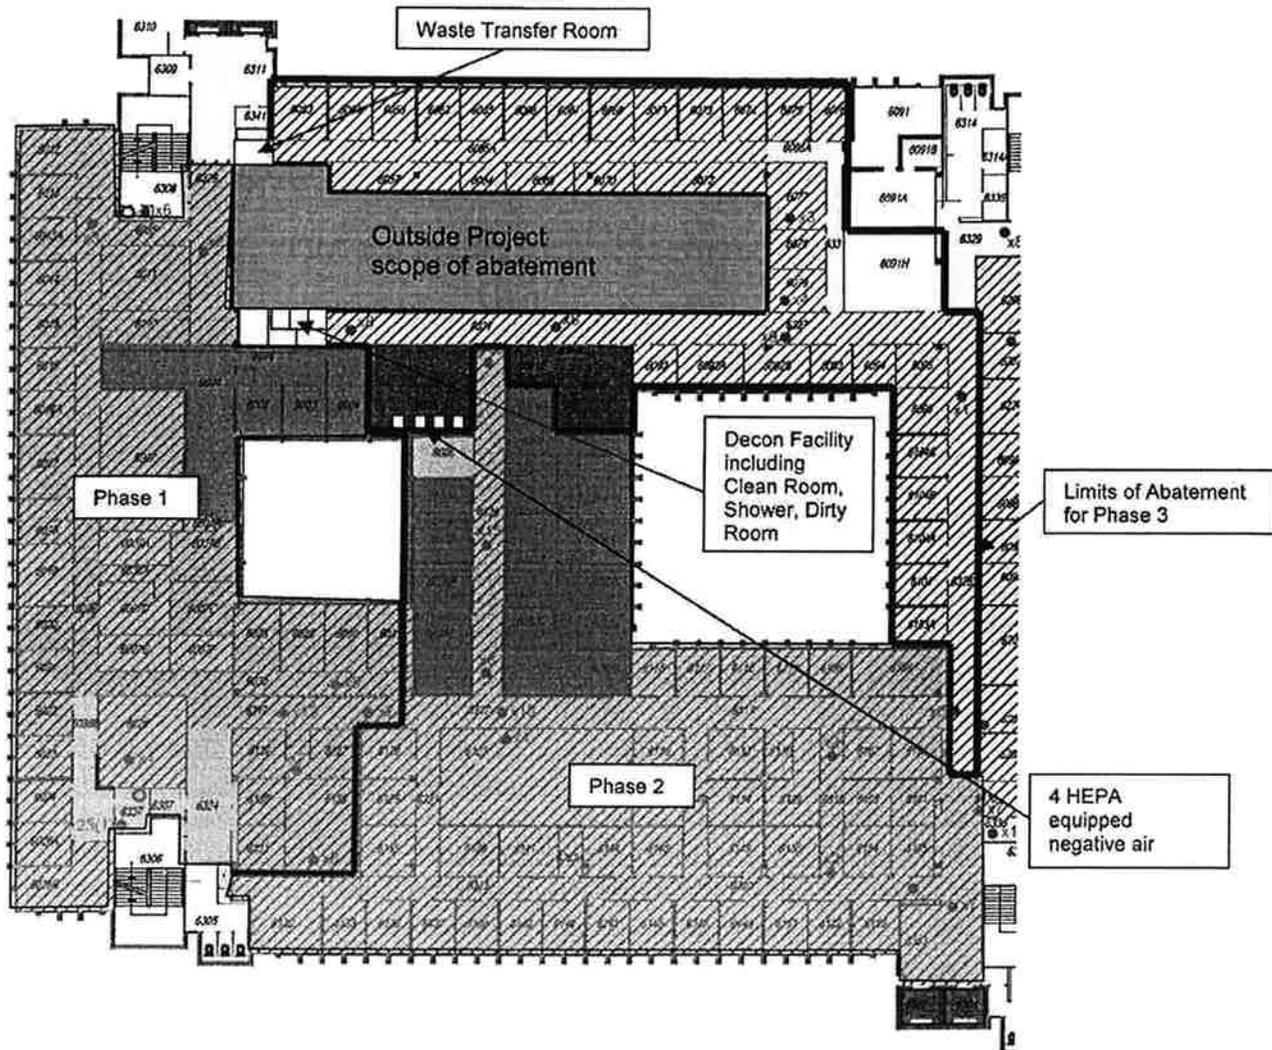
**WORK AREA LOCATION DESCRIPTION & ILLUSTRATION: Math and Computer Bldg. 6<sup>th</sup> Floor Phase 3**

Approximate Area of Enclosure:	<input type="checkbox"/> square metres (m <sup>2</sup> )	1 m <sup>2</sup> = 10.76 ft <sup>2</sup>	Approximate Height of Enclosure:	<input type="checkbox"/> metres (m)	1 m = 3.28 ft
	<input type="checkbox"/> square feet (ft <sup>2</sup> )			<input type="checkbox"/> feet (ft)
