# DETAILED ASBESTOS-CONTAINING BUILDING MATERIALS SURVEY REPORT

## DURHAM DISTRICT SCHOOL BOARD EA LOVELL CONTINUING EDUCATION CENTRE 120 CENTRE STREET SOUTH OSHAWA, ONTARIO

**Maple Project No. 16312-118**

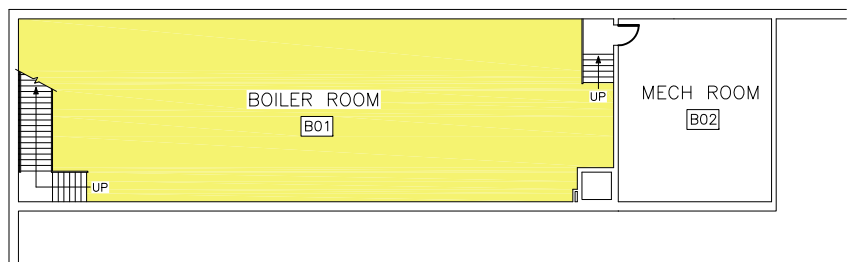
- NOTE:**
- 1) Drywall joint compound and exterior textured plaster are suspected to contain asbestos until sampling proves otherwise. Locations are not shown.
  - 2) Interior smooth and textured plaster are confirmed to be asbestos-containing through limited sampling. Locations are not shown.
  - 3) Woven gaskets present in B01 are suspected to contain asbestos.
  - 4) Fire rated doors present within eBase #B01, B02 and 347 are suspected to contain asbestos until sampling proves otherwise.
