Re: Asbestos and Lead Test Results
Burlington City Hall, 426 Brant Street, Burlington, Ontario
Pinchin File: 320578.008

Pinchin Ltd. (Pinchin) was retained by the City of Burlington (Client) to collect bulk samples of building materials for asbestos and lead analysis within the Burlington City Hall located at 426 Brant Street, Burlington, Ontario. Sample collection was performed by Pinchin on May 15, 2024.

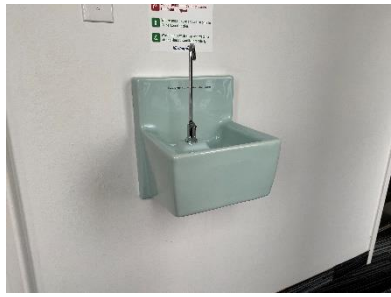
Sample No.	Location	Description	Result (Type and %)	Photo
S0040A-D	5 th and 6 th Floor (Locations 10 and 11)	Plaster on walls at fountains	Base Coat: Chrysotile <0.5%* Skim Coat: None Detected

*The base coat of the plaster contains a small percentage of chrysotile asbestos in the assessed area (samples S0040A-D; phase a). This small concentration (<0.5%) is less than the regulatory cut-off for an asbestos-containing material and therefore the plaster is a non-asbestos material.

Remedial work is not required.

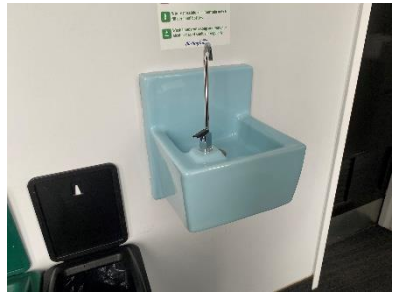
Sample No.	Location	Description	Result (%)	Photo
L0006	5 th and 6 th Floors (Locations 10 and 11)	White plaster on walls	0.00052

Results less than 0.009% (90 mg/kg) are assumed to be insignificant.
