DESIGNATED SUBSTANCE SURVEY

Bluffer's Park East Washroom

1 Brimley Road South

CCIG Project No: T1611451CA

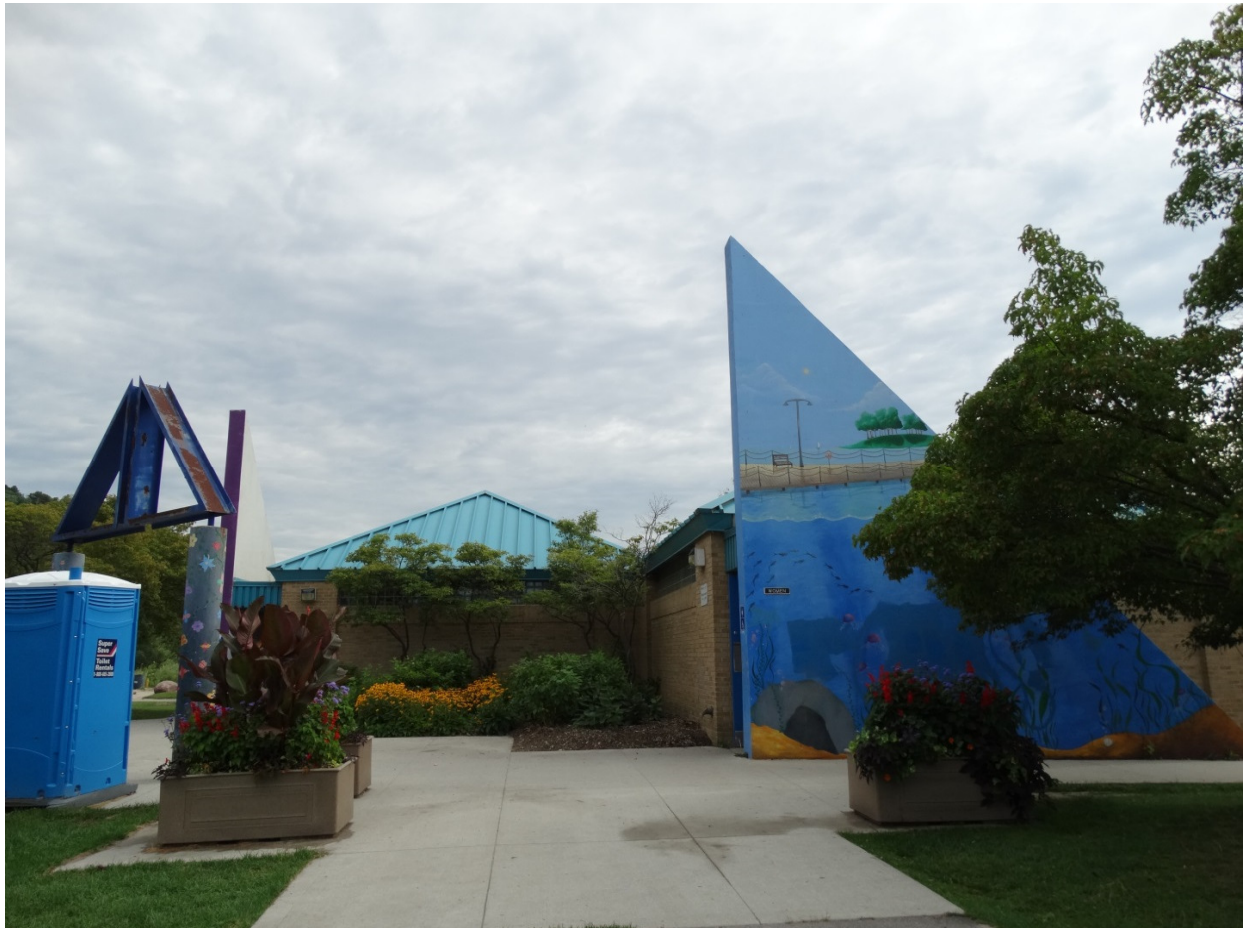
The Survey Area consisted of a single (1) storey washroom building with garage. The building was constructed in 1989. Interior finishes consist of ceramic tiles, painted concrete block, exposed concrete, and metal panels. All domestic hot and cold water lines throughout the Survey Area are copper with all-service jacket on fibreglass insulation.

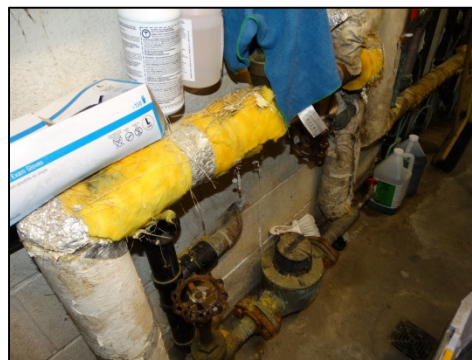
- Mechanical Piping Insulation

Pipe insulation was observed throughout the Survey Area and found to be comprised of fiberglass with all service jacket cover. No sampling conducted.

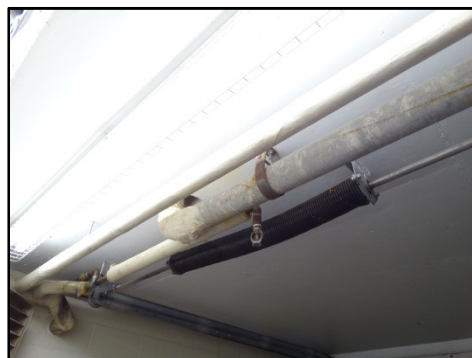
- Storm Drainage Piping

Transite piping is presumed to contain asbestos. No other ACMs were found or are expected to be found.

Storm drainage piping is transite and presumed to contain asbestos. No samples were taken due to the nature of the material.

Maintain storm drainage piping in good condition. Remove in accordance with O. Reg. 278/05.

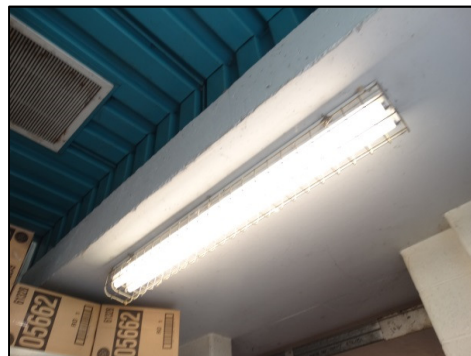
- Light Ballasts/Transformers

The building is illuminated using newer T-8 fluorescent and compact fluorescent bulbs. The ballasts are not expected to contain PCBs. The transformers are non-PCB type ballasts.
